REPORT OF THE DIRECTOR
BUREAU OF SAFETY

ACCIDENT ON THE
BURLINGTON-ROCK ISLAND RAILROAD

NORMANGEE, TEX.

INVESTIGATION NO. 2229

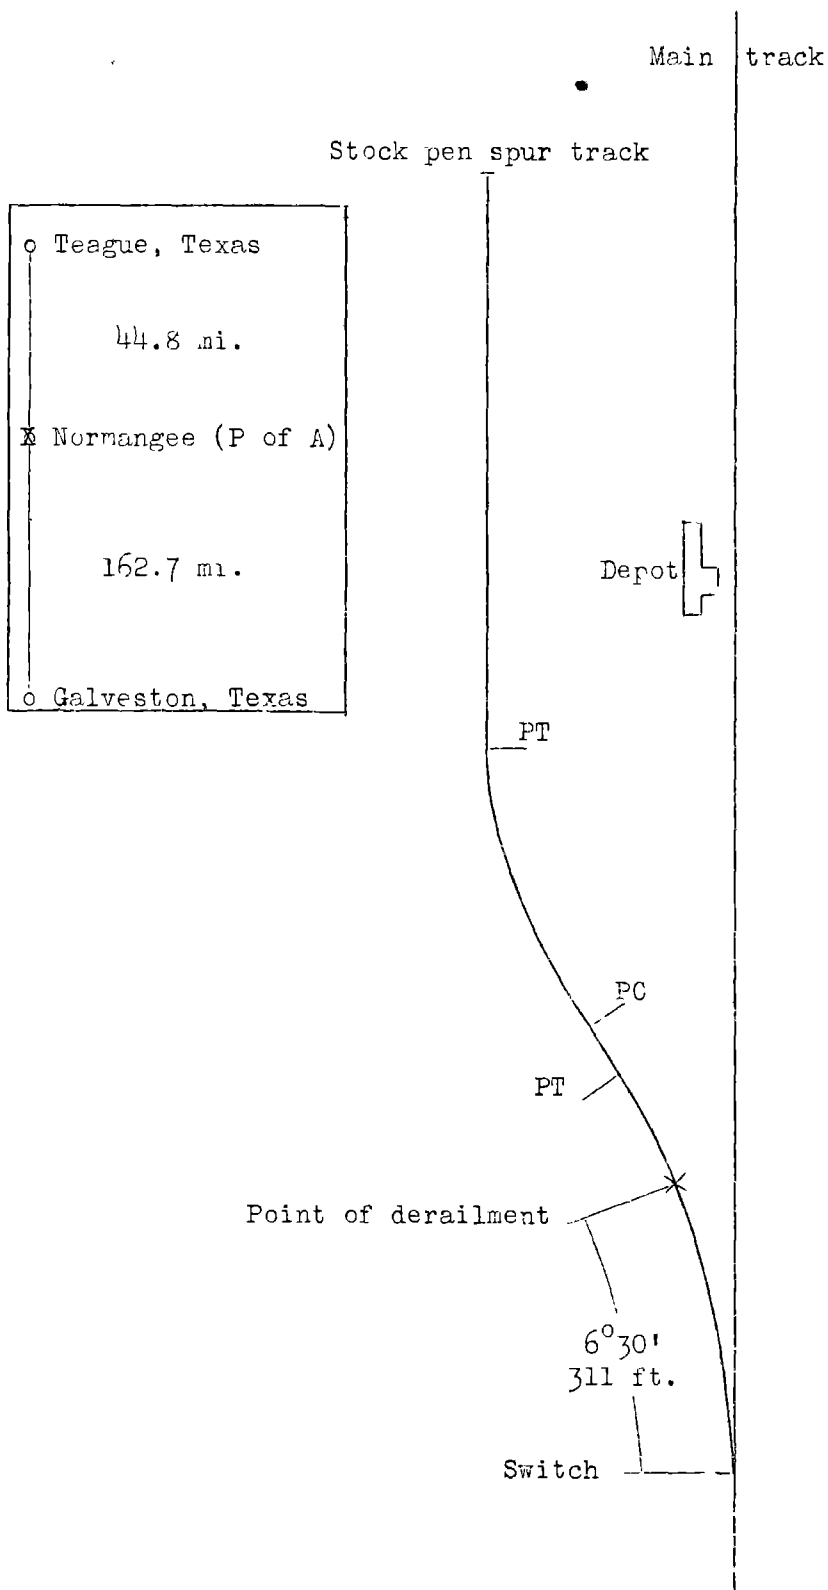
Inv. No. 2229
 Burlington--Rock Island RR,
 Normangee, Texas
 Nov. 30, 1937

This accident occurred on the Teague Subdivision which extends from Teague to Galveston, Tex., a distance of 207.5 miles. The point of derailment was on the stock pen spur track which lies west of the main track at Normangee and is 1,600 feet long.

The spur track switch is a facing-point switch for northward movements and leads off the main track through a #11 turnout which is built of 90-pound track material. Beyond the turnout rails the spur track is laid with 75-pound rail, on 20 ties per 33-foot rail; it is single-spiked and fully tie plated, and is ballasted with oyster shells to a depth of approximately 6 inches under the ties. At the point of derailment the spur track is on a fill approximately $2\frac{1}{2}$ feet in height. Starting at the frog of the switch and proceeding northward along the spur, there is a $6^{\circ}30'$ curve to the left which extends to a point 418 feet north of the point of switch. The derailment was initiated on this curve at a point 311 feet north of the switch. At the point of derailment the grade is approximately 0.3 percent descending northward. The superelevation varies from zero at the ends of the curve to $5\frac{1}{2}$ inches at its center and is $1\frac{7}{8}$ inches at the point of derailment. The main track is tangent and level in each direction from the spur track switch. General maintenance of the spur track is good; at no point was the gauge more than $\frac{3}{8}$ inch wide, except at a public road crossing located a short distance south of the derailment, where it was $\frac{3}{4}$ inch wide. Speed on the spur track is restricted to 15 miles per hour. A stock pen is located to the west of the spur track between points about 350 feet and 450 feet north of the switch.

Examination of the spur track south of the point of derailment to the switch point disclosed that it was in good condition as to rails, spikes, ties, tie plates, ballast and gauge. However, the superelevation was very irregular; it dropped from $5\frac{1}{2}$ inches to $1\frac{7}{8}$ inches within the 45 feet just south of the point of derailment, and within the 23 feet immediately south of the point

of derailment there was a variation downward of $2 \frac{7}{16}$ inches. Marks of derailment were practically the same as those previously described by Chief Engineer Broome.
