REPORT OF THE DIRECTOR  
BUREAU OF SAFETY

ACCIDENT ON THE  
CALIFORNIA WESTERN RAILWAY  
AND NAVIGATION COMPANY

FORT BRAGG, CALIF.

INVESTIGATION NO. 2033

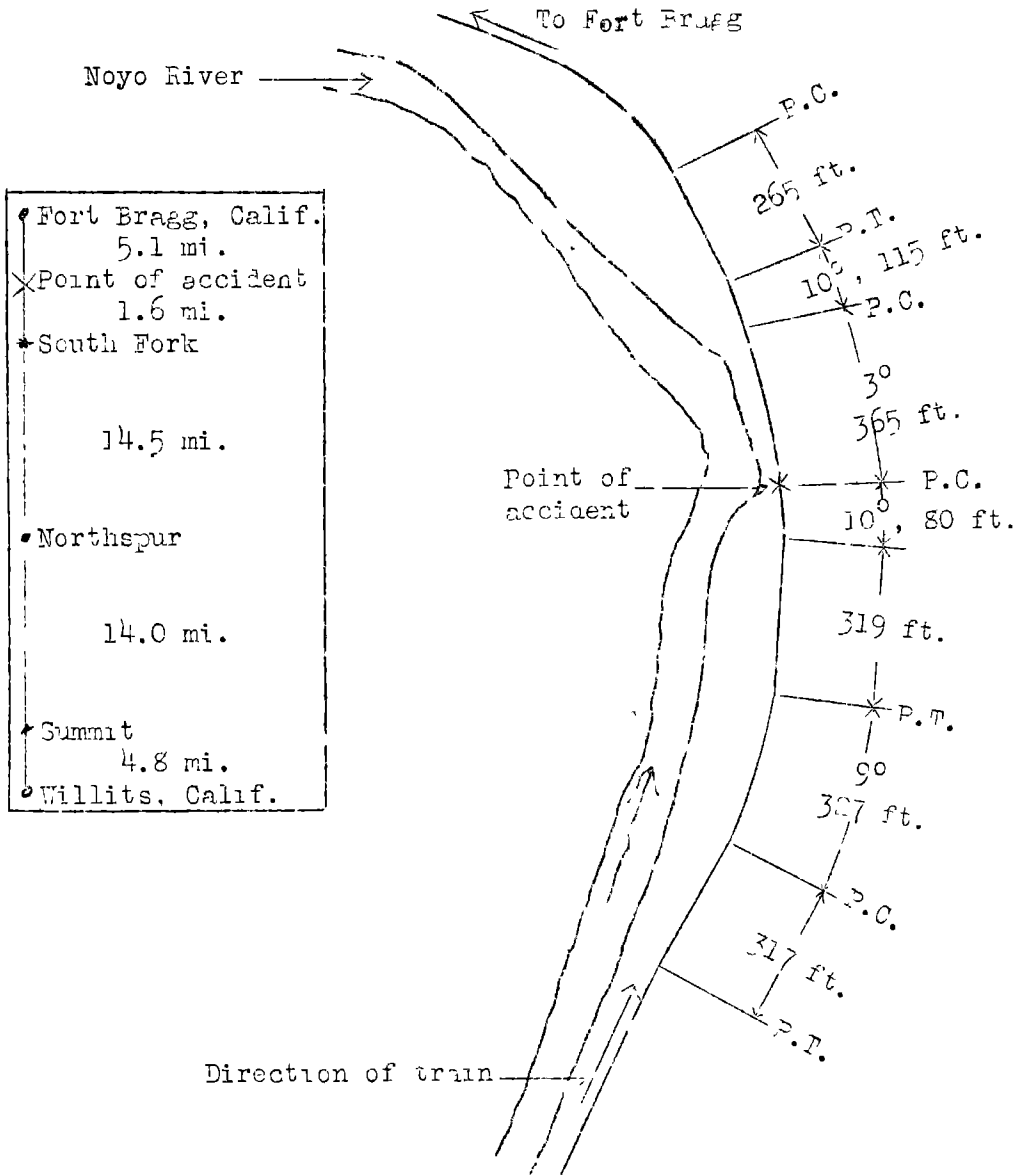
Inv. No. 2033  
California Western Ry. & Nav. Co.  
Fort Bragg, California  
Jan. 11, 1936

The washout had caused a gap in the fill beneath the track about 40 feet in length and 10 feet in depth and engine 23 dropped into this gap, stopping upright and in line with the track, with the forward end jammed into the embankment at the eastern end of the gap and the top of the engine about 2 feet above the original height of the rails; the rear wheels of the tender remained on the rails at the western edge of the gap. The employee killed was the fireman and the employee injured was the engineman.
