## INTERSTATE COMMERCE COMMISSION

REPORT OF THE DIRECTOR OF THE BUREAU OF SAFETY CONCERNING  
AN ACCIDENT WHICH OCCURRED ON THE CENTRAL OF GEORGIA  
RAILWAY AT GIRARD, ALA., ON JUNE 2, 1932.

July 25, 1932.

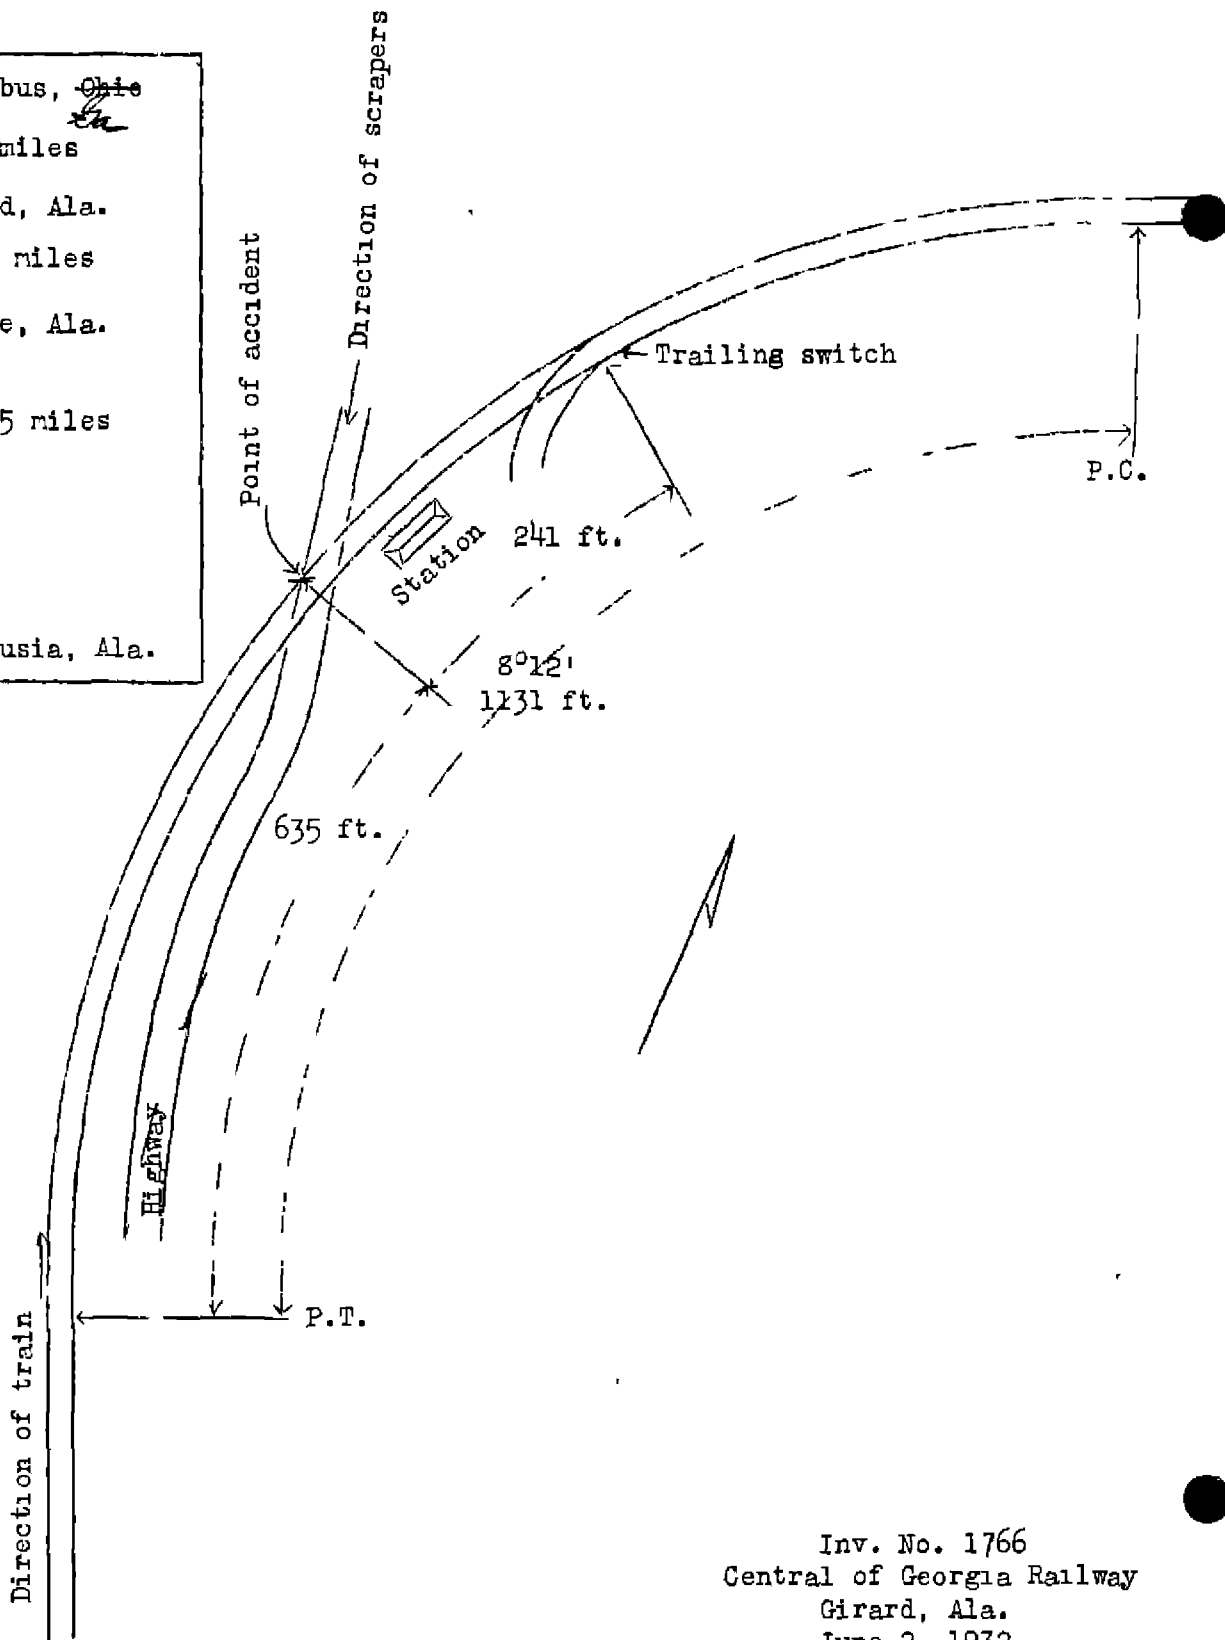
Inv. No. 1766  
Central of Georgia Railway  
Girard, Ala.  
June 2, 1932

The engine and tender were derailed to the left, the engine being stopped bottom up and practically reversed at the foot of a fill, with the forward end 303 feet from the initial point of derailment and 28 feet from the center line of the track. The tender cistern was torn from its frame and stopped on its right side opposite the rear end of the engine and with its head end resting on the rear wheels of the engine, the frame remained coupled to the engine. Both the engine and tender were badly damaged and the leading car sustained slight damage, although it had only one pair of wheels derailed. The employce killed was the engineman and the employce injured was the fireman.

An examination of the track by the Commission's inspectors about 24 hours after the occurrence of the accident disclosed that the first mark of derailment was a flange mark between the rails 3 inches from the inside or south rail and about 8 inches from the west side of the crossing. The next marks appeared on the surface of the road 5 inches outside of the outside or north rail, 19 feet east of the first mark. These marks were followed by a mark on an angle-bar bolt on the north rail 36 feet beyond, and from that point other marks were found on the ties which extended to a trailing-point switch, a distance of 186 feet; from this latter point repairs had been made to the track. Scraper marks were clearly visible on the highway on both sides of the highway and there was a pile of dirt located on the west side of the highway to the north of the track which resembled the dirt still remaining on the track at the initial point of derailment.

This accident was caused by dirt having been scraped on the track at a highway grade crossing.

This crossing is not planked and there is considerable loose dirt on the highway, some of it undoubtedly the result of the work done by the road scraper. Motor traffic, as well as heavy rains, can cause enough of this dirt to lodge on the crossing to permit a dangerous condition to arise, and consideration should be given to removing this loose dirt from the highway on each side of the crossing.
