INTERSTATE COMMERCE COMMISSION  
WASHINGTON

REPORT OF THE DIRECTOR

ACCIDENT ON THE  
CENTRAL OF GEORGIA RAILWAY

LOVEJOY, GA.

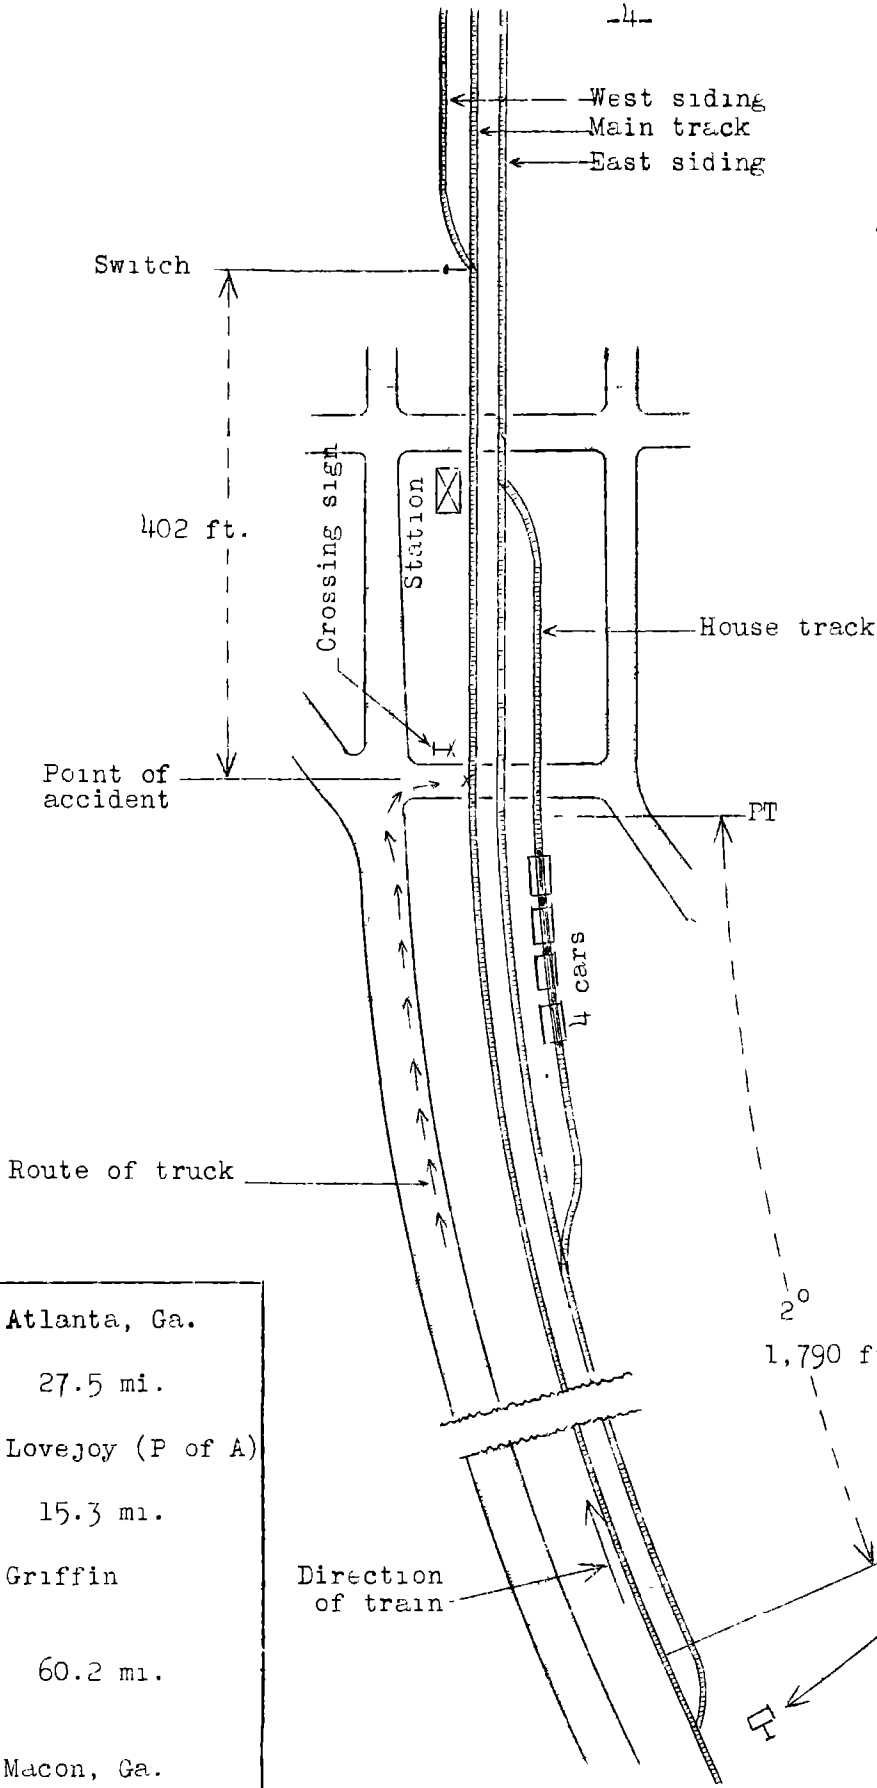
Inv. No. 2219  
 Central of Georgia Ry.  
 Lovejoy, Ga.  
 Nov. 6, 1937

The cars on the house track restricted the view of the crossing from the engineman's side of the cab of a west-bound engine to a distance of 360 feet across the inside of the curve. The view of the crossing from the fireman's side of the cab around the outside of the curve was materially restricted. At a point on the south approach of the highway to the crossing 30 feet from the center line of the main track the driver of a westward vehicle, making the right-hand turn necessary to move northward over the tracks, can see an approaching west-bound train for a distance of 1,092 feet; at a point 16 feet from the tracks the view toward the east is restricted to 858 feet.
