RAILROAD ACCIDENT INVESTIGATION

Report No 3918

CENTRAL OF GEORGIA RAILWAY COMPANY

JUNE 18, 1961

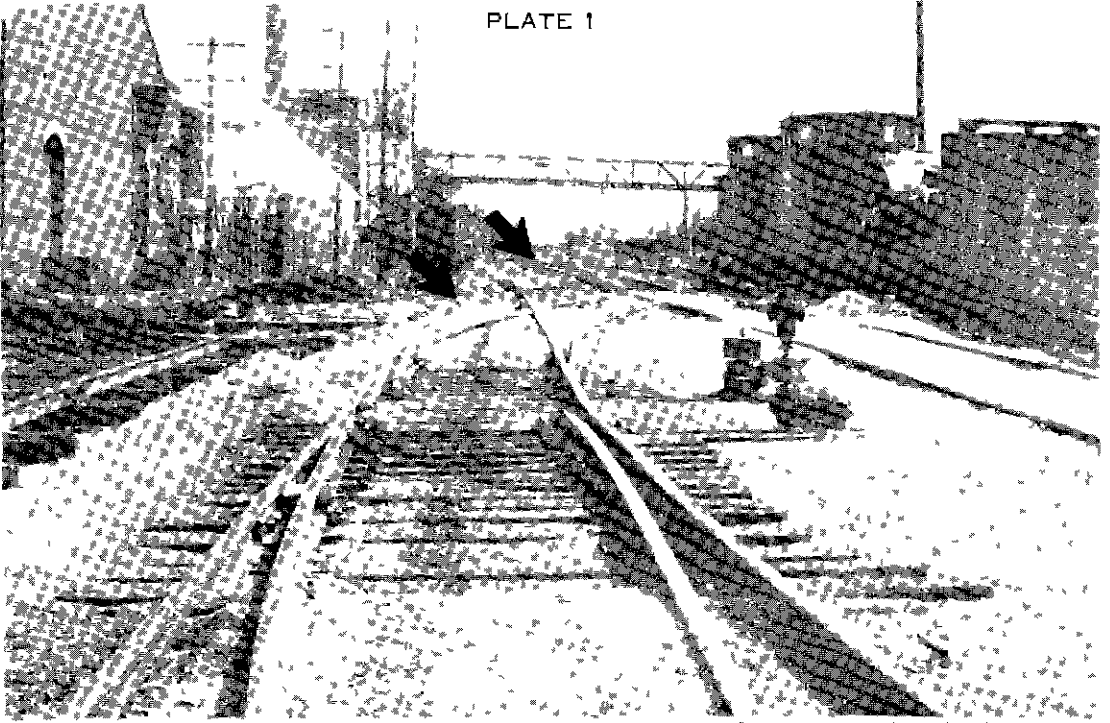
PLATE 1

Arrow at left points to lead track of "400" yard Arrow at right points to "A" lead and shows direction of No 88 approaching crossover involved (center of picture) Macon Jct interlocking is shown under bridge at top center

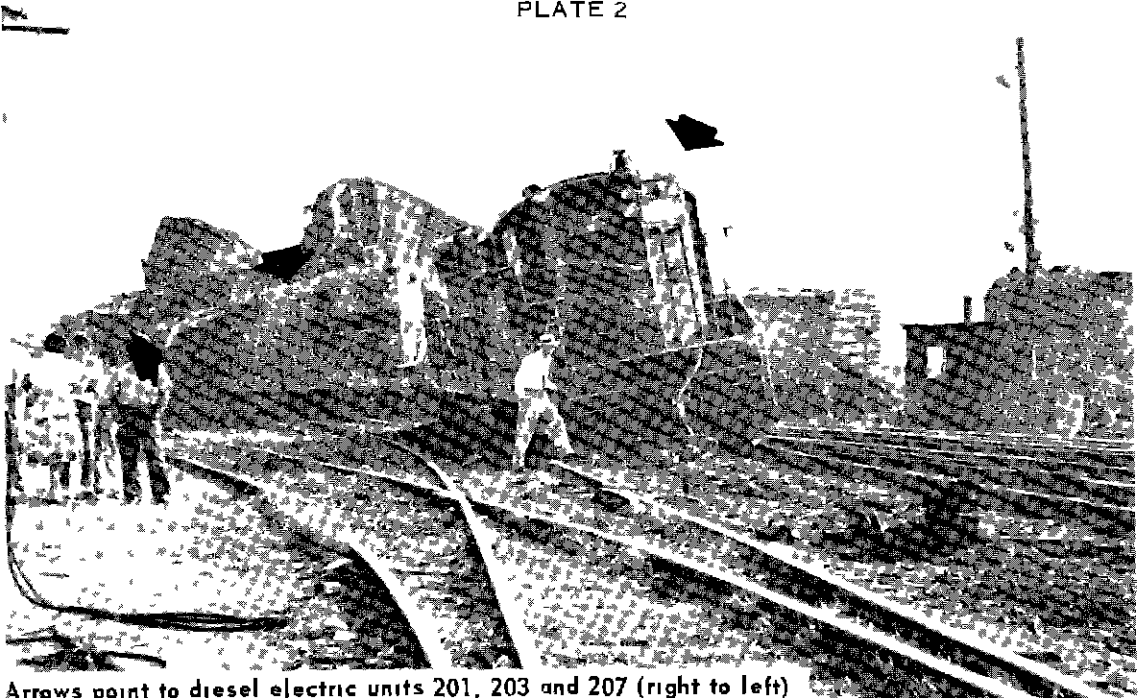
PLATE 2

Arrows point to diesel electric units 201, 203 and 207 (right to left)

Separations occurred at both ends of the 3rd diesel-electric unit and between the derailed cars. The 1st diesel-electric unit, with the 2nd unit attached, stopped with the front end about 485 feet east of the point of derailment. All five diesel-electric units stopped upright in various leaning positions on or near the structure of the lead track of "400" yard. The derailed cars stopped in various positions near the crossover. Two of the diesel-electric units were heavily damaged, and the other three units were somewhat damaged. Of the 31 derailed cars of the train and the 8 derailed cars that were standing on the adjacent yard track, 23 were destroyed, 5 were heavily damaged, 6 were considerably damaged and 5 were slightly damaged.
