INVESTIGATION NO. 3253
CENTRAL OF GEORGIA RAILWAY COMPANY
REPORT IN RE ACCIDENT
NEAR STURDIVANT, ALA., CN
MAY 8, 1949

Accident near Sturdivant, Ala., on May 8, 1949, caused by
a land slide.

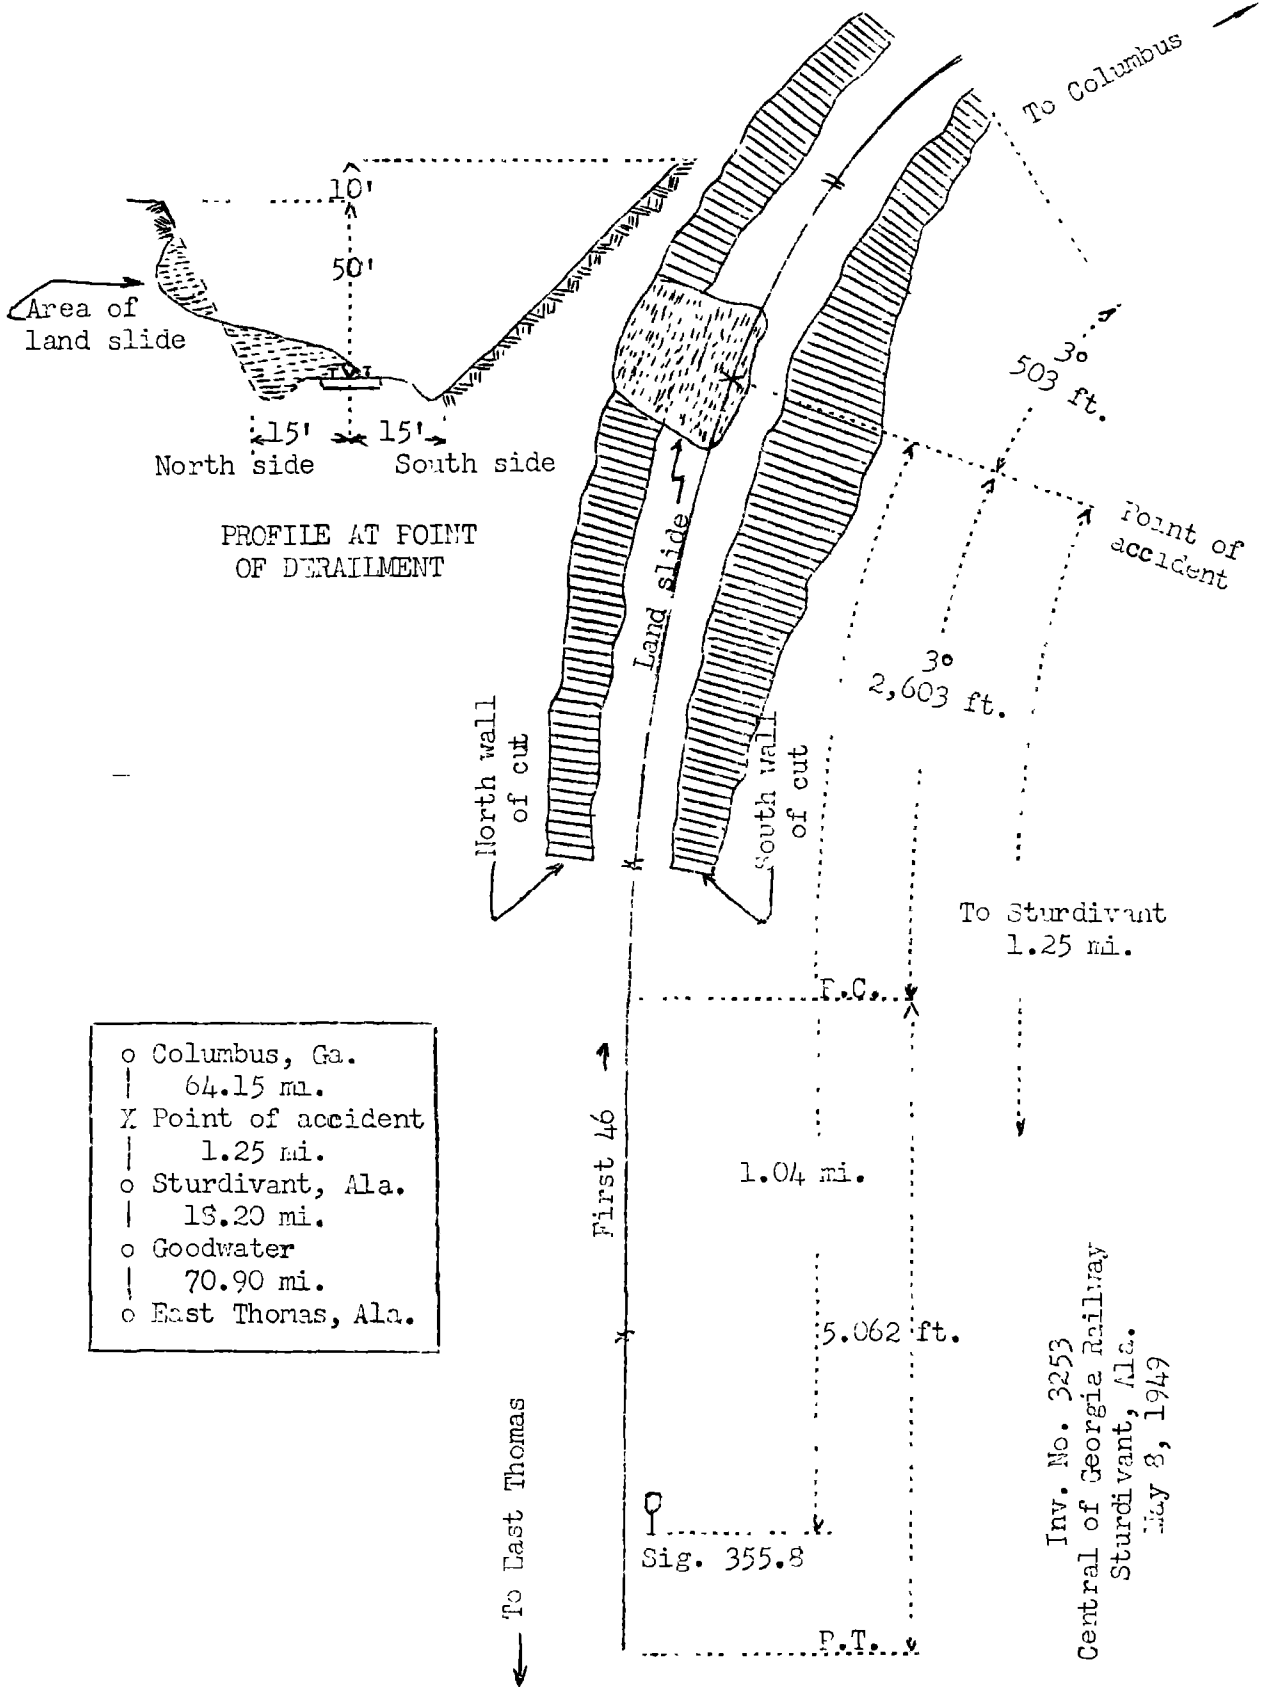
Inv. No. 3253
 Central of Georgia Railway
 Sturdivant, Ala.
 May 3, 1949

PROFILE AT POINT OF DERAILMENT

- o Columbus, Ga.
- | 64.15 mi.
- X Point of accident
- | 1.25 mi.
- o Sturdivant, Ala.
- | 13.20 mi.
- o Goodwater
- | 70.90 mi.
- o East Thomas, Ala.
