RAILROAD ACCIDENT INVESTIGATION

THE CENTRAL RAILROAD COMPANY OF NEW JERSEY

ELIZABETHPORT, N J

ACCIDENT NEAR ELIZABETHPORT, N J

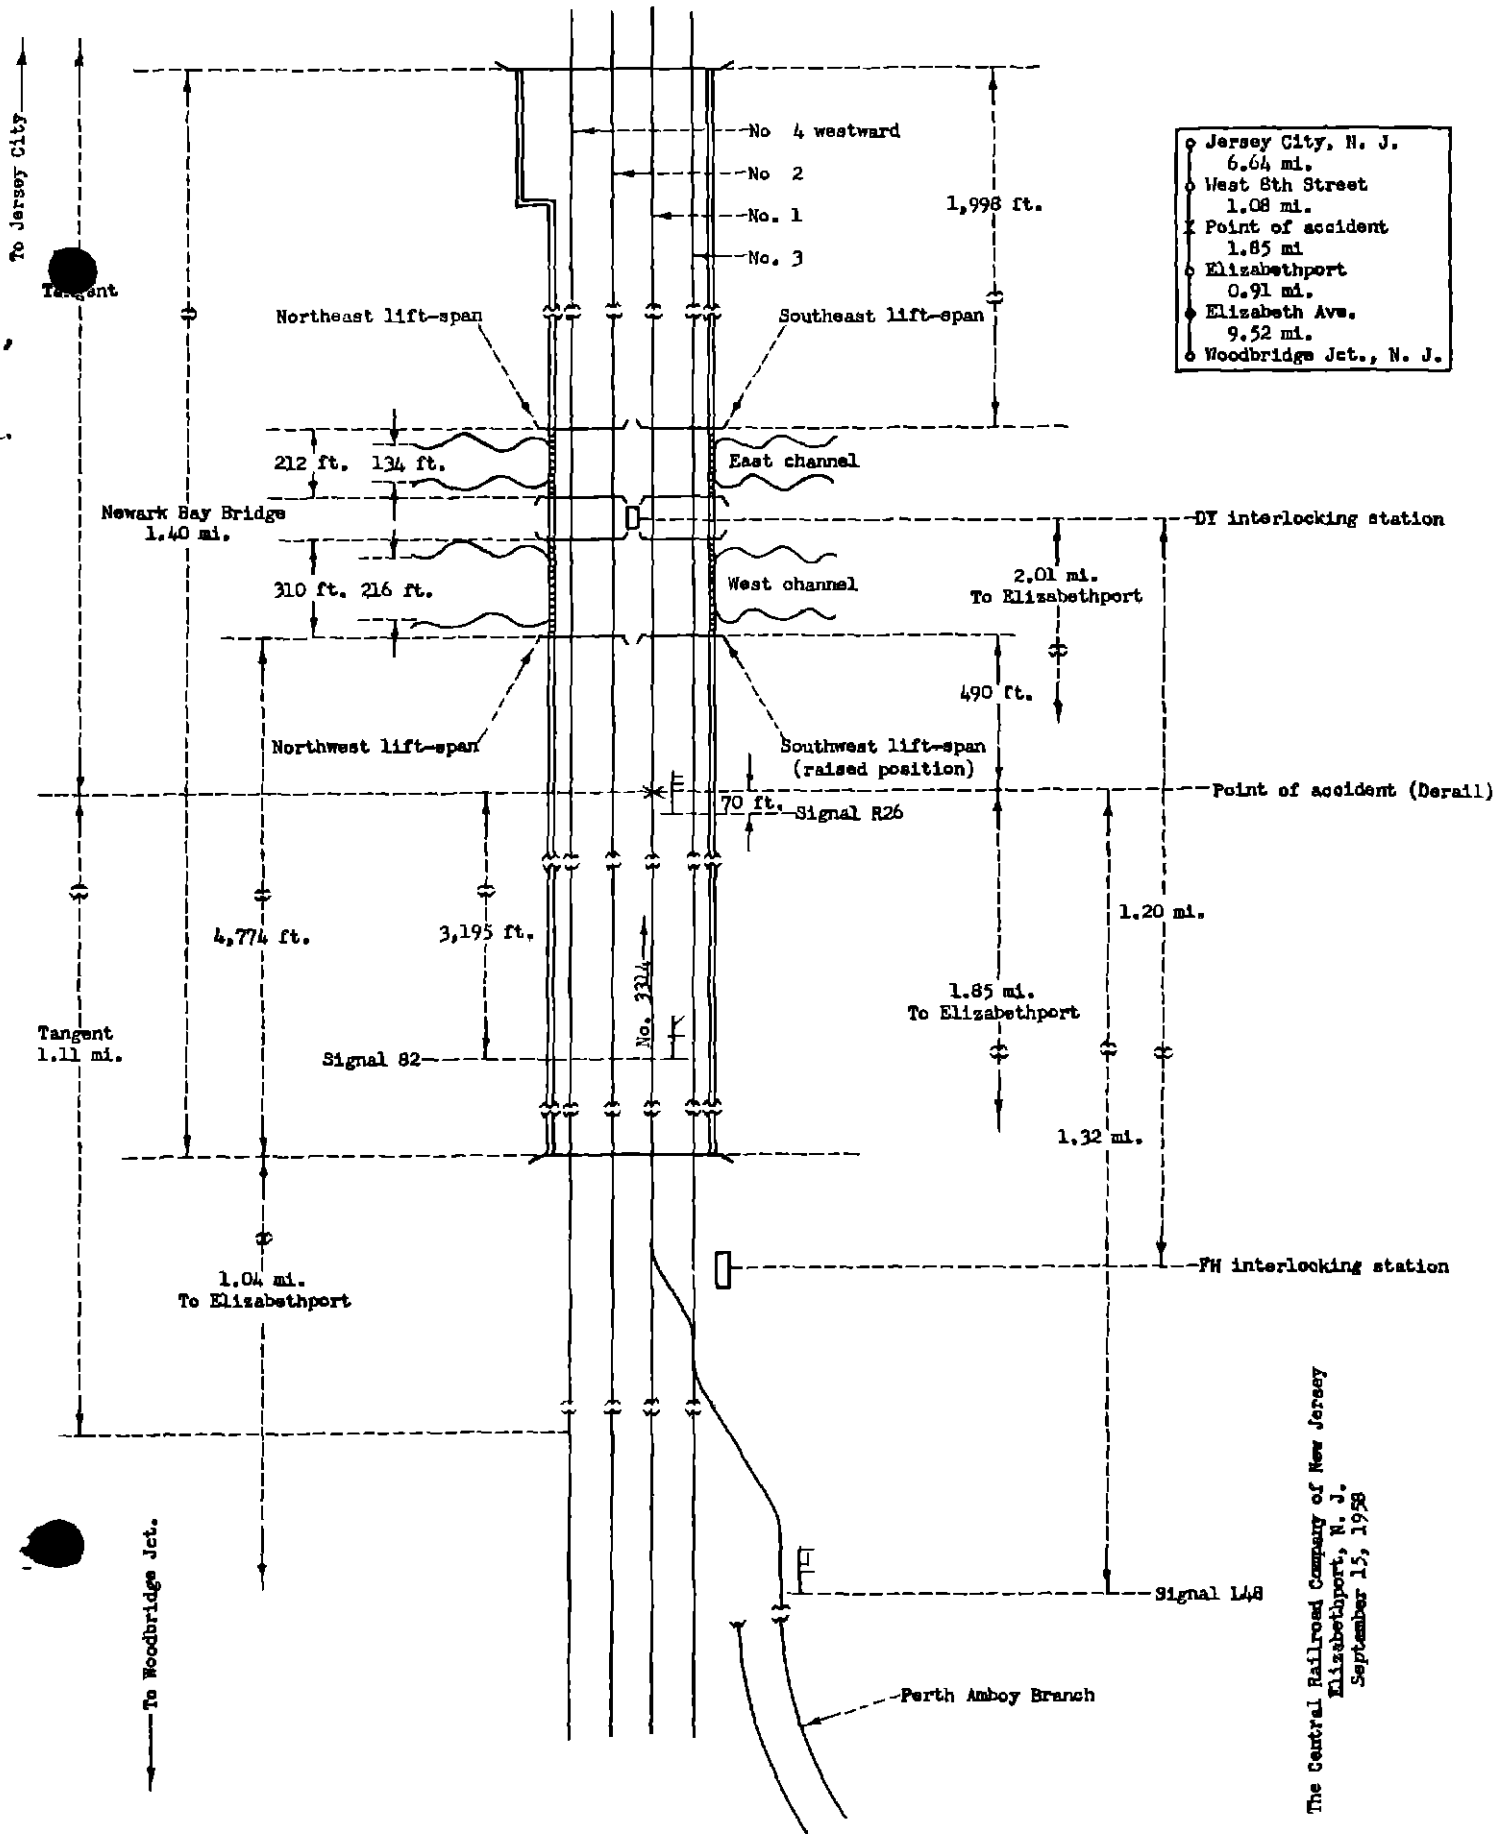
The Central Railroad Company of New Jersey
 Elizabethport, N. J.
 September 15, 1958

This accident occurred on that part of the Central Division extending between Woodbridge Jct and Jersey City, N. J., 20.00 miles, via the Perth Amboy Branch and Elizabethport, N. J. Elizabethport is located 10.43 miles east of Woodbridge Jct. That part of the railroad extending between Woodbridge Jct and Elizabeth Ave., 9.52 miles, is designated as the Perth Amboy Branch. In the vicinity of the point of accident the railroad consists of a 4-track line. The main tracks from north to south are designated as No. 4 westward, and Nos. 2, 1, and 3. Trains moving with the current of traffic on track No. 4 and in either direction on the other main tracks are operated by signal indications. Trains of the Central Railroad of New Jersey, hereinafter referred to as the C. N. J., regularly are operated over that part of the New York and Long Branch Railroad, hereinafter referred to as the N. Y. & L. B., extending between Bayhead Jct and Woodbridge, N. J., 39.70 miles. Between Elizabethport and West 8th Street, Bayonne, N. J., 2.93 miles, the main tracks span two channels of Newark Bay on a bridge 1.40 miles in length designated as the Newark Bay Bridge. The west end of the bridge is located 1.04 miles east of the station at Elizabethport. The bridge is provided with four lift spans which can be raised to permit the movement of water-borne traffic through the channels. These lift spans are designated as northwest, northeast, southwest and southeast. The northwest and southwest lift spans are 310 feet in length. The west ends of these spans are located 4,774 feet east of the west end of the bridge. The northeast and southeast lift spans are 212 feet in length. The east ends of these spans are located 1,998 feet west of the east end of the bridge. Tracks Nos. 1 and 3 are laid on the southwest and southeast lift spans, and tracks Nos. 2 and 4 are laid on the northwest and northeast lift spans. DY interlocking station is located on the bridge between the westerly and easterly lift spans 2.01 miles east of the station at Elizabethport. FH interlocking station is located 1.20 miles west of DY interlocking station. A split switch-point derail is provided in the north rail of track No. 1 at a point 490 feet west of the west end of the southwest lift span and 1.85 miles east of the station at Elizabethport. It is facing-point for eastbound movements. In the event that an eastbound train proceeds over the derail when it is in open position, the equipment of the train will become derailed to the north. The accident occurred within interlocking limits at the derail on track No. 1. Track No. 1 is tangent throughout a distance of 1.11 miles immediately west of the point of accident and a considerable distance eastward. The grade is level at the point of accident.
