RAILROAD ACCIDENT INVESTIGATION

REPORT NO. 4176

READING COMPANY

THE CENTRAL RAILROAD COMPANY OF NEW JERSEY

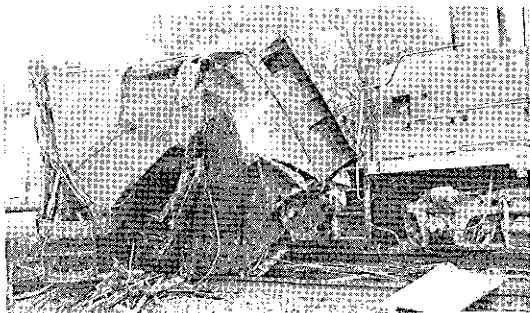
The caboose and last three cars of this train were derailed. The impact caused the caboose to rise from its trucks and override the underframe of the first locomotive unit of the following train. It then struck the control compartment of that unit, fell to structure of track No 2, and stopped about 50 feet west of the collision point. It was destroyed (see following photograph). The last three cars stopped in various positions on or near the structures of the main tracks. They were also destroyed or heavily damaged.

Caboose of preceding train, alongside 2nd and 3rd locomotive units of following train.

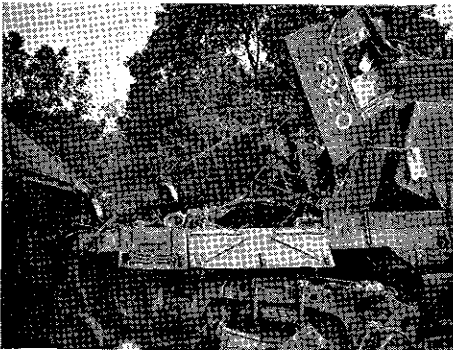
This train stopped with the front end about 170 feet west of the collision point. The 1st and 2nd locomotive units were derailed. They stopped upright on and in line with the structure of track No 1. The control compartment at the front of the 1st unit was demolished as result of being struck by the caboose of the preceding train (see photograph on the following page). The 3rd to 7th cars, inclusive, derailed because of buckling action, and stopped in various positions on or near the track structures. The 1st locomotive unit was destroyed. The 2nd unit, the 3rd and 4th non-derailed units, all 5 derailed cars, and 1 non-derailed car were damaged moderately.

Front, or cab, end of 1st locomotive unit
of following train.
