REPORT OF THE DIRECTOR
BUREAU OF SAFETY

ACCIDENT ON THE
CENTRAL RAILROAD OF NEW JERSEY

WEISSPORT, PA.

INVESTIGATION NO. 2243

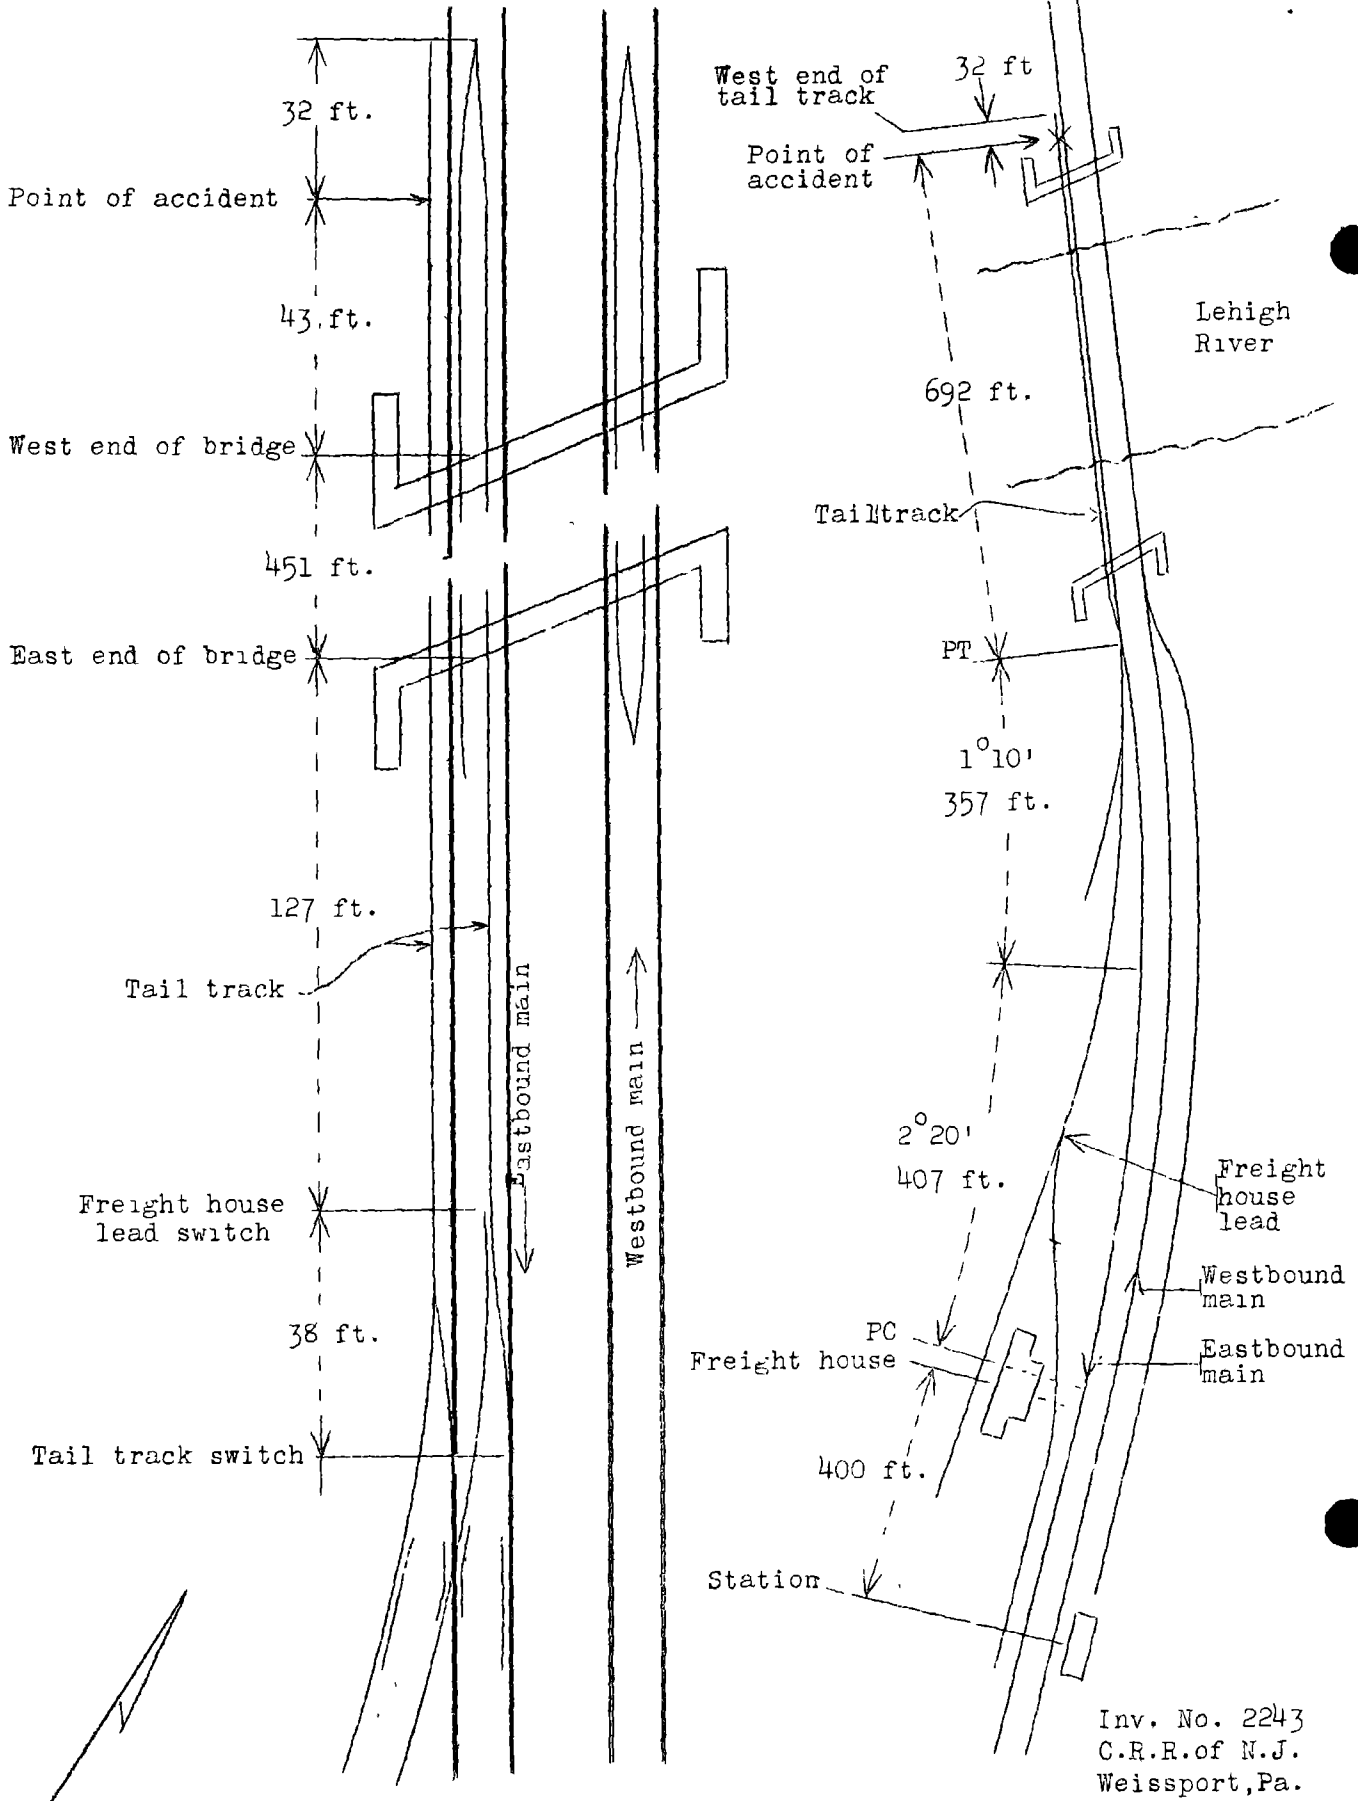
Inv. No. 2243
 C.R.R. of N.J.
 Weissport, Pa.
 Jan. 11, 1938

This accident occurred on that part of the Lehigh and Susquehanna Division which extends between Phillipsburg, N. J., and Scranton, Pa., a distance of 118.86 miles; it is a double-track line over which trains are operated by timetable, trains orders, and an automatic block-signal system. The accident occurred near the west end of a tail track, at a point 1,770 feet west of the station at Weissport where several auxiliary tracks are located west of the station. West of the entrance to these auxiliary tracks a two track bridge 451 feet long spans the Lehigh River. A freight house is located south of the main tracks, about 400 feet west of the station but on a lower level. In order to avoid the use of a facing-point switch at the connection of the eastward main track with the freight-house lead, movements between these tracks are made through a switch-back, known as the tail track. The tail track leads off the eastward main track through a trailing-point switch and extends westward a distance of 692 feet; due to the width of the bridge the eastward main track and the tail track overlap, each rail of the tail track being located 11 inches south of the corresponding rail of the eastward main. The north rail of the tail track serves as an inner guard rail for the north rail of the eastward main track over the bridge. An auxiliary rail laid 11 inches north of the south rail and parallel thereto, serves as an inner guard rail on the bridge for the south rail of the eastward main track; this auxiliary rail and the north rail of the tail track come to a point in the center of the eastward main track about 75 feet west of the west end of the bridge. The gauge of the tail track is standard to a point about 35 feet west of the bridge but from that point westward the north rail curves southward until it joins the frog point in the center of the track. The derailment occurred at a point approximately 43 feet west of the west end of the bridge.

At a point 38 feet west of the entrance switch of the tail-track there is a facing-point switch for east-bound movements which connects the tail track with the freight-house lead. This lead is directed toward the southeast on a 5.25 percent descending grade; team and house tracks diverge from it near the freight house.
