RAILROAD ACCIDENT REPORT

DERAILMENT OF
AMTRAK PASSENGER TRAIN NO. 60,
THE MONTREALER, ON THE
CENTRAL VERMONT RAILWAY
NEAR ESSEX JUNCTION, VERMONT
JULY 7, 1984

NTSB/RAR-85/14

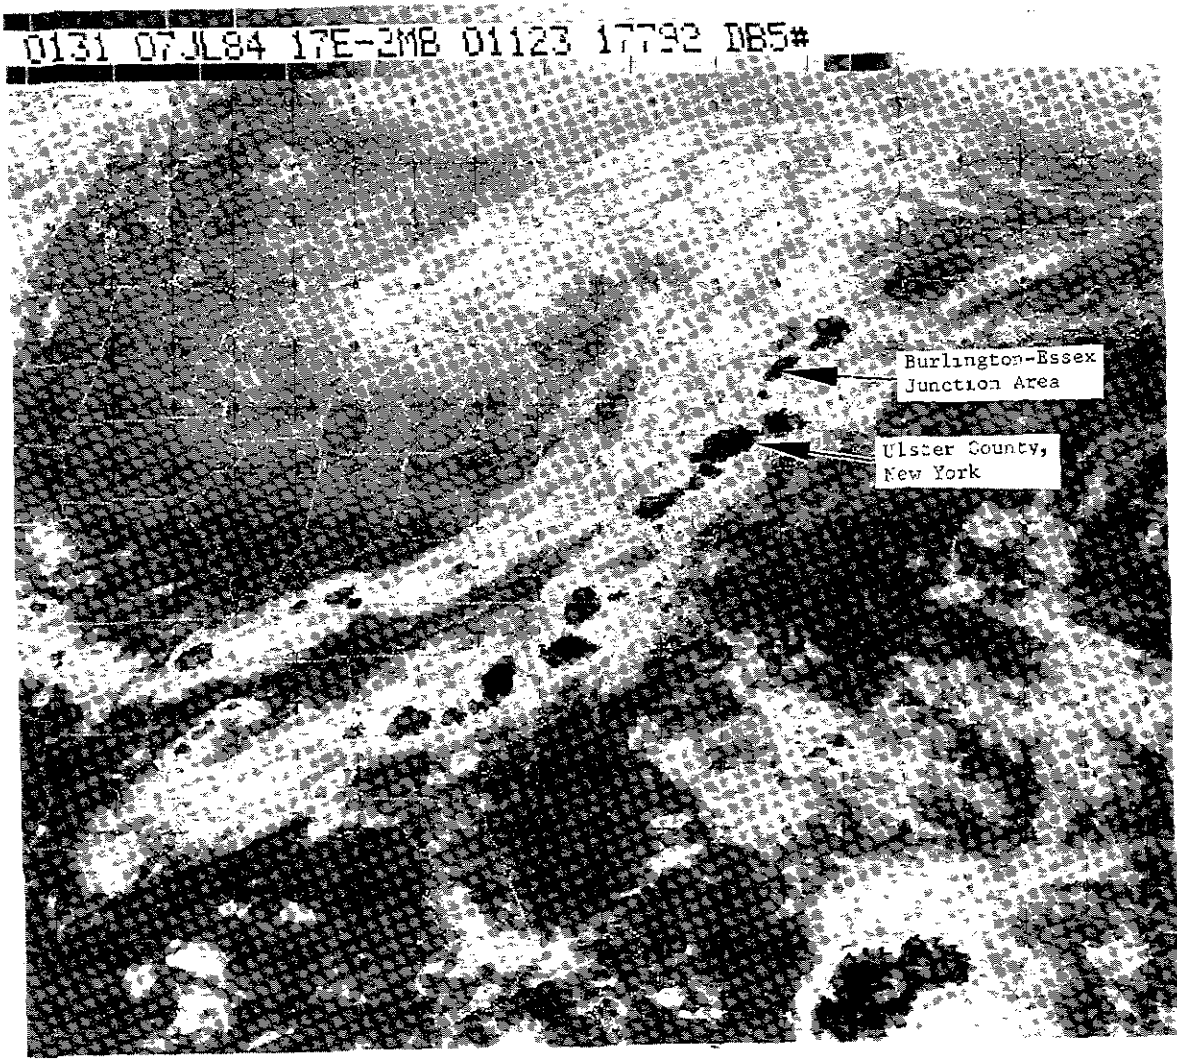
Figure 5.--Infrared weather satellite photo taken at 9:31 p.m, July 6, 1984. The dark areas are convective cells. The cell which dropped 2.67 inches of rain in less than an hour on Ulster County, New York probably struck the area east of Essex Junction, Vermont, about 3 1/2 to 4 hours after this photo was made.

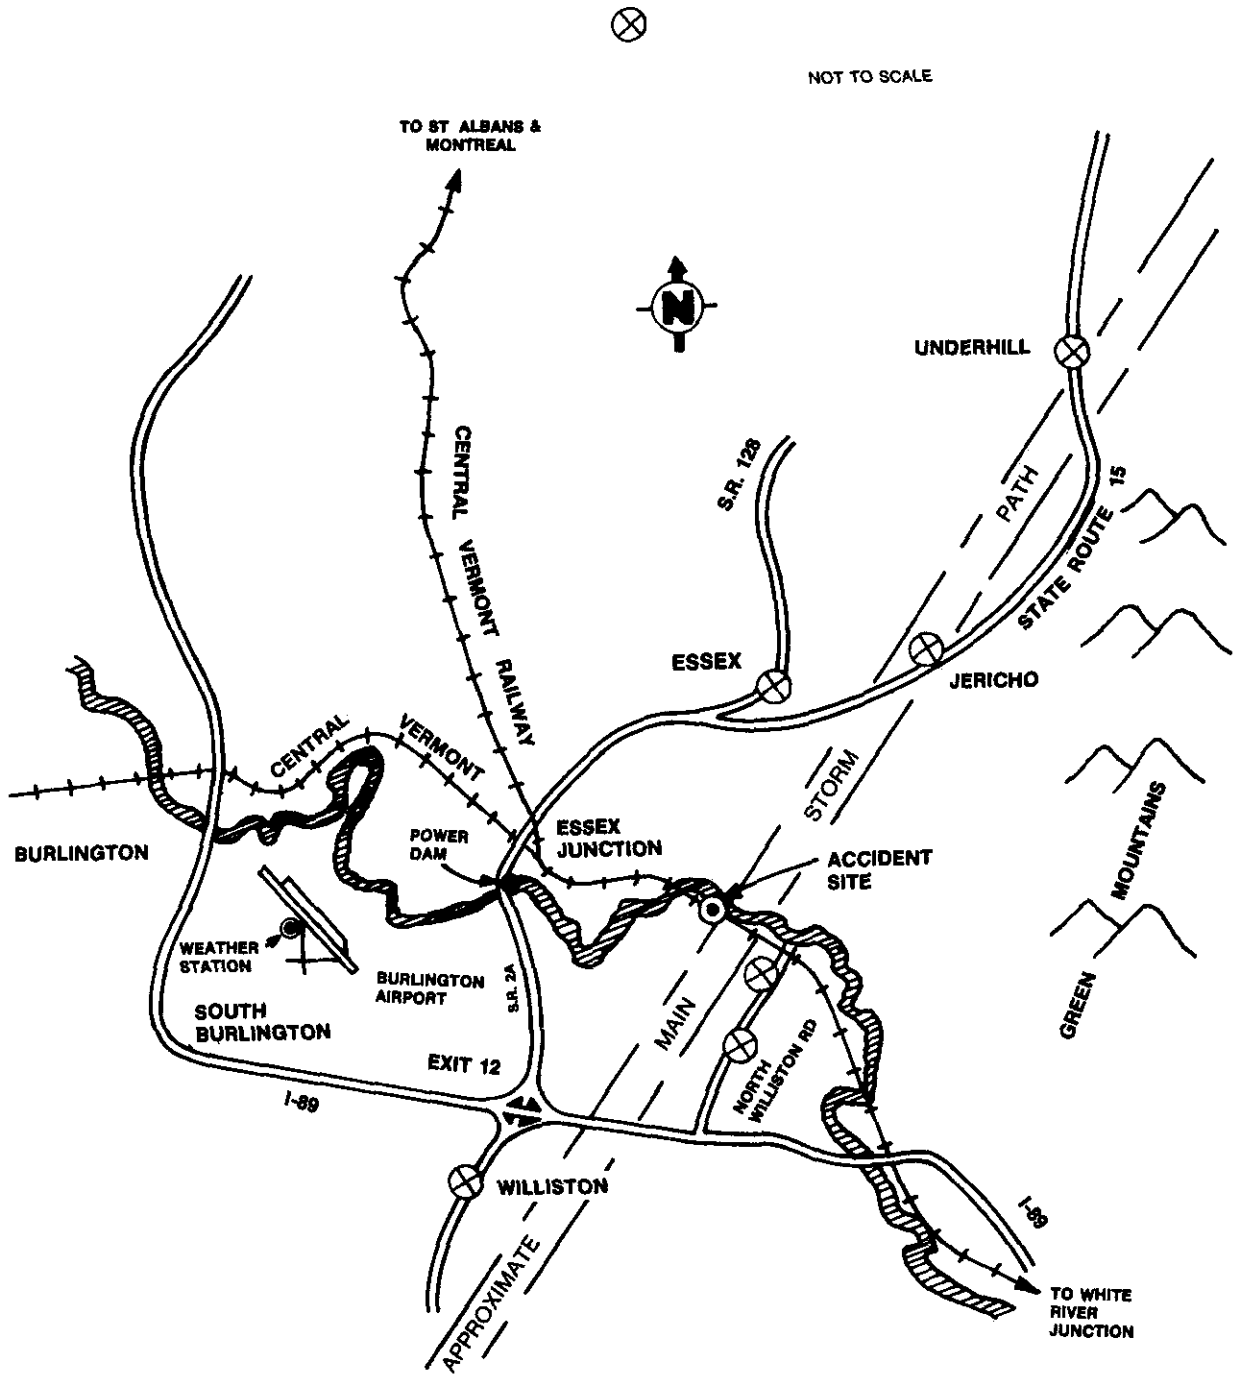
Figure 6.--Plan view of Essex Junction area showing locations where roads were flooded and/or washed-out during the night of July 6-7, 1984.

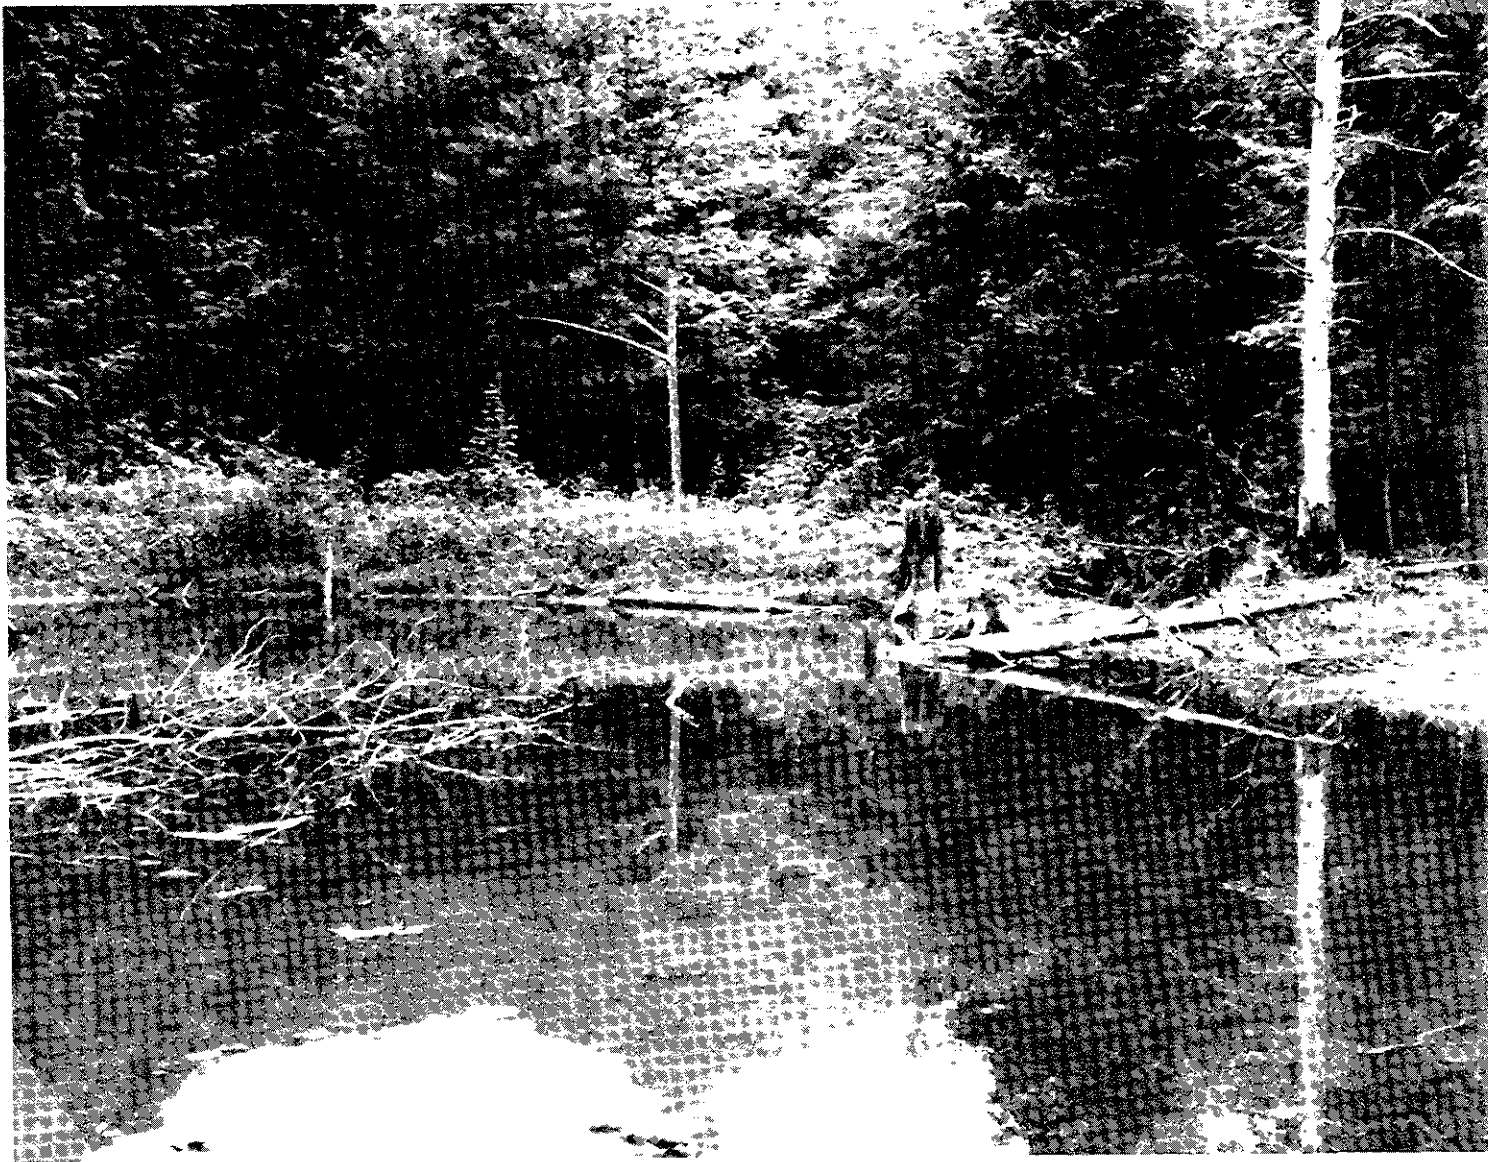
Figure 8.--Partial view of the beaver pond farthest upstream on Redman Creek, looking toward the dam. Blowout hole is at center right. The dam showed evidence that the pond had filled up behind it and had flooded over the top before the blowout.
