RAILROAD ACCIDENT INVESTIGATION

Report No. 4117

THE CHESAPEAKE AND OHIO RAILWAY COMPANY

FIRE CREEK, W. VA.

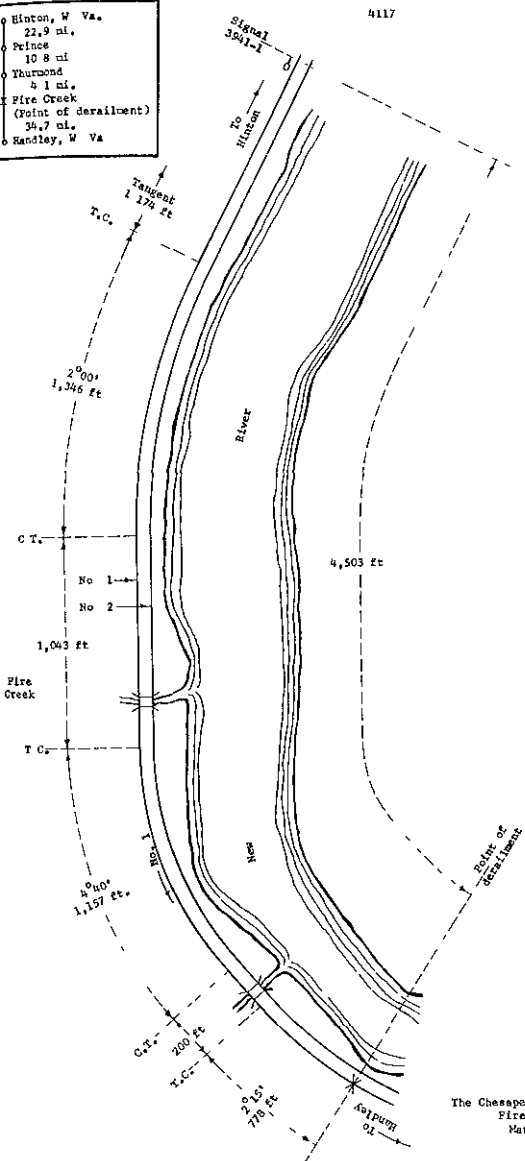
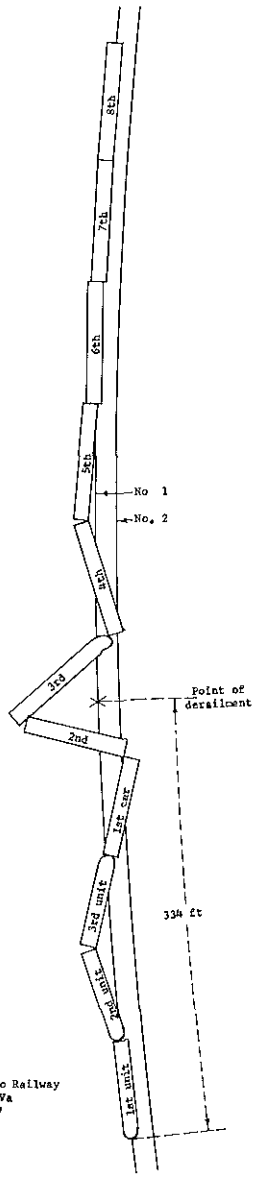
The Chesapeake and Ohio Railway
 Fire Creek, W. Va
 March 15, 1967

The train stopped with the front end 334 feet west of the derailment point. The 3 locomotive units and the first 8 cars were derailed. They stopped upright on or near the track structure as indicated in the sketch appended to this report. Separations occurred at both ends of the 2nd and 3rd cars. The three diesel-electric units were heavily damaged. Of the derailed cars, 2 were destroyed, 4 were heavily damaged, and 2 were slightly damaged.
