BUREAU OF SAFETY

REPORT NO. 1987

Railroad: Chesapeake and Ohio.  
Date: May 29, 1935.  
Location: Gulfoo, Ky.  
Kind of accident: Derailment.  
Train involved: Freight.  
Train number: No. 73.  
Engine number: 2313.  
Consist: 28 cars and caboose.  
Speed: 25-30 m.p.h.  
Track: 4° curve to the left;  
descending grade.  
Weather: Clear.  
Time: 3:40 a.m.  
Casualties: 2 killed and 1 injured.  
Cause: Open switch.

REPORT OF THE DIRECTOR OF THE BUREAU OF SAFETY CONCERNING AN  
ACCIDENT ON THE CHESAPEAKE AND OHIO RAILWAY AT  
GULFCO, KY., ON MAY 29, 1935.

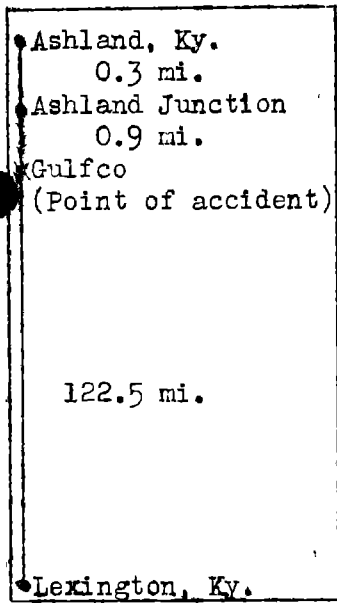
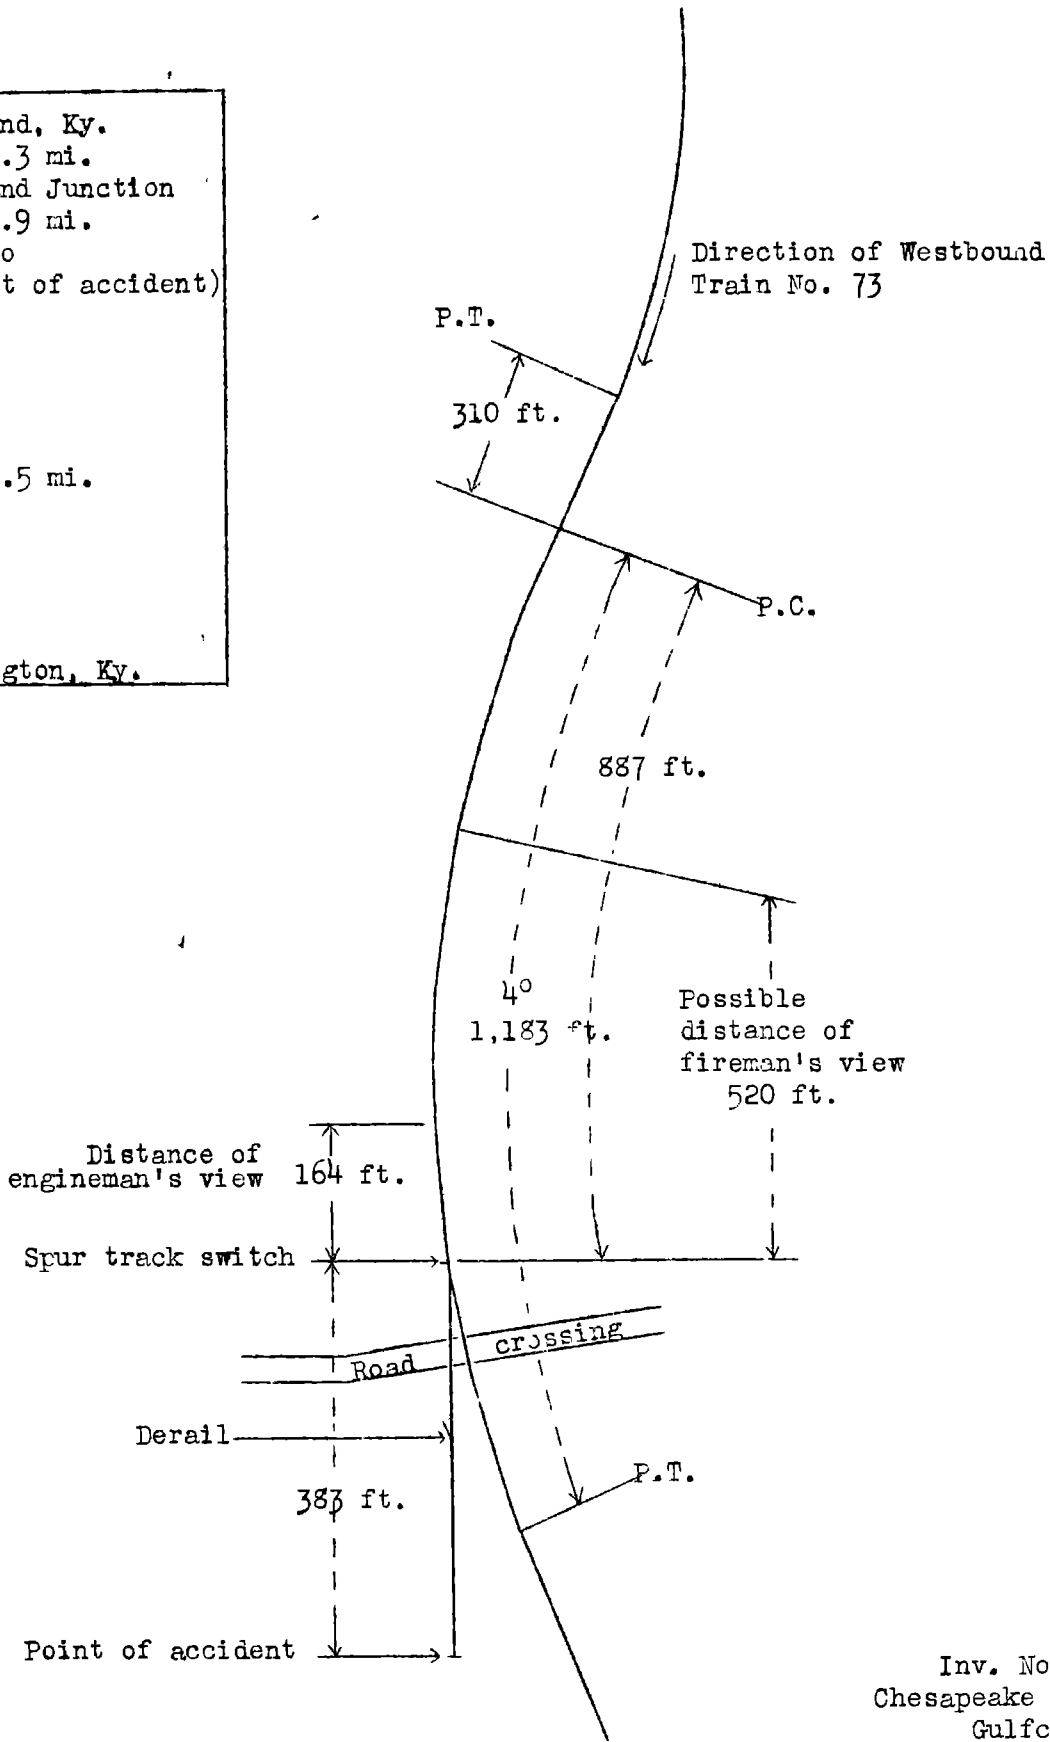
Inv. No. 1987  
 Chesapeake & Ohio Ry.,  
 Gulfco, Ky.  
 May 29, 1935

The spur track has a facing-point switch for west-bound trains, with a No. 10 turnout. The switch stand, located on the north side of the track, is of the Star high type with the center of the lens of the switch lamp 8 feet 6 inches above the ties, and displays a green indication when the switch is lined for the main track and a red indication when lined for the spur track. The stand also is equipped with banners located below the lamp, providing the same color indications. A switch-point derail is located on the spur track 198 feet west of the switch; at the time

of the accident the derail was in open position and locked, and there were no cars on the spur track.

The main track runs through a cut at the eastern end of the curve on which the accident occurred, the cut being 45 feet deep on the inside of the curve; the view of the switch to be had by the engineman of a west-bound train is restricted to 164 feet and by the fireman to 520 feet.
