INTERSTATE COMMERCE COMMISSION

REPORT OF THE DIRECTOR OF THE BUREAU OF SAFETY CONCERNING AN
ACCIDENT ON THE CHESAPEAKE AND OHIO RAILWAY AT PAINTSVILLE,
KY., ON JULY 7, 1934.

August 11, 1934.

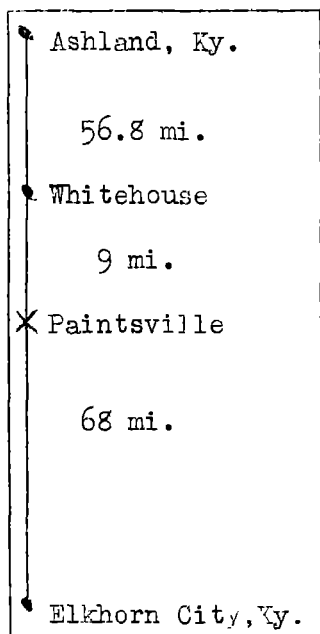
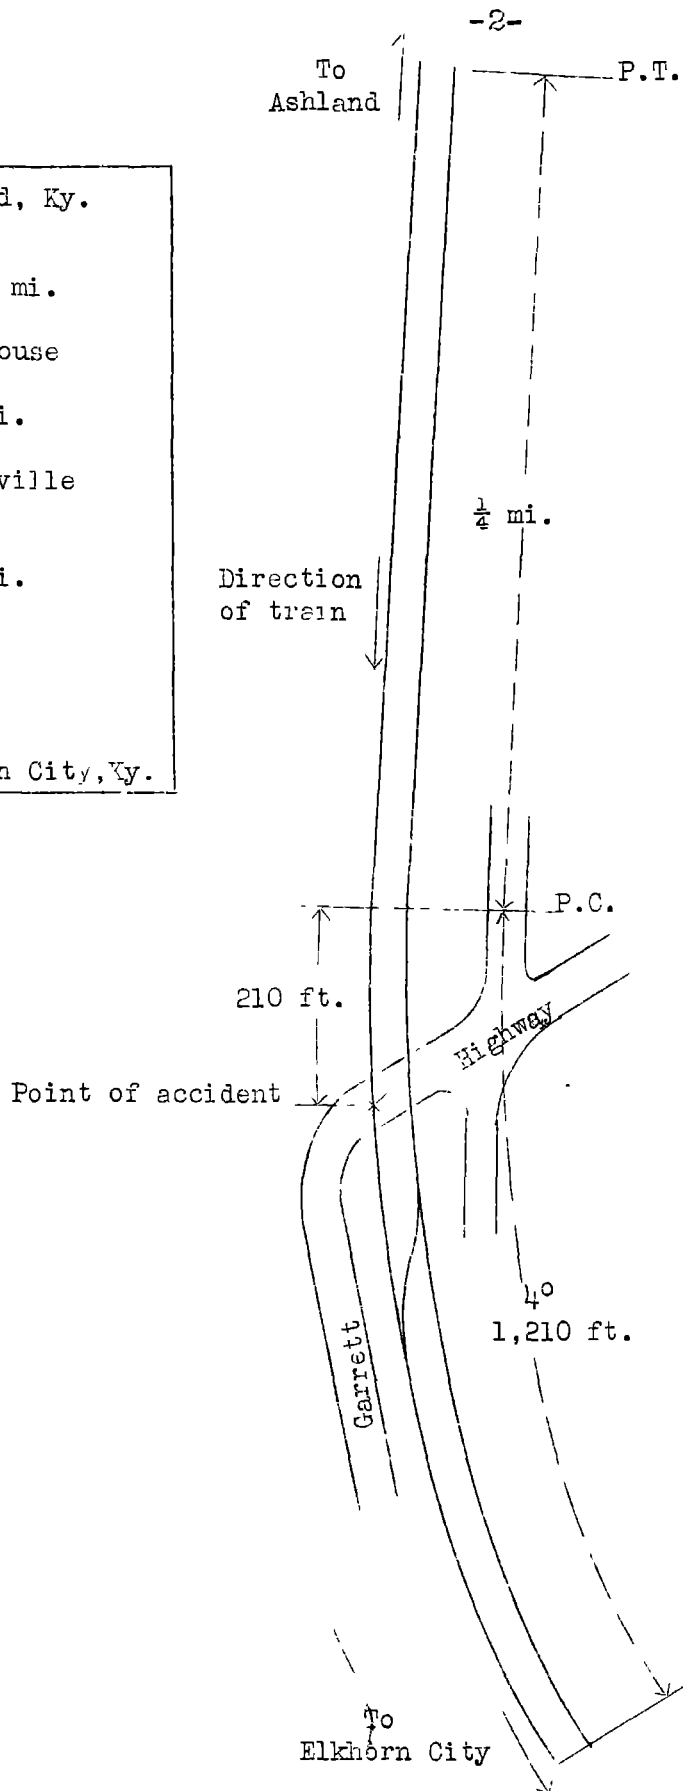
Inv. No. 1919
Chesapeake & Ohio Ry.
Paintsville, Ky.
July 7, 1934

An inspection of the track was made by the Commission's inspectors on July 10, after the equipment had been removed, and the surface, alignment and gauge west of the crossing were in good condition. The first mark of derailment was a light flange mark on a tie 19 feet eastward from the center of the crossing and 10 inches from the gauge side of the north rail. These marks continued, except at intervals of one or two ties, until they reached the crossover 200 feet eastward while corresponding marks were on the tie plates south of the south rail, all very light and scarcely visible at places. From the frog of the crossover the marks followed along the south side of the turnout rail and the ends of the ties on the south side of the track were broken, while from this point to where the engine stopped the track was badly damaged. The marks from the crossing to the crossover had the appearance of having been made by one pair of wheels. Observations of vehicular traffic as it moved over the south side of the crossing, where there is an abrupt turn in the highway to the east, disclosed that the wheels of automobiles churned up the crossing material and deposited it on the south rail. The inspectors also inspected the engine at the shops and found parts of the running gear broken, but it was their opinion that this damage was a result of the accident.

This accident was caused by crossing material on the rails at a highway grade crossing.

The crossing had been recently renewed, but was left uncompleted for a considerable period. Observations made subsequent to the accident revealed that due to the sharp turn in the highway immediately south of the track automobiles churned up the crossing material and deposited portions of it on the south rail. After the accident crushed stone was found on this rail and showed evidence of having been run over ^{by} the wheels of a train, while from the marks on the track it appeared that the leading pair of engine truck wheels were derailed to the right when they encountered some of this material on the south rail and then followed the rails closely until they reached the crossover east of the crossing where the truck slued further to the right, resulting in the final derailment. In view of the temporary condition of the crossing and instructions given by the supervisor, together with the information given him by the trackwalker, the section foreman should have taken steps to insure that the crossing was maintained in such condition that trains could pass over it safely.
