INVESTIGATION NO. 2791
THE CHESAPEAKE AND OHIO RAILWAY COMPANY
REPORT IN RE ACCIDENT
AT PRESQUE ISLE YARD, TOLEDO, OHIO, ON
APRIL 11, 1944

Accident at Presque Isle Yard, Toledo, Ohio, on April 11,
1944, caused by a crossover switch not being lined
for the intended movement of a cut of cars.

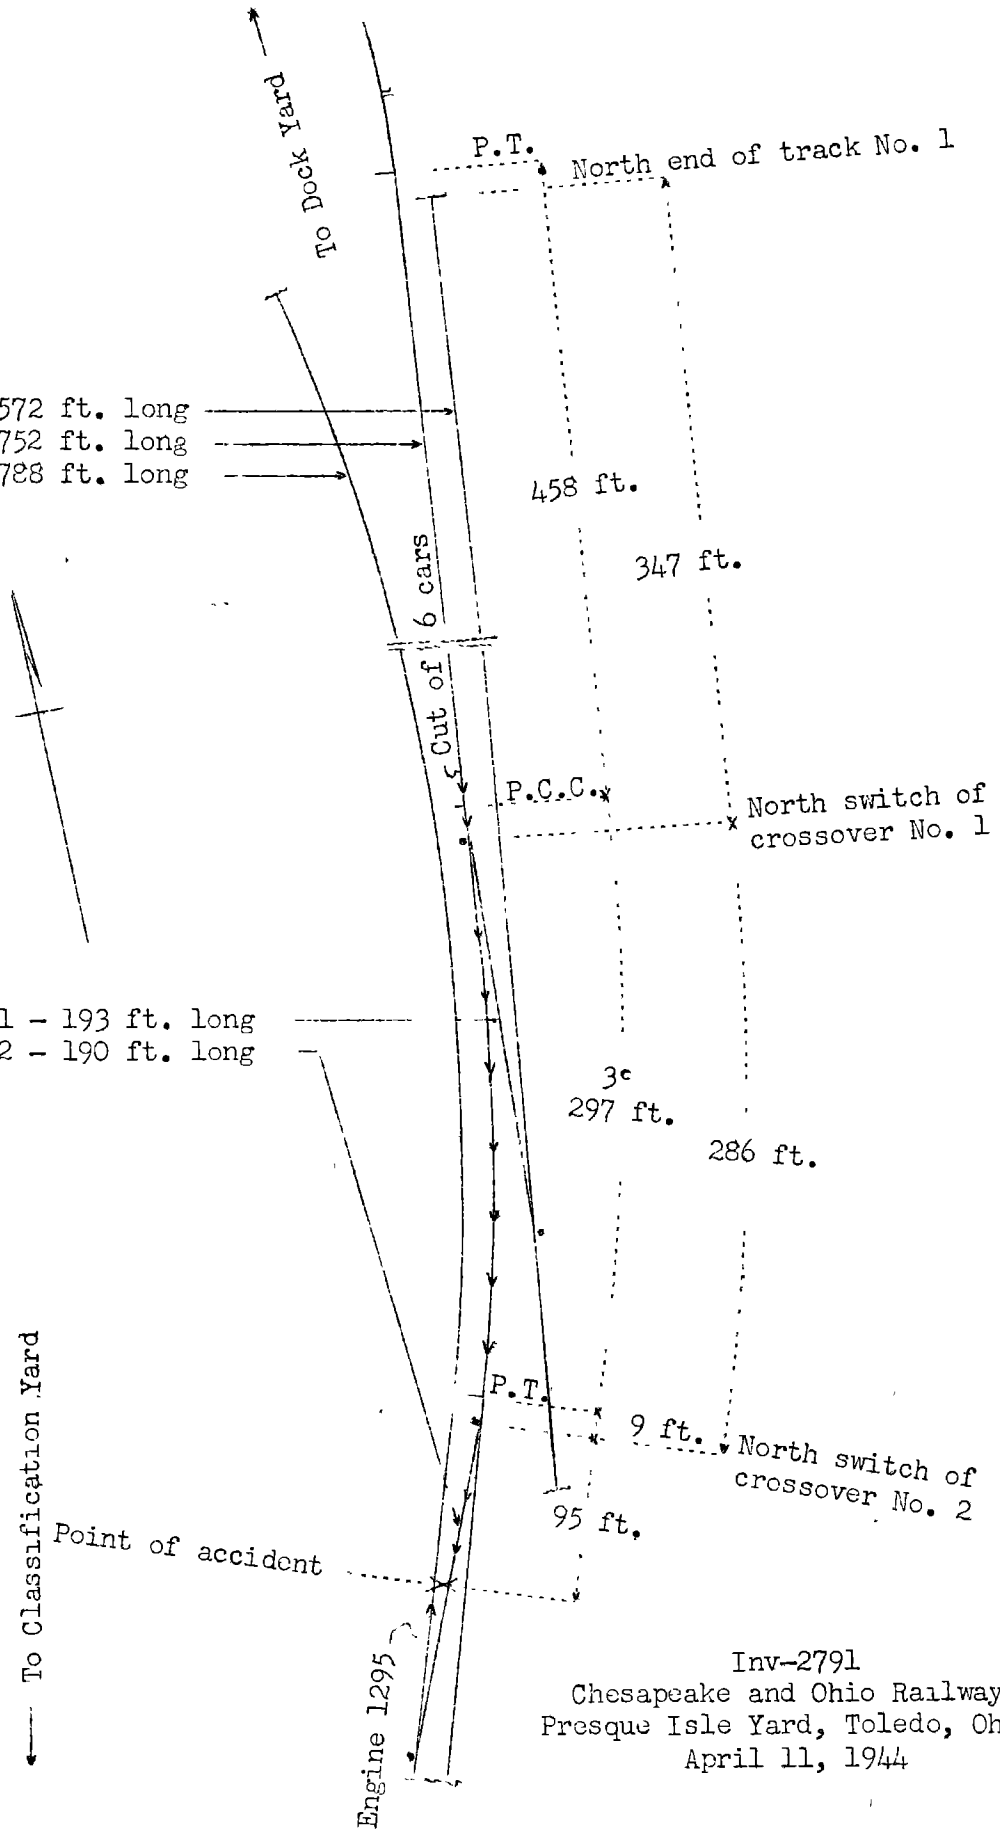
Inv-2791
 Chesapeake and Ohio Railway
 Presque Isle Yard, Toledo, Ohio
 April 11, 1944

- Track No. 1 - 572 ft. long
- Track No. 2 - 752 ft. long
- Track No. 3 - 788 ft. long

- Crossover No. 1 - 193 ft. long
- Crossover No. 2 - 190 ft. long

Yard engine 1295, headed southward, was moving northward on track No. 3 at an estimated speed of 4 miles per hour when it was struck by the first car of a cut of 6 cars at the fouling point of crossover No. 2.

During switching operations, a cut of 6 cars was detached from yard engine 1275 on track No. 2. These cars passed the north switch of crossover No. 1, moved southward on track No. 2, entered crossover No. 2 at the north switch, and while moving at an estimated speed of 8 miles per hour the first car struck engine 1295.

Engine 1275 was pushing a cut of 6 cars southward on track No. 2, and the crew thought the north switch of crossover No. 1 was lined for the cut of cars to move through crossover No. 1 and thence on track No. 1. However, after the cut of cars was detached from the engine and had passed the north switch of crossover No. 1, the conductor observed that the north switch of crossover No. 1 was not lined for the intended movement, and that the north switch of crossover No. 2 was lined for the cars to enter crossover No. 2. No employee had been instructed to accompany the cut of cars, and the collision occurred before action could be taken to stop the movement. The conductor of engine 1295, who was on the engine, and the engineer were not aware of anything being wrong until the accident occurred. It could not be determined when the fireman first became aware of anything being wrong, as he was killed in the accident. If proper attention had been given to the position of the switch involved before the cut of cars was permitted to move through this switch, this accident would not have occurred.

It is found that this accident was caused by a crossover switch not being lined for the intended movement of a cut of cars.
