INTERSTATE COMMERCE COMMISSION

REPORT OF THE DIRECTOR OF THE BUREAU OF SAFETY CONCERNING AN ACCIDENT WHICH OCCURRED ON THE CHESAPEAKE AND OHIO RAILWAY AT RICHMOND, VA., ON JUNE 30, 1932.

August 5, 1932.

Inv. No. 1771
 Chesapeake & Ohio Ry.
 Richmond, Va.
 June 30, 1932

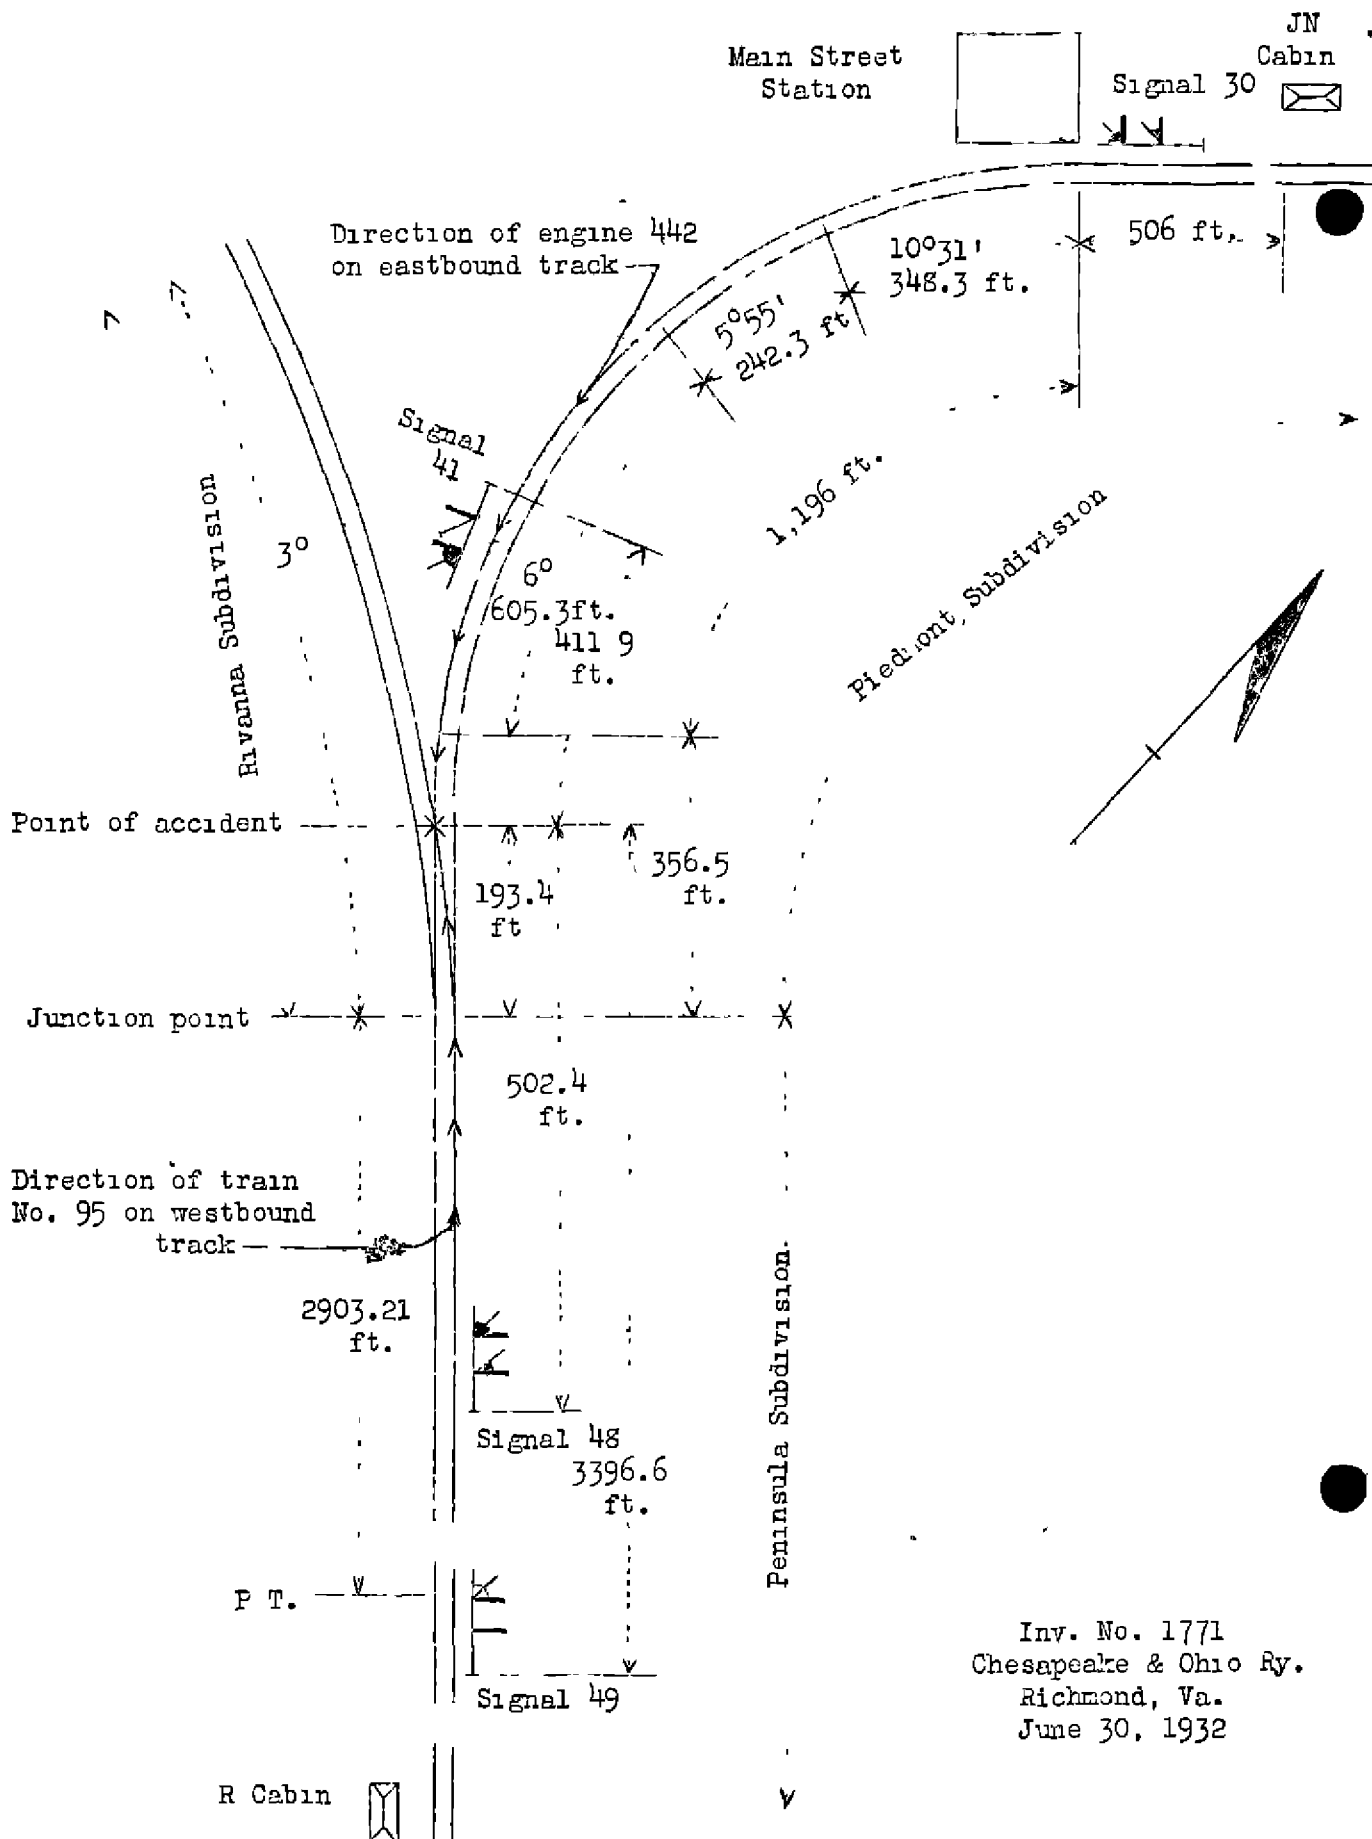
This accident occurred within interlocking limits at Rivanna Junction, which is the junction of three subdivisions of the Richmond Division. In the immediate vicinity of the point of accident these subdivisions are double-track lines, and the movements of trains and engines are governed by interlocking signals. Main Street Station is on the Piedmont Subdivision about 1,500 feet from the junction point; JN Cabin is about 506 feet north of the station, and R Cabin, the interlocking tower and telegraph office at the west end of Fulton yard, is on the Peninsula Subdivision 1.7 miles east of Main Street Station. Approaching the point of accident from the station, there is a sharp curve to the left and this is followed by tangent track for a distance of 356.5 feet to the junction point. Approaching from the east on the Peninsula Subdivision the track is tangent for a distance of 2,903.21 feet, followed by a 3° curve to the left on the Rivanna Subdivision. The accident occurred at the movable point crossing where the westbound track of the Rivanna Subdivision crosses the eastbound track of the Piedmont Subdivision, 193.4 feet west of the junction point. The tracks in this vicinity are laid on a steel viaduct approximately 31 feet above the ground level. The grade is practically level.

The switches and signals are controlled from an electric interlocking machine at JN Cabin. The eastbound signals involved on the Piedmont Subdivision are signal 30, located just north of the station, and signal 41, located 411.9 feet west of the point of accident; on the Peninsula Subdivision, westbound signals 49 and 48, located 3,396.6 and 502.4 feet, respectively, east of the point of accident. Signals 41 and 48 are of the color-light type.
