INTERSTATE COMMERCE COMMISSION
WASHINGTON

REPORT OF THE DIRECTOR
BUREAU OF SAFETY

ACCIDENT ON THE
CHESAPEAKE & OHIO RAILWAY

INVESTIGATION NO. 2060

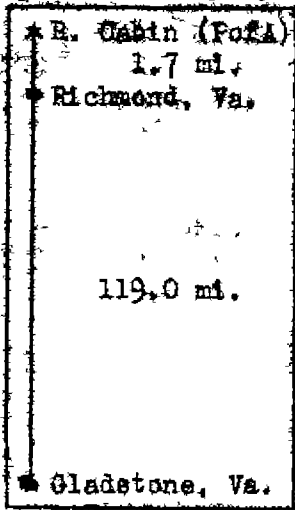
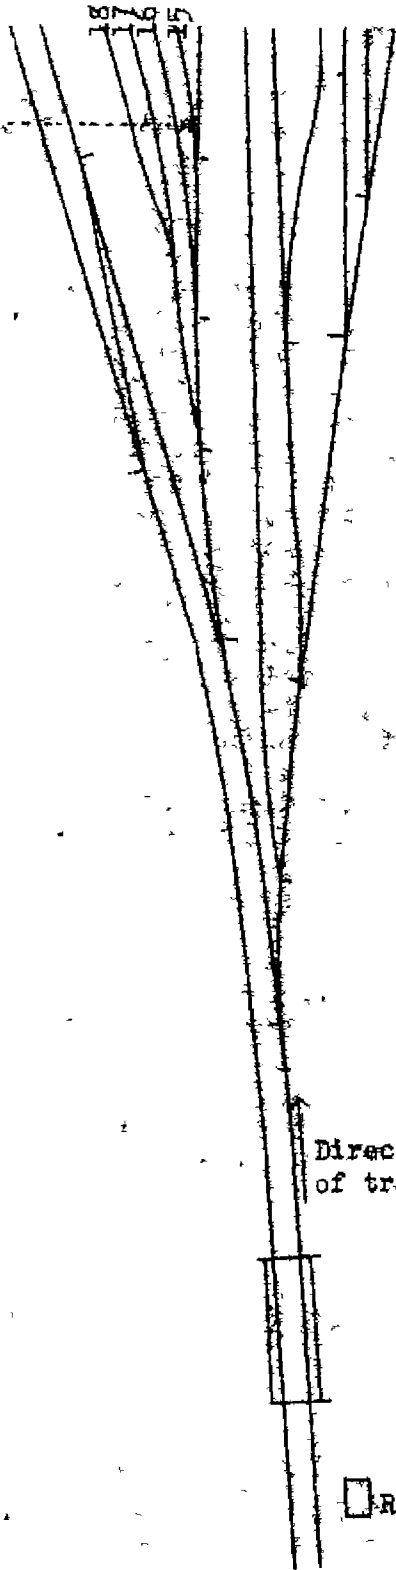
Point of accident

This accident occurred on the Rivanna Subdivision of the Richmond Division, which extends between Gladstone and R. Cabin, Richmond, Va., a distance of 120.7 miles, in the vicinity of the point of accident this is a double-track line over which trains are operated by time table and an automatic block-signal system, signal indications superseding time table authority for movements with the current of traffic, an interlocking plant is located at R. Cabin at the entrance to Fulton yard. Time table directions are used in this report. The accident occurred at the turnout of yard track 15 in the east-bound yard, at a point 738 feet east of R. Cabin; this is a No. 7 turnout which extends to the left and measures 65 feet 5 inches from the point of switch to the point of frog and is equipped with a 130-pound rail balanced No. 7 frog, 16 feet 8 inches in length, with a manganese insert, manufactured in 1935, both the turnout and the frog were in good condition prior to the derailment. Standards of this railroad specify a maximum curvature of 14' 12" and a total length of 152 feet for each No. 7 turnout. The first marks of derailment were found on the north guard rail at a point 2 feet 7 inches west of and nearly opposite the point of frog.
