BUREAU OF SAFETY

REPORT NO. 1986

REPORT OF THE DIRECTOR OF THE BUREAU OF SAFETY CONCERNING AN  
ACCIDENT ON THE CHESAPEAKE & OHIO RAILWAY NEAR SOUTH  
FAYETTE, W. VA., ON MAY 21, 1935.

Inv. No. 1986  
Chesapeake & Ohio Ry.  
South Fayette, W. Va.  
May 21, 1935

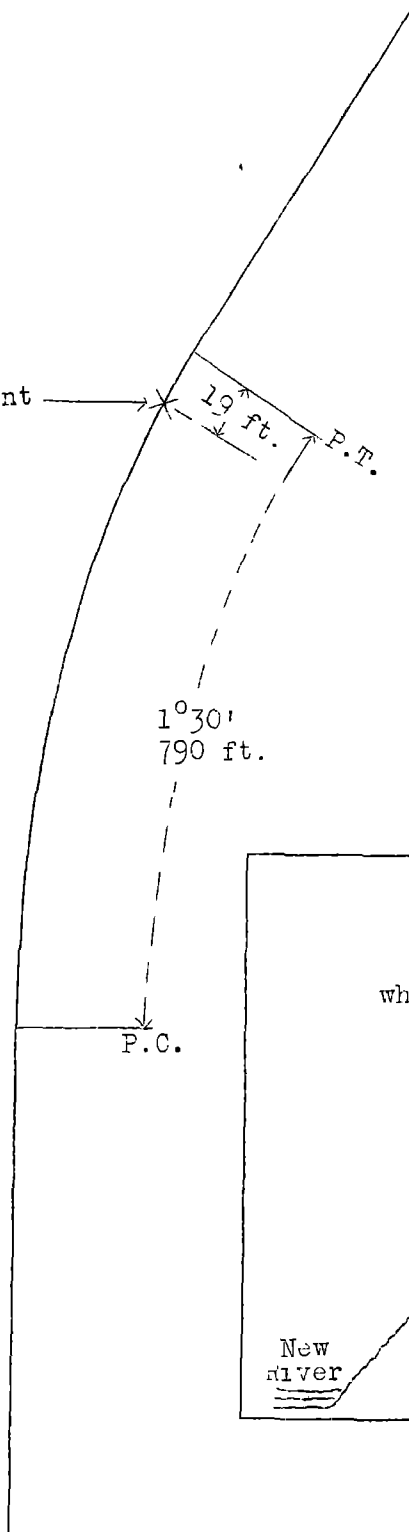
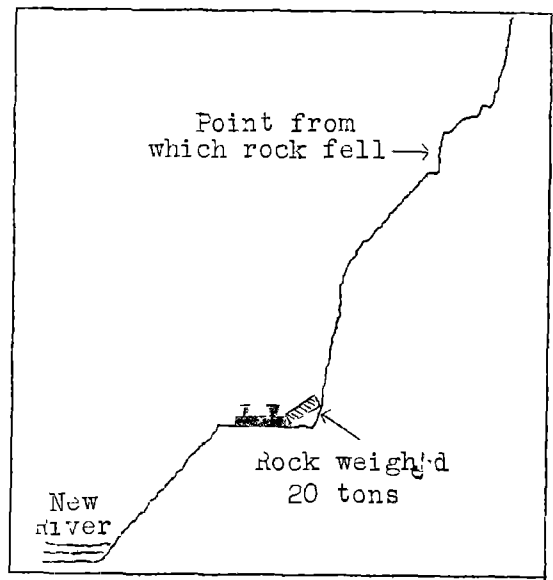
Point of accident →

The investigation developed that a large rock, weighing about 20 tons, became dislodged from a point about 37 feet above the track and fell against the road bed, forcing the track out of alinement about 2 feet for a distance of about 75 feet. The bottom of the displaced rock, before it fell from its position in the bluff, rested on a layer of shale and earth, and, after the rock fell about 350 cubic yards of shale and earth also fell, covering the rock to a depth of 3 feet. Apparently the rock did not foul the rail, as there were no marks on the right side of the engine to indicate that it had struck the rock, and it was evident that the track circuit controlling the automatic block signals was not disturbed as a result of the fallen rock and the earth and shale slide, consequently the engine crew of the freight train received no warning of danger when passing the last east-bound automatic signal. The last train to pass was a passenger train, less than 2 hours previously, and at that time nothing wrong was observed.
