✓
RAILROAD ACCIDENT INVESTIGATION,

Report No. 4124

THE CHESAPEAKE AND OHIO RAILWAY COMPANY

THOMPSONVILLE, MICH.

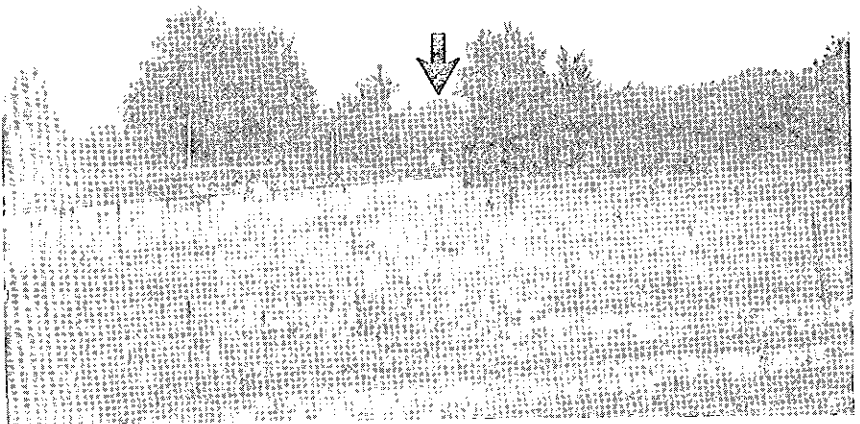
Photo No. 1

report However, as the vehicle approaches the track within 150 feet, the driver has an unobstructed view of the railroad throughout a distance of 500 to 600 feet south of the crossing (See Photo No. 1)

View southward from point on county road 100 feet west of the crossing. Train (arrow) is about 600 feet from the crossing.

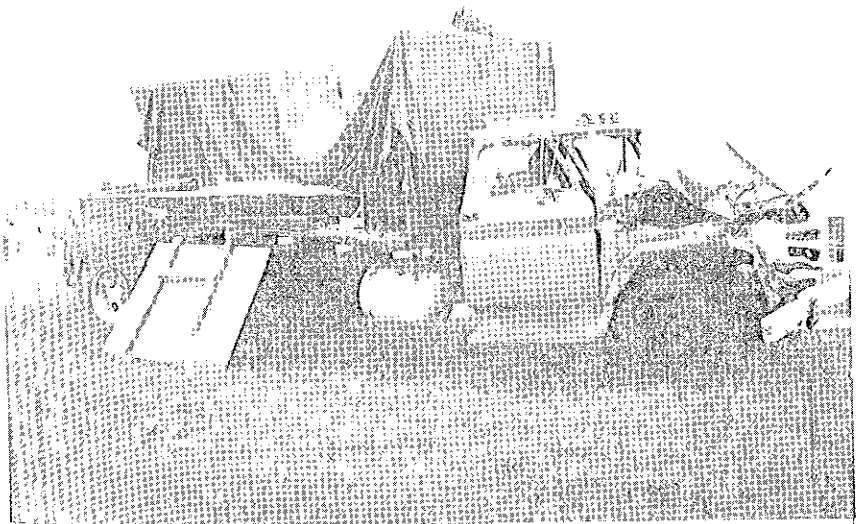
Photo No. 2

Examination of the motortruck after the accident disclosed that the brakes for the wheels of the rear tandem axle were inoperative, due to not being connected to the brake system. This defective condition, however, apparently has no significant bearing on the accident.

The motortruck stopped upright in the northwest angle of the crossing, about 50 feet west and 70 feet north of the track and county road centerlines, respectively. It was heavily damaged.

Motortruck involved in accident

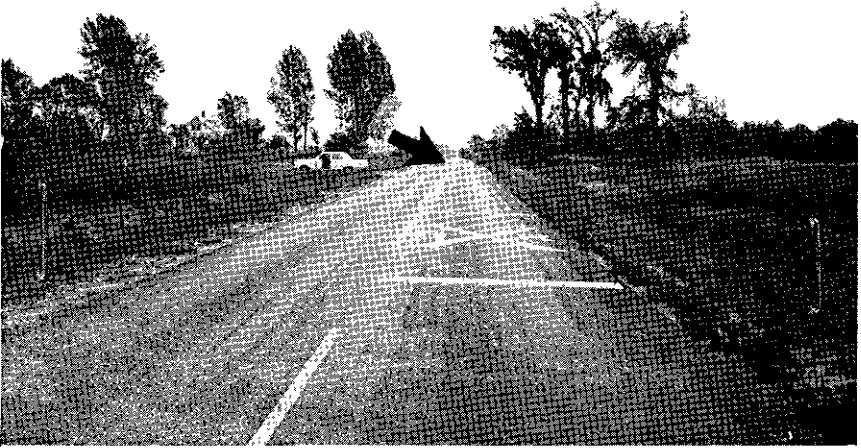
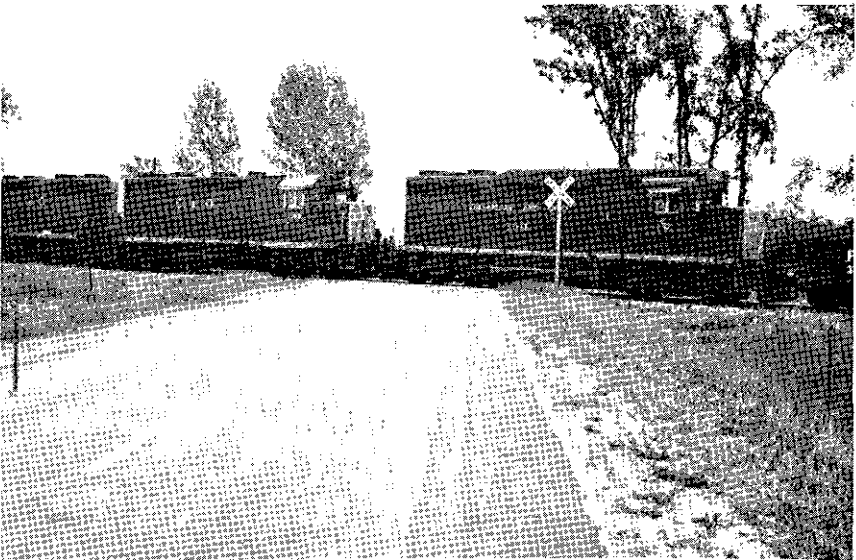
According to the owner-driver, the motortruck neared the railroad crossing at 35 to 40 miles per hour under heavy rain and poor visibility conditions. He stated that he did not see the railroad-crossing warning signs located west of the crossing (See Photos No. 3 and No. 4), and neither saw nor heard the train involved until he suddenly saw its locomotive crossing the county road immediately in front of his vehicle. The owner-driver further stated that he did not know he was in close proximity to the crossing before this time, and that he immediately turned his vehicle northward and applied its brakes. Apparently before its speed was materially reduced, the motortruck entered the crossing from the westward highway lane and struck the train. The

Truck driver's view approaching the crossing.
Train approached from the right.
