RAILROAD ACCIDENT INVESTIGATION

Report No 3802

THE CHESAPEAKE AND OHIO RAILWAY COMPANY

THURMOND, W VA

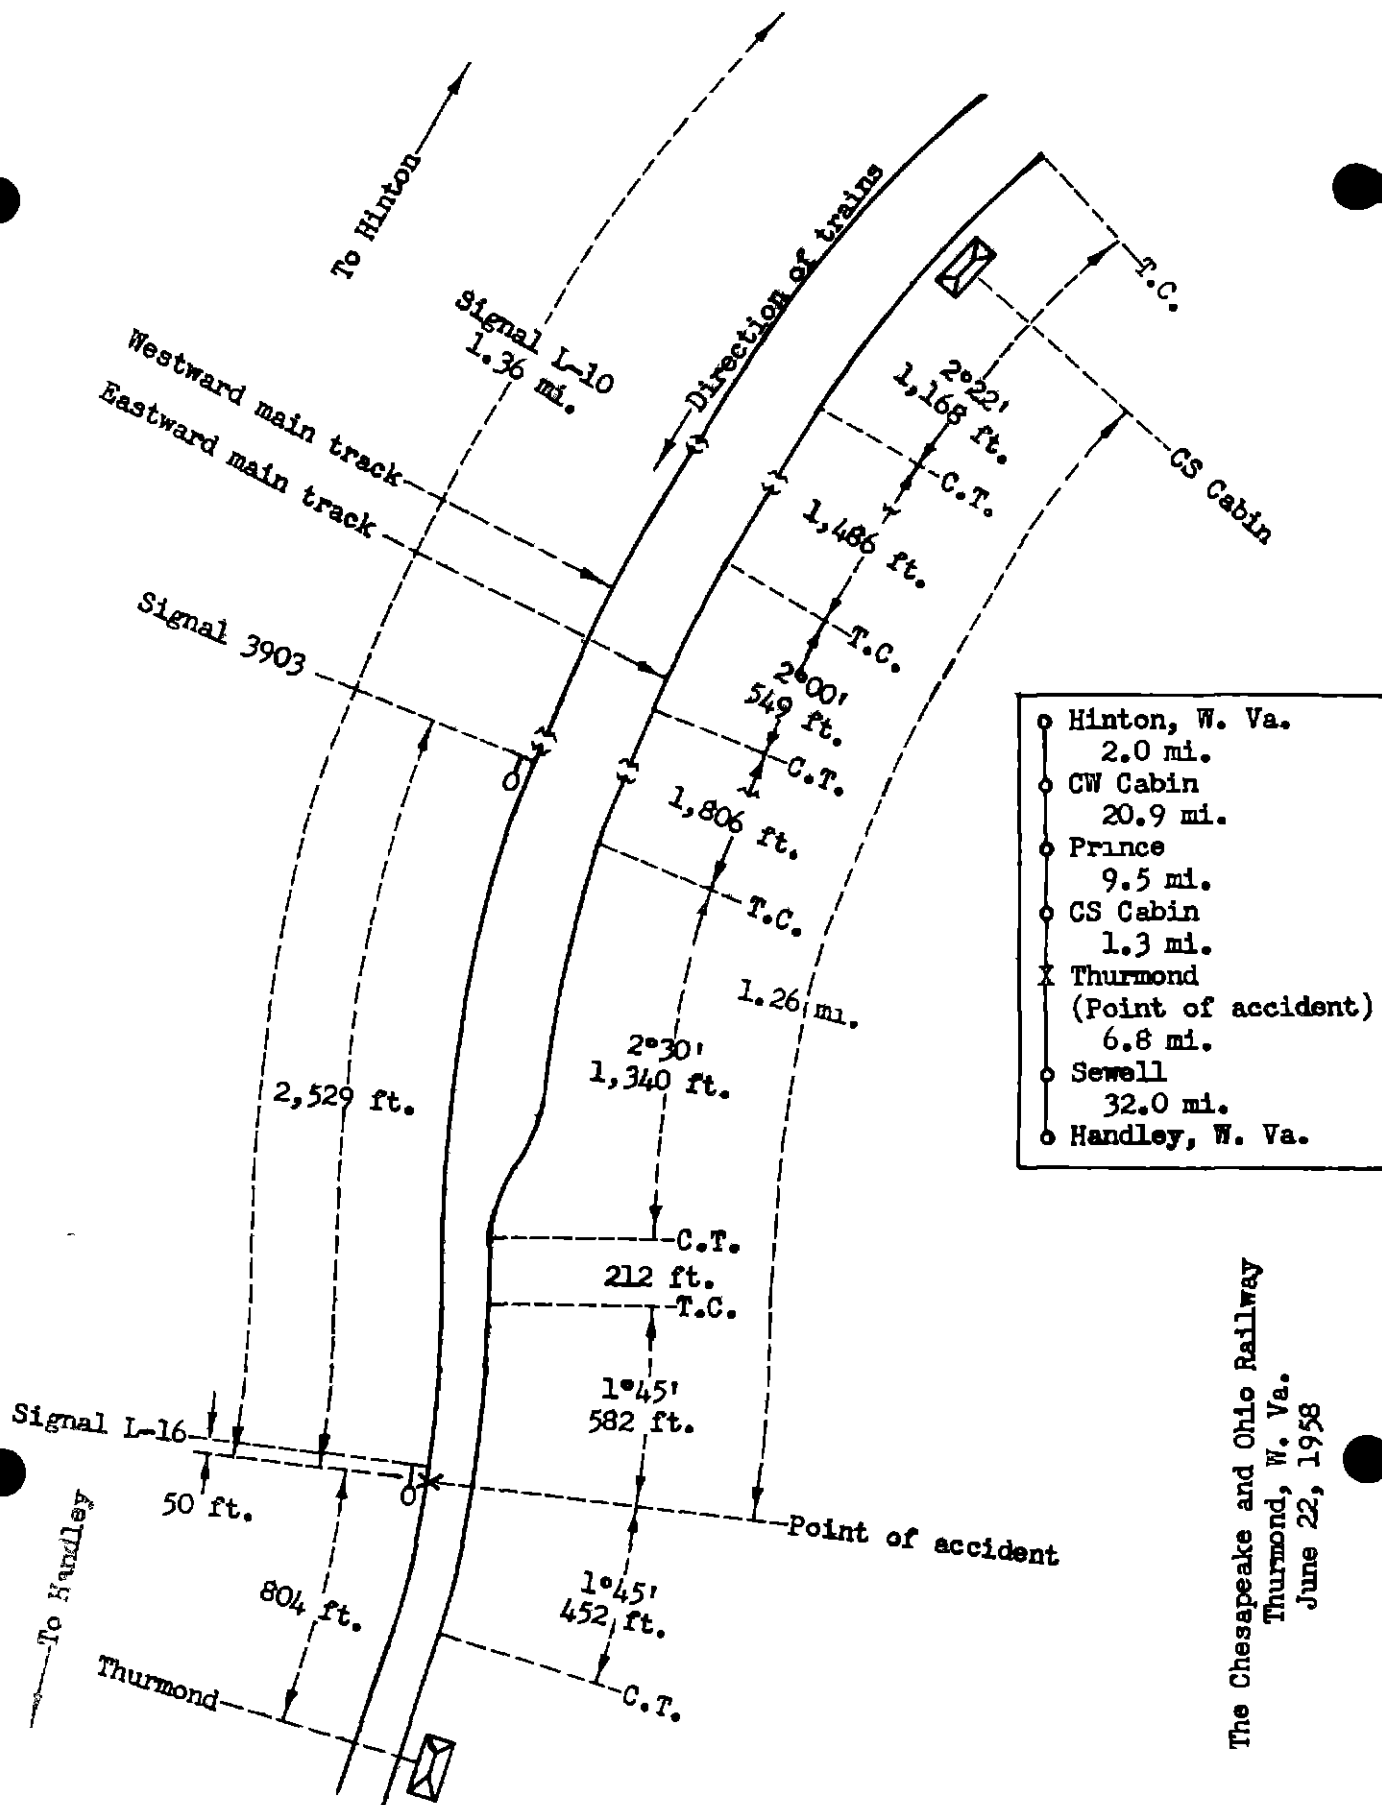
The Chesapeake and Ohio Railway
 Thurmond, W. Va.
 June 22, 1958

This accident occurred on that part of the Hinton Division extending between Hinton and Handley, W Va , 72.5 miles. In the vicinity of the point of accident this is a double-track line over which trains moving with the current of traffic are operated by timetable, train orders, and an automatic block-signal system. The accident occurred on the westward main track at a point 33.7 miles west of Hinton and 804 feet east of the station at Thurmond. From the east on the westward main track there are, in succession, a 2°22' curve to the left 1,168 feet in length, a tangent 1,486 feet, a 2°00' curve to the left 549 feet, a tangent 1,806 feet, a 2°30' curve to the left 1,340 feet, a tangent 212 feet, and a compound curve to the right, having a maximum curvature of 1°45', 582 feet to the point of accident and 452 feet westward. Throughout a distance of 7,182 feet east of the point of accident the grade for westbound trains is an average of 0.097 percent descending and is 0.08 percent descending at the point of accident.

Semi-automatic signal L-10, automatic signal 3903, and semi-automatic signal L-16, governing westbound movements on the westward main track, are located, respectively, 1.36 miles, 2,529 feet, and 50 feet east of the point of accident. These signals are of the color-light type and are continuously lighted. All units are equipped with spreadlight lenses. Semi-automatic signal L-10 is controlled from the interlocking at CS Cabin, 1.26 miles east of the point of accident, and semi-automatic signal L-16 is controlled from the station at Thurmond. The aspects applicable to this investigation and the corresponding indications and names are as follows:

The controlling circuits are so arranged that when the block of signal L-16 is occupied, signal L-10 displays an Approach-Medium aspect, signal 3903 displays an Approach aspect, and signal L-16 displays a Stop aspect.
