RAILROAD ACCIDENT INVESTIGATION

REPORT NO. 4157

THE CHESAPEAKE AND OHIO RAILWAY COMPANY

NOVEMBER 3, 1969

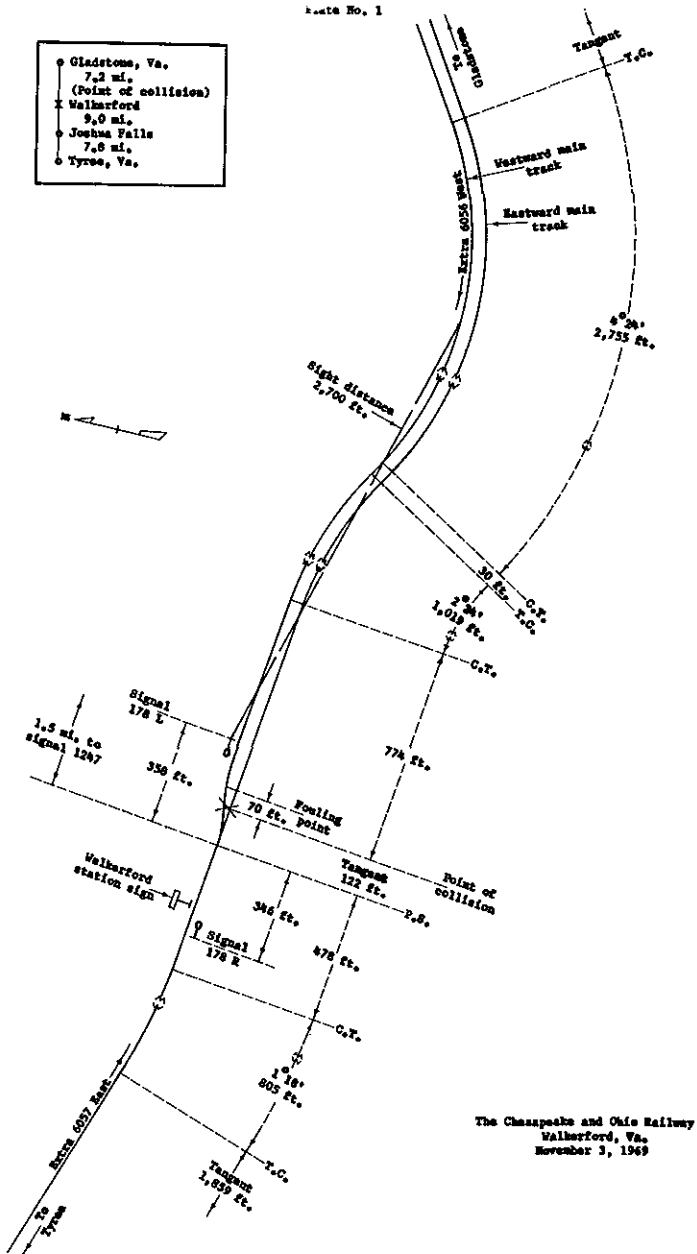
At the end of double track at Walkerford, the westward main track converges with the eastward main track via a No. 16 turnout and a power-operated switch at the junction of the single-track and double-track line, as indicated in Plate No. 1

The collision occurred on the double-track line at Walkerford, 122 feet east of the power-operated switch at the end of double track and approximately 70 feet west of the fouling point of the eastward and westward main tracks

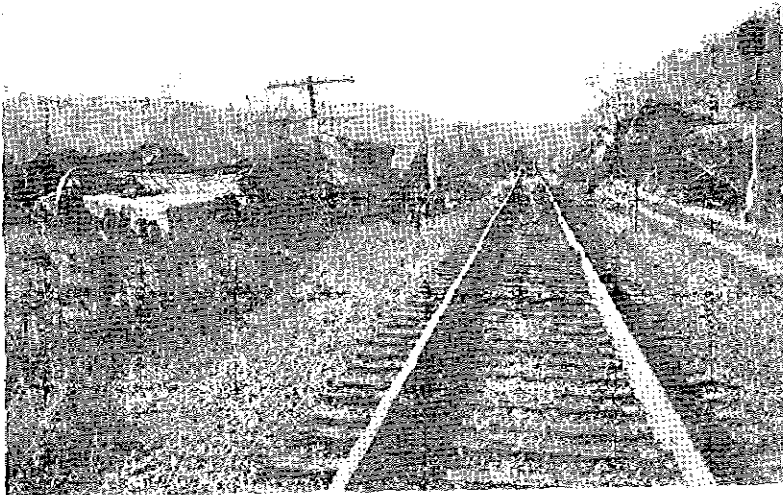
PLATE NO. 2

First locomotive of Extra 6057 East at left.

The 3 locomotive units and first 27 cars of this train derailed to the south of the main track structures. The first locomotive unit overturned onto its left side. It stopped with the front end headed in a westerly direction, and with the rear end 238 feet east of the collision point (See Plate No. 2). The second and third units stopped in line alongside the eastward main track and adjacent to the first unit, as shown in Plate No. 2. The derailed cars stopped in various positions on the south side of the track structures.

The first locomotive unit and 22 derailed cars were destroyed. The other 2 units and 5 derailed cars were heavily damaged

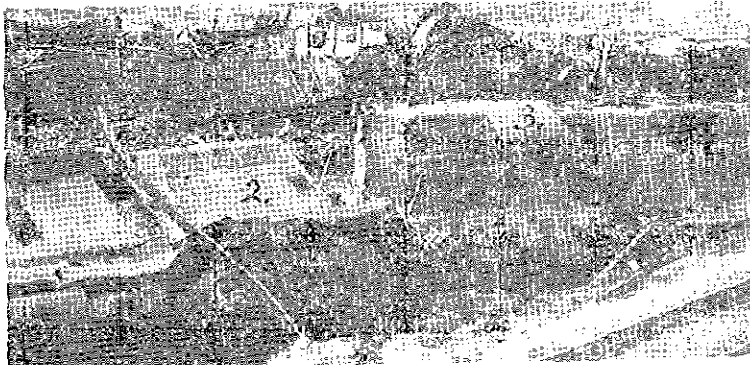
Second and third locomotive units of Extra 6057 East.

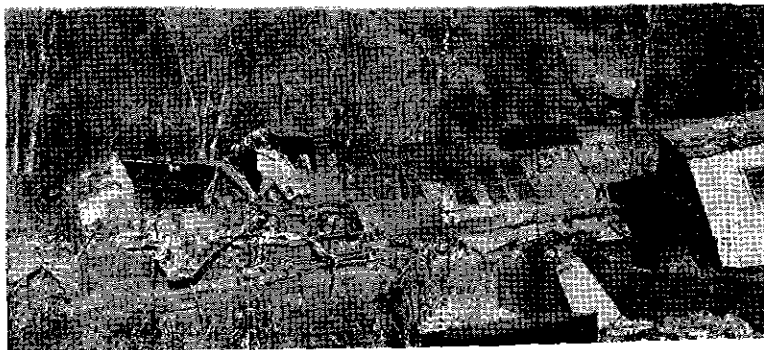
PLATE NO. 3

First locomotive unit of Extra 6056 West

The 3 locomotive units and first 19 cars of this train derailed to the north of the track structures. The first locomotive unit overturned and stopped on its right side with the front end 108 feet west of the collision point (See Plate No 3). The second unit also overturned onto its right side. It stopped directly behind, and in line with, the first unit. The third unit (See Plate No 3) stopped upright a short distance to the rear of the second unit. The derailed cars stopped in various positions on the north side of the track structures.

The first and third locomotive units, and 13 of the derailed cars were destroyed. The second unit and the remaining six derailed cars were heavily damaged.

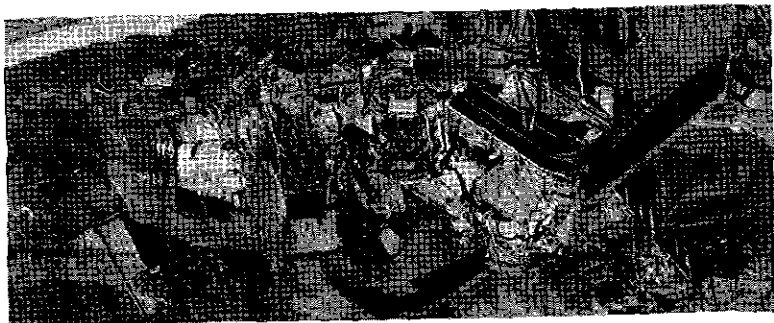
Third locomotive unit of Extra 6056 West
