INTERSTATE COMMERCE COMMISSION

REPORT OF THE DIRECTOR OF THE BUREAU OF SAFETY CONCERNING AN
ACCIDENT ON THE CHESAPEAKE AND OHIO RAILWAY NEAR WAYNE,
IND., ON NOVEMBER 23, 1933.

January 30, 1934.

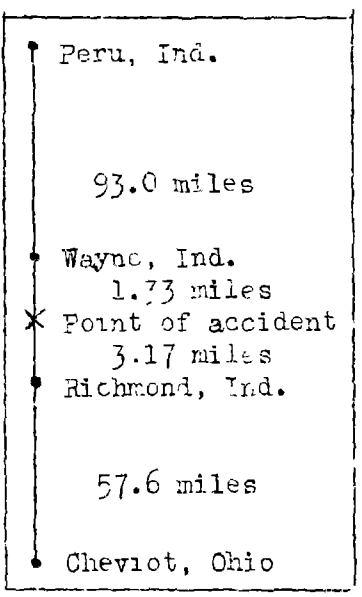
Inv. No. 1863
Chesapeake and Ohio Ry.
Wayne, Ind.
Nov. 23, 1933

Point of accident
