RAILROAD ACCIDENT INVESTIGATION

REPORT NO 4093

CHICAGO & EASTERN ILLINOIS RAILROAD COMPANY

HOOPESTON, ILL

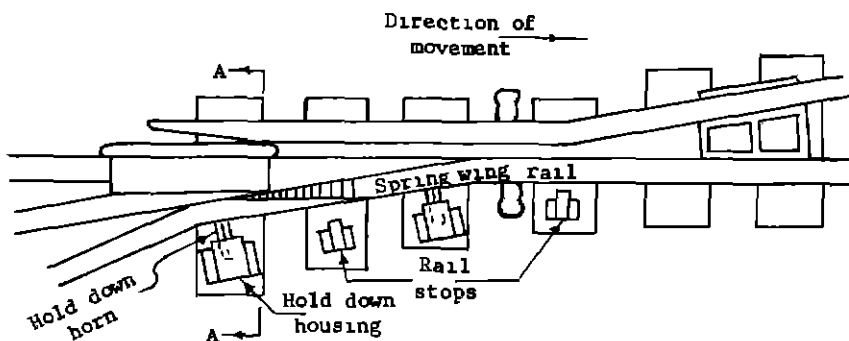
The frog was provided with hold down horns and housings 4 inches and 40 inches north of the frog point. The welds securing the hold down housings to the frog base plate were broken. The spikes supplementing the welds were loose. These defective conditions permitted vertical movements in excess of the allowable one-eighth inch of the spring wing rail above the level of the frog and of the frog below the level of the spring wing rail. Examination of the fractures of the welds disclosed worn and rusty surface conditions indicating a 75 percent old fracture at the south hold down housing and a 95 percent old fracture at the north housing. The spike holes in the ties for the hold down housings were worn to the extent that the spikes could be inserted full length by hand. The south hold down housing was found 108 feet south of the frog on the west side of the track. The north housing was found along the west side of the frog base plate.

The worn and rusty condition of the fractures of the welds and the loose condition of the spikes clearly indicates that the hold down housings of the spring rail frog were inadequately maintained.

Apparently, as the first locomotive unit moved over the frog, the complete fracture occurred in the 95 percent defective weld of the north hold down housing. This immediately put additional strain on the south hold down housing, resulting in the complete fracture of its 75 percent defective weld. As the first wheel of the second locomotive unit moved onto the frog, which then had no

Sketch of frog showing position of wheel where a dangerous condition existed, due to defective hold downs, as shown in Section A-A.

It is recommended that the Chicago & Eastern Illinois Railroad Company immediately take such action as is necessary to insure the adequate maintenance of spring rail frog assemblies.

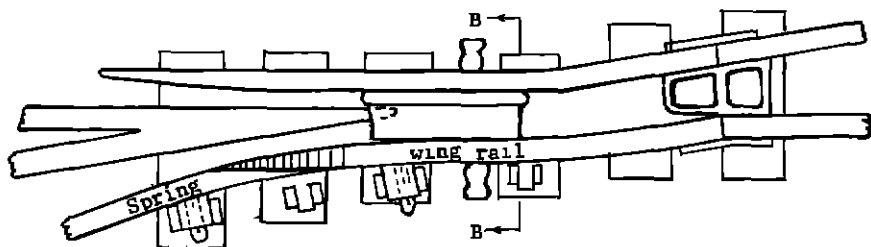
effective hold down assemblies, the frog was depressed sufficiently for the rim of the wheel to engage the spring wing rail and force it outward. This allowed the wheel to drop from the frog point into the throat of the frog. The wheel then rerailed at the toe of the frog. The second wheel likewise was derailed at the frog and rerailed south of the frog. The two wheels on the west side of the rear truck of the second locomotive unit and all wheels of the third unit and first 11 cars of the train derailed at the frog. The resultant battering of the receiving end of the closure rail and subsequent displacement of track components caused the general derailment south of the frog.

Sketch of frog showing wheel derailed after engaging spring wing rail and forcing it out of position, as shown in Section B-B

Section B-B
Wheel derailed after passing over point of frog.
