REPORT OF THE DIRECTOR OF THE BUREAU OF SAFETY CONCERNING AN
ACCIDENT AT THE INTERSECTION OF THE TRACKS OF THE CHICAGO
AND EASTERN ILLINOIS RAILWAY AND THE SOUTHERN RAILWAY AT
PRINCETON, IND., ON DECEMBER 24, 1933

Inv. No. 1477
Chicago & Eastern Indiana Ry.
Southern Ry.
Princeton, Ind.
Dec. 24, 1933

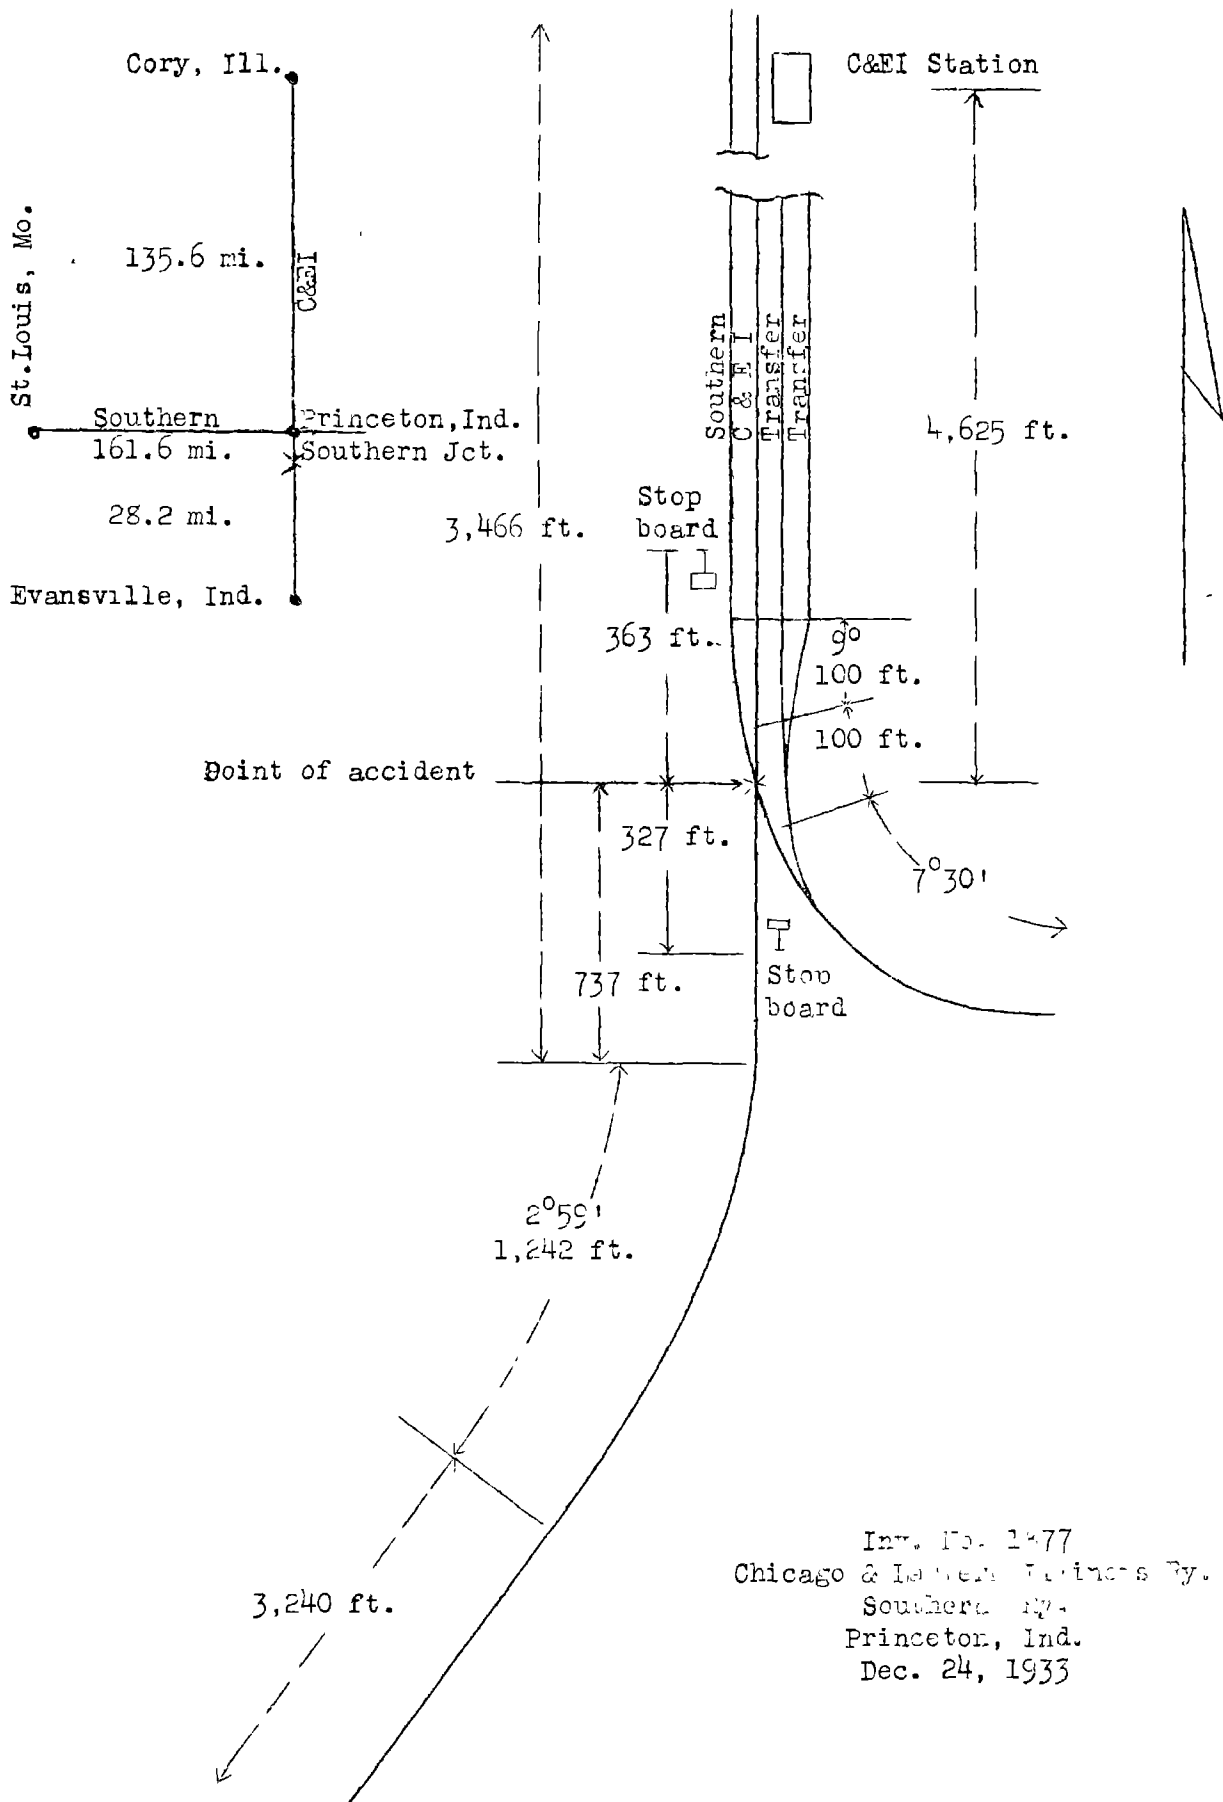
This accident occurred at the intersection of the tracks of the Evansville District of the Chicago Division of the Chicago and Eastern Illinois Railway, hereinafter referred to as the C&EI, extending between L. & W. Station, near Evansville, Ind., and Cory, Ill., a distance of 123.8 miles, and that part of the St. Louis Division of the Southern Railway extending between St. Louis, Mo., and Princeton, Ind., a distance of 161.6 miles. Each railroad is a single-track line; in the vicinity of the point of accident trains on the C&EI are operated by time table, train orders, and an automatic block-signal system and trains on the Southern are operated by time table, train orders, and a manual block-signal system. Time table directions on the C&EI are north and south, and on the Southern they are east and west. In the immediate vicinity of the point of accident the C&EI track runs practically north and south by compass directions; the Southern track parallels the C&EI track on the west to a point 4,825 feet south of the C&EI station and then crosses the C&EI track at an angle of 45° at a point known on the C&EI as Southern Junction, and continues eastward. Southern Junction is located within yard limits and is 1.68 miles south of a station on the Southern Railway known as West Junction. Just north of this crossing two transfer tracks parallel the C&EI track on the east, connecting with the Southern track east of the crossing.

Approaching the crossing from the south on the C&EI, the track is tangent for a distance of approximately 3,240 feet, followed by a 2°59' curve to the left 1,242 feet in length, and then tangent track for a distance of 3,466 feet, the crossing being located on the latter tangent at a point 737 feet from its southern end. Approaching the crossing from the west on the Southern, the track is tangent for a distance of approximately 2,609 feet, followed by a 9° curve to the left 100 feet in length, tangent track for a distance of 100 feet, on which the crossing is located, and then a 7°30' curve to the left. The grade for north-bound trains on the C&EI is generally ascending to within 250 feet of the crossing, from which point for some distance it is 0.37 percent descending.

There are stop signs but no other signals at this crossing. The stop sign for north-bound C&EI trains is located on the east side of the track about 327 feet south of the crossing, while the stop sign for east-bound Southern trains is located west of the track at a point 363 feet north of the crossing. The stop signs for both railroads are similar in design; the post is 9 feet in height with an oval board approximately 4 by 2 feet bearing the word "STOP"; a lamp is located above the board and displays a red light at night.

A clear view of the crossing could be had by the fireman of a north-bound C&EI train for a distance of 1,155 feet, while the engineman's view was restricted to 850 feet, due to the curve to the left.
