REPORT OF THE DIRECTOR OF THE BUREAU OF SAFETY CONCERNING AN ACCIDENT ON THE CHICAGO & ERIE RAILROAD NEAR LIMA, OHIO ON DECEMBER 21, 1932.

Inv. No. 1800
 Chicago & Erie Railroad
 Lima, Ohio
 Dec. 21, 1932.

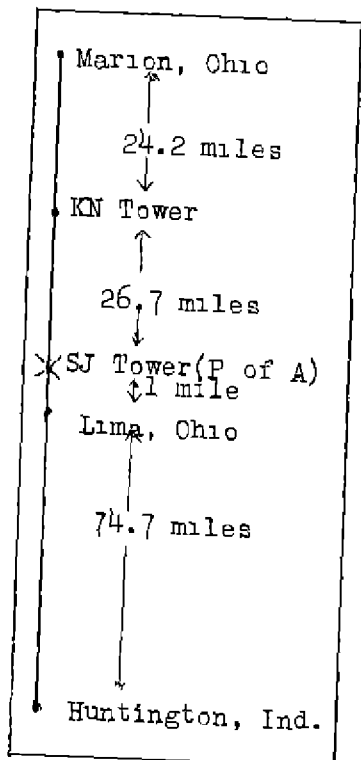
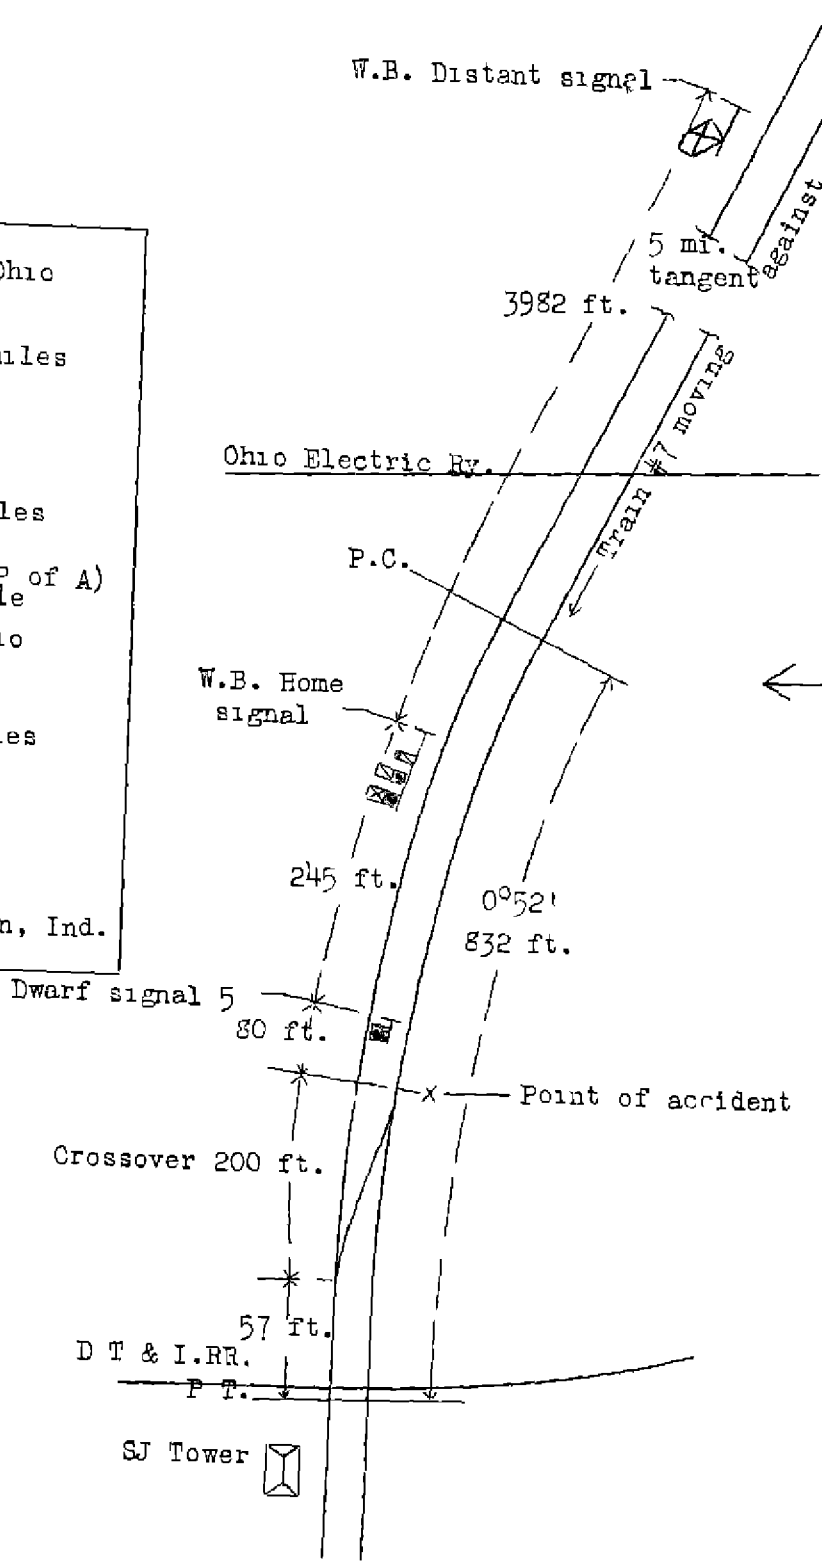
The track of the DT&IRR extends north and south and crosses the Erie tracks at right angles. SJ tower is located in the northwest angle of this crossing, and in it is located the interlocking machine controlling the switches and signals located in the vicinity. Dwarf signal 5, the only signal directly involved, is a two-position, upper-quadrant signal, located between the two main tracks at a point 80 feet east of the crossover, and governs westbound movements against the current of traffic, night indications are purple for stop and yellow for proceed at restricted speed. The westbound home signal at SJ tower is located about 325 feet east of the crossover, while the westbound distant signal is located 3,982 feet east of the home signal, at the time of the accident westbound freight train extra 3144, consisting of 91 cars and a caboose, stood on the westbound main track with its engine just east of the distant signal.
