REPORT NO. 3357

CHICAGO AND NORTH WESTERN RAILWAY COMPANY

IN RE ACCIDENT

AT BARRINGTON, ILL., ON

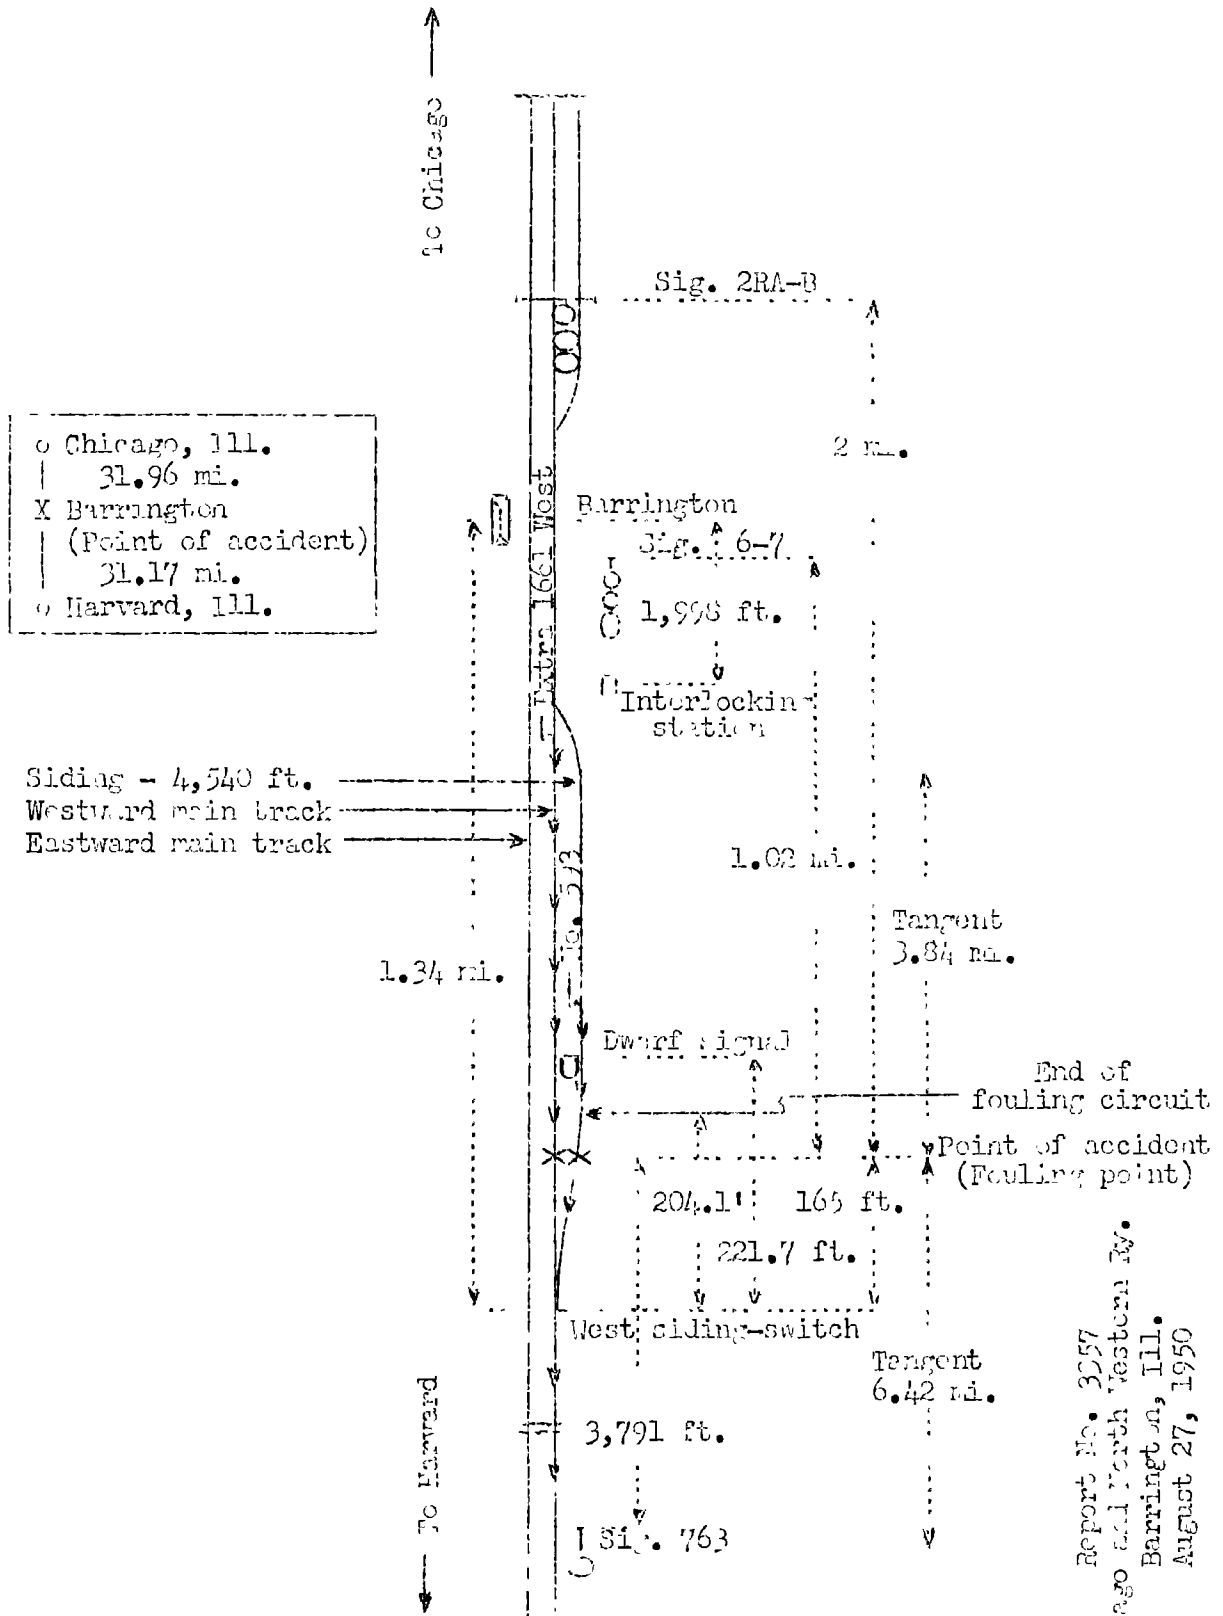
Report No. 3057  
 Chicago and North Western Ry.  
 Barrington, Ill.  
 August 27, 1950

o Chicago, Ill.  
 | 31.96 mi. 
 X Barrington  
 | (Point of accident) 
 | 31.17 mi. 
 o Harvard, Ill.

Siding - 4,540 ft.  
 Westward main track  
 Eastward main track

Location of Accident and Method of Operation
