REPORT OF THE DIRECTOR
BUREAU OF SAFETY

ACCIDENT ON THE
CHICAGO & NORTH WESTERN RAILWAY

CRYSTAL LAKE, ILL.

INVESTIGATION NO. 2420

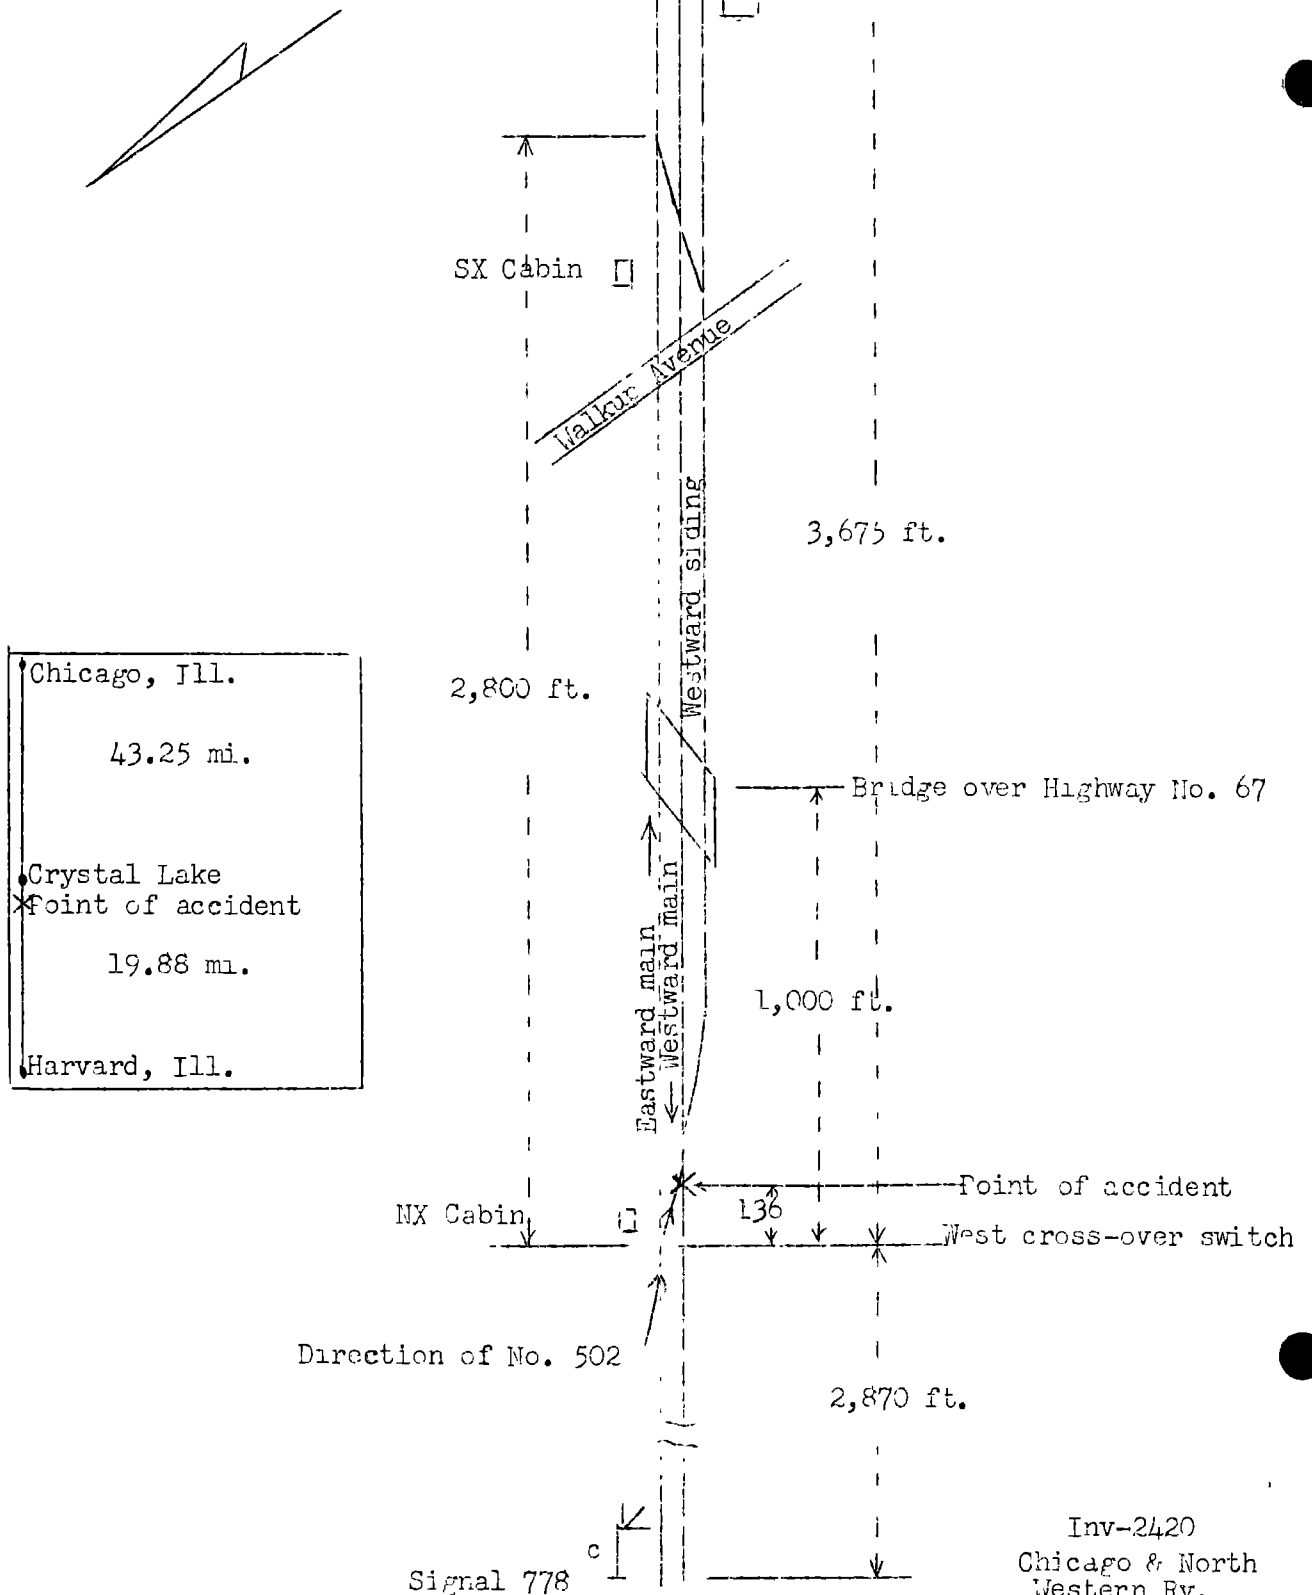
The Commission's inspectors observed that the first mark of derailment was a light flange mark on the south rail of the west crossover 18 feet east of the east frog, or 136 feet east of the west crossover switch. The switch point at the east end of the crossover was torn out, and from that point eastward the westward main track was torn up a distance of 580 feet. The siding was torn up a distance of 200 feet.
