CHICAGO & NORTH WESTERN RAILWAY

EVANSTON, ILL.

July 2, 1937

INVESTIGATION NO. 2185

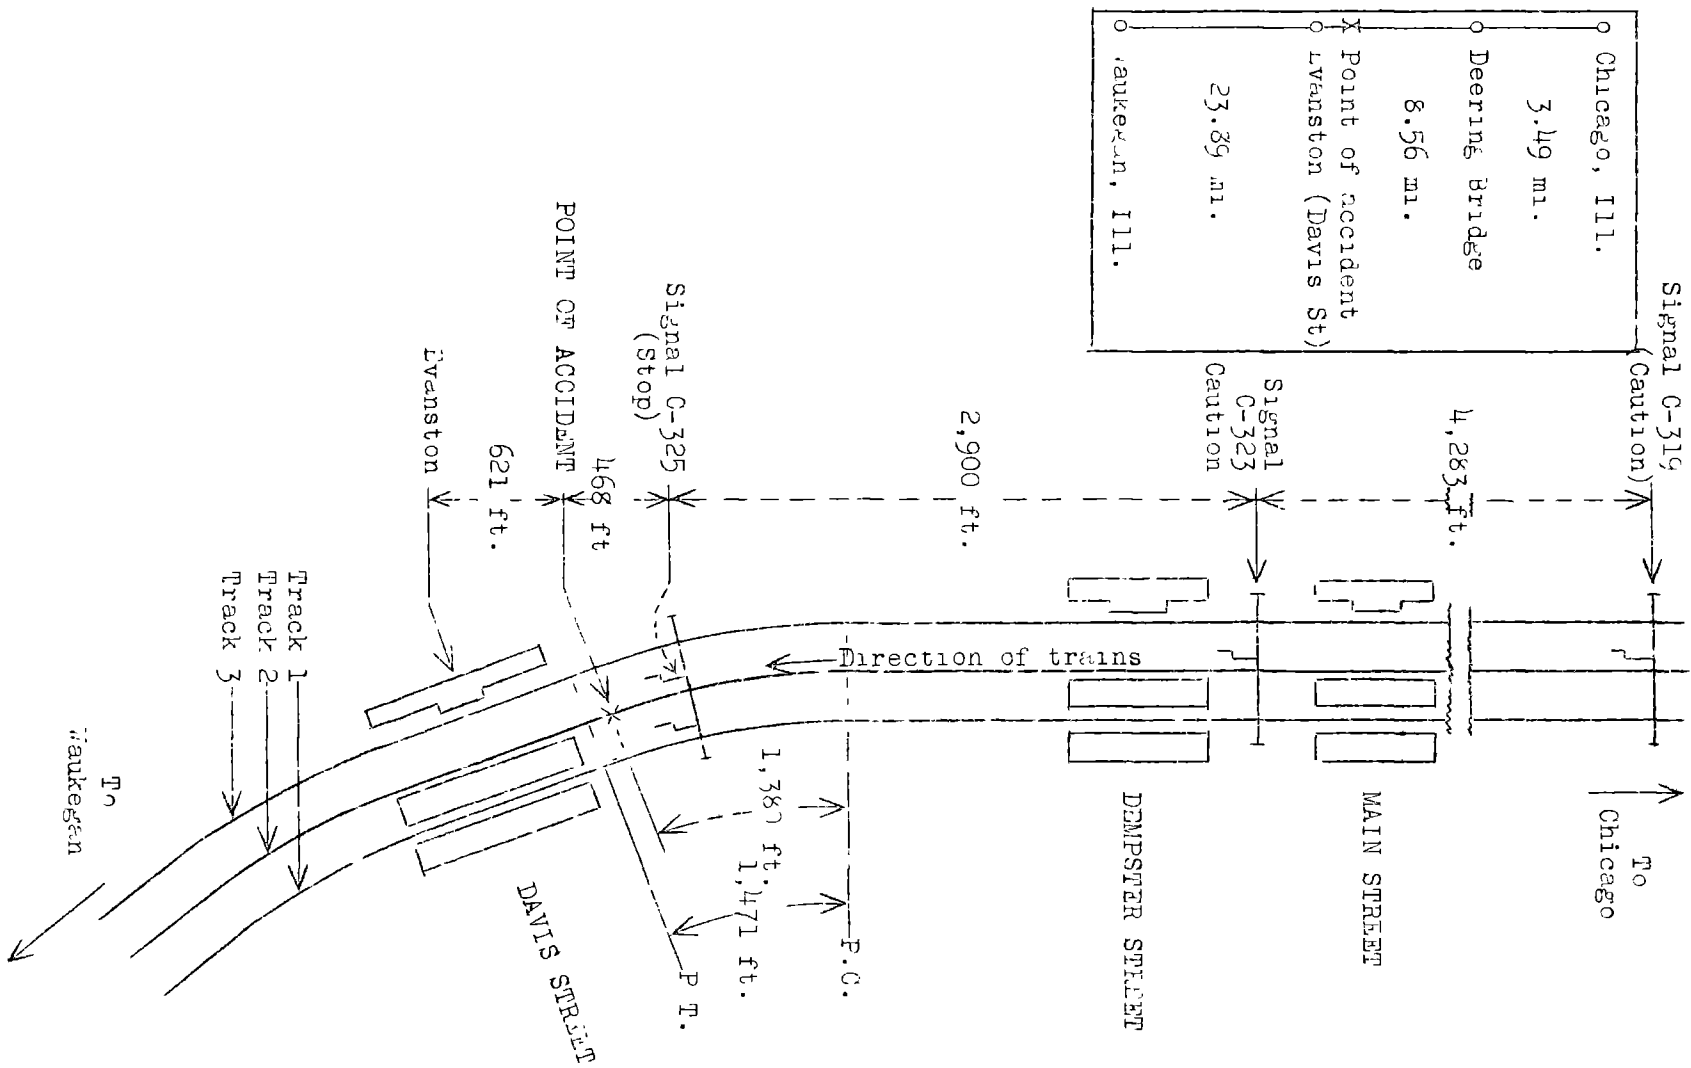
Inv. No. 2185  
Chicago & North Western Ry.  
Evanston, Ill.  
July 2, 1937

The automatic block signals are of the 3-position, upper-quadrant, semaphore type, electrically lighted, mounted on signal bridges spanning the tracks. Track 2 is signalled for movements in each direction. The signals involved are signals C-325, C-323 and C-319, located 468 feet, 3,368 feet and 7,651 feet, respectively, east of the point of accident. When signal C-325 displays a stop indication, which was the case in this instance, signals C-323 and C-319 display approach indications, requiring that the engineman be prepared to stop at next signal and train exceeding 30 miles per hour must at once reduce to that speed.

The rear of a train standing at the point of accident could be seen from the engineman's side of an approaching west-bound engine for a distance of 330 feet, and from the fireman's side for 1,260 feet. The stop indication of signal C-325 could be seen through the front windows from both sides of the cab, for a distance of 5,400 feet, and this indication was continuously visible from a point 4,330 feet east of the signal until the signal was reached.
