INTERSTATE COMMERCE COMMISSION

ACCIDENT ON THE
CHICAGO & NORTH WESTERN RAILWAY

EVANSVILLE, WIS.

INVESTIGATION NO. 2322

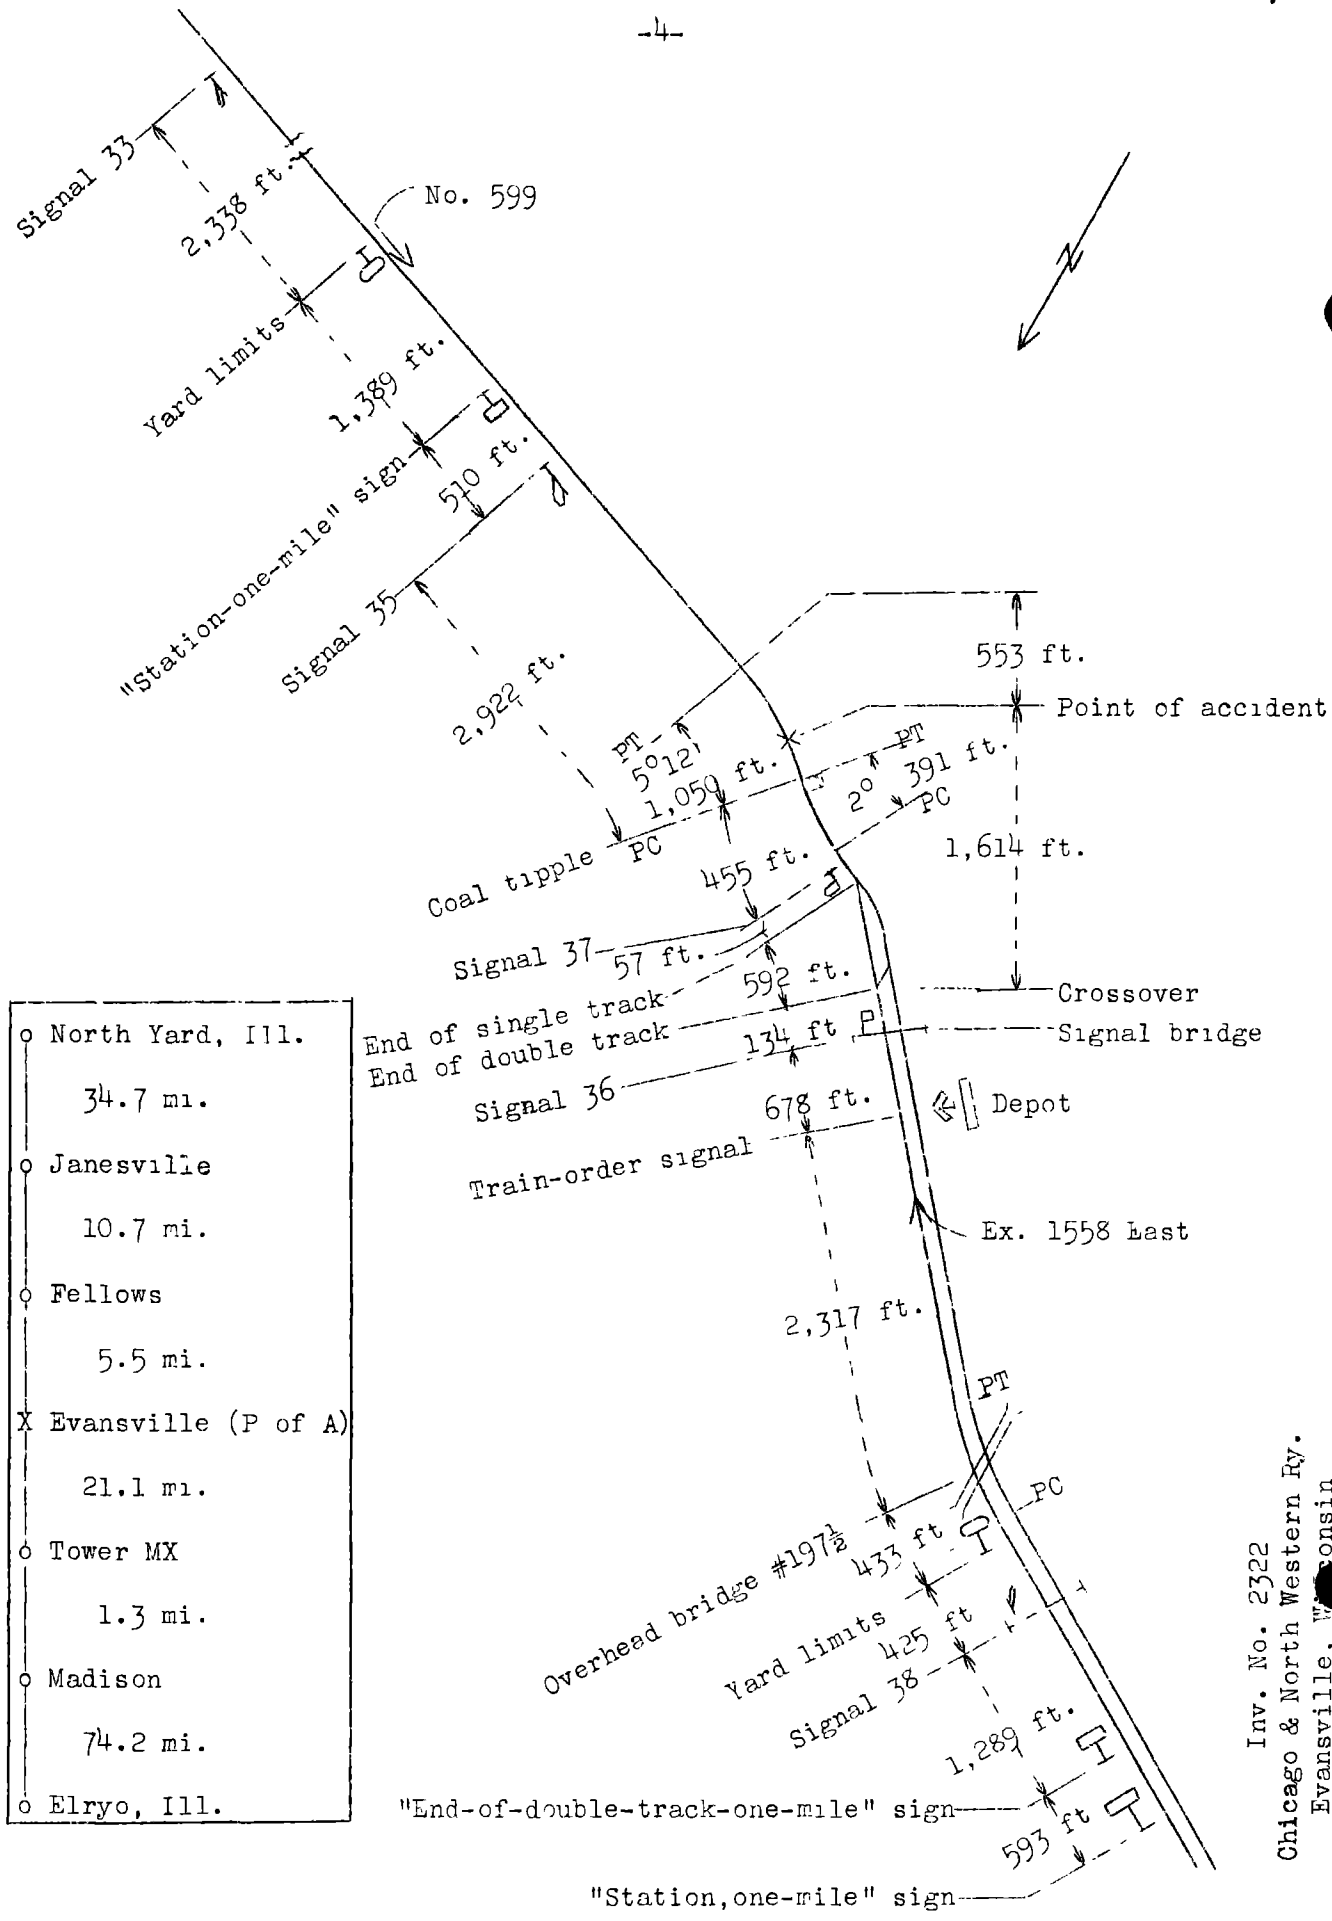
Inv. No. 2322
 Chicago & North Western Ry.
 Evansville, W. Consin
 January 2, 1900

o	North Yard, Ill.
	34.7 mi.
o	Janesville
	10.7 mi.
o	Fellows
	5.5 mi.
X	Evansville (P of A)
	21.1 mi.
o	Tower MX
	1.3 mi.
o	Madison
	74.2 mi.
o	Elryo, Ill.
