REPORT OF THE DIRECTOR
BUREAU OF SAFETY

ACCIDENT ON THE
CHICAGO & NORTH WESTERN RAILWAY

LAKE BLUFF, ILL.

FEBRUARY 3, 1938.

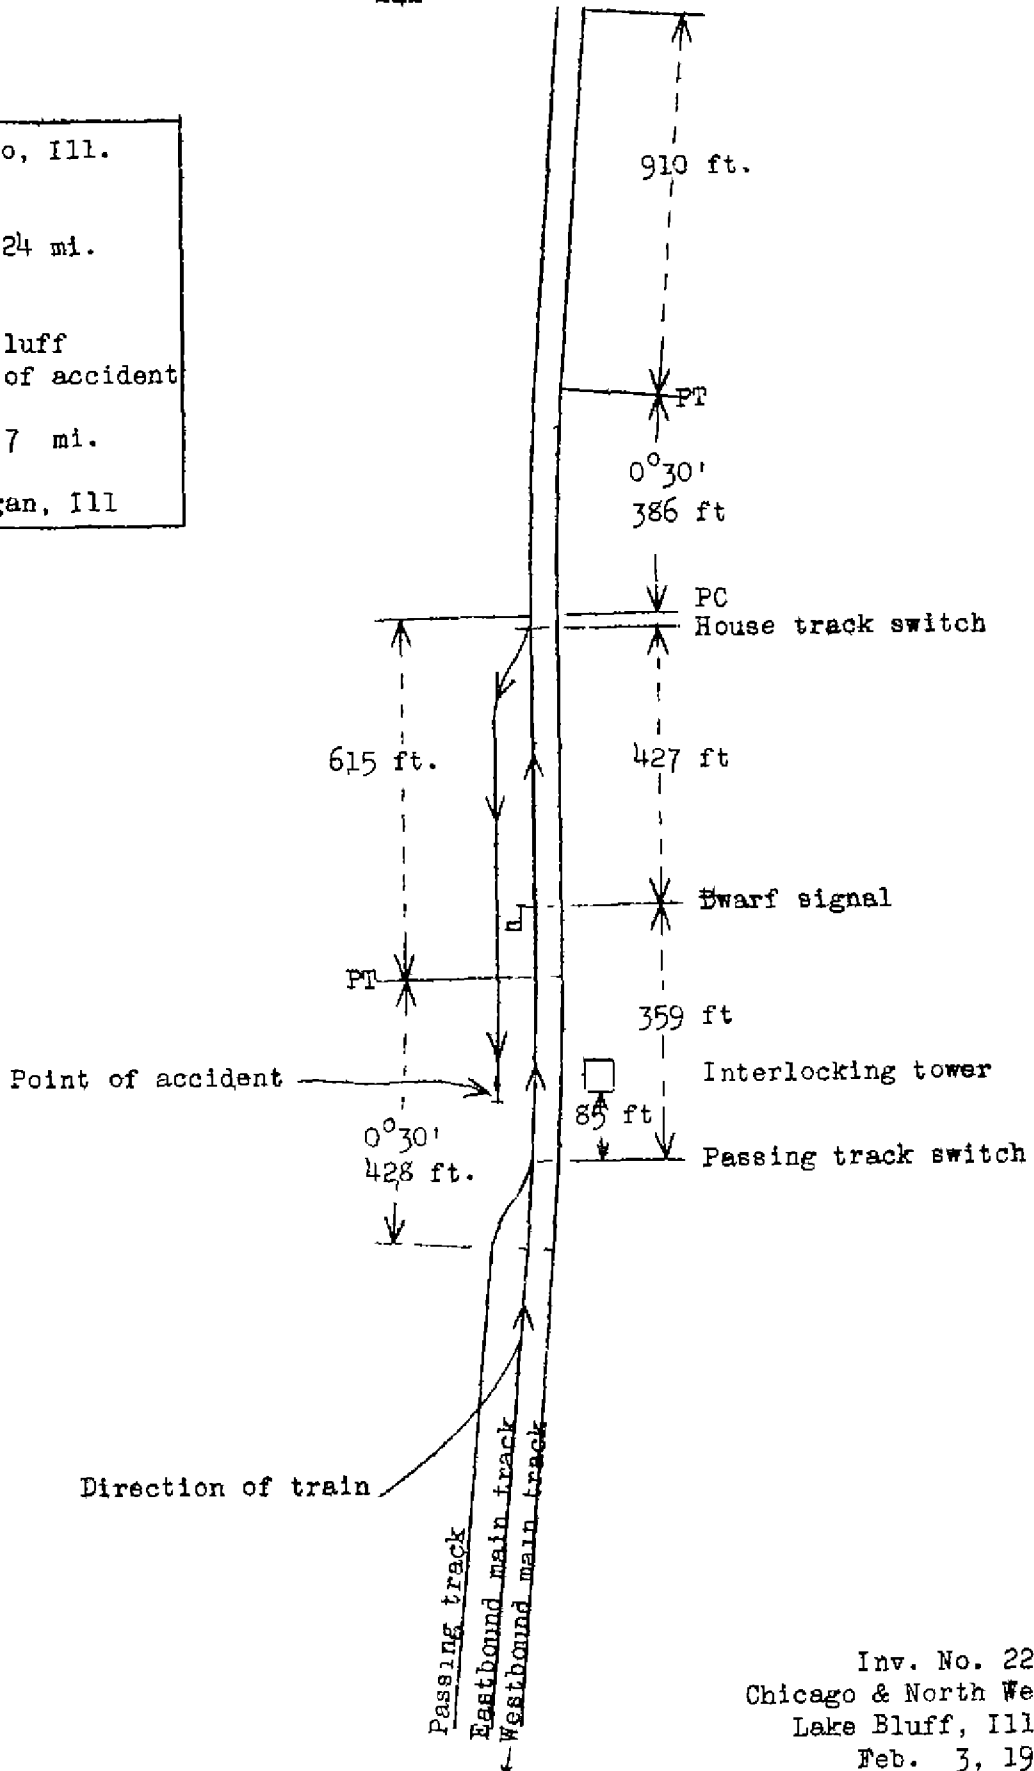
Inv. No. 2248
 Chicago & North Western Ry.
 Lake Bluff, Illinois
 Feb. 3, 1938

The house-track switch is of the hand-throw type, equipped with a single target without a lamp. West of the west end of the house track, a stub end siding, 2,450 feet in length, parallels the eastward main track on the north and has its entry switch at the east end. This switch is located approximately 85 feet west of the interlocking tower and is operated from the interlocking tower. A dwarf signal governing movements through this switch is located 359 feet east of the switch and 427 feet west of the house-track switch.

The train moved eastward to clear the interlocking plant, but instead of backing into the siding it backed into the house track; it was moving at a speed of about 4 or 5 miles per hour and the two rear cars were derailed at the stub end of that track.

The rear car was shoved beyond the end of the track a distance of about 78 feet, and stopped on its side fouling the eastward main track. The rear truck of the adjoining car was derailed, but this car remained in upright position. The employee killed was the head brakeman, who was on top of the rear car.
