## INTERSTATE COMMERCE COMMISSION

REPORT OF THE DIRECTOR OF THE BUREAU OF SAFETY CONCERNING AN  
ACCIDENT ON THE CHICAGO & NORTH WESTERN RAILWAY AT  
MONICO, WIS., ON FEBRUARY 8, 1934.

April 24, 1934.

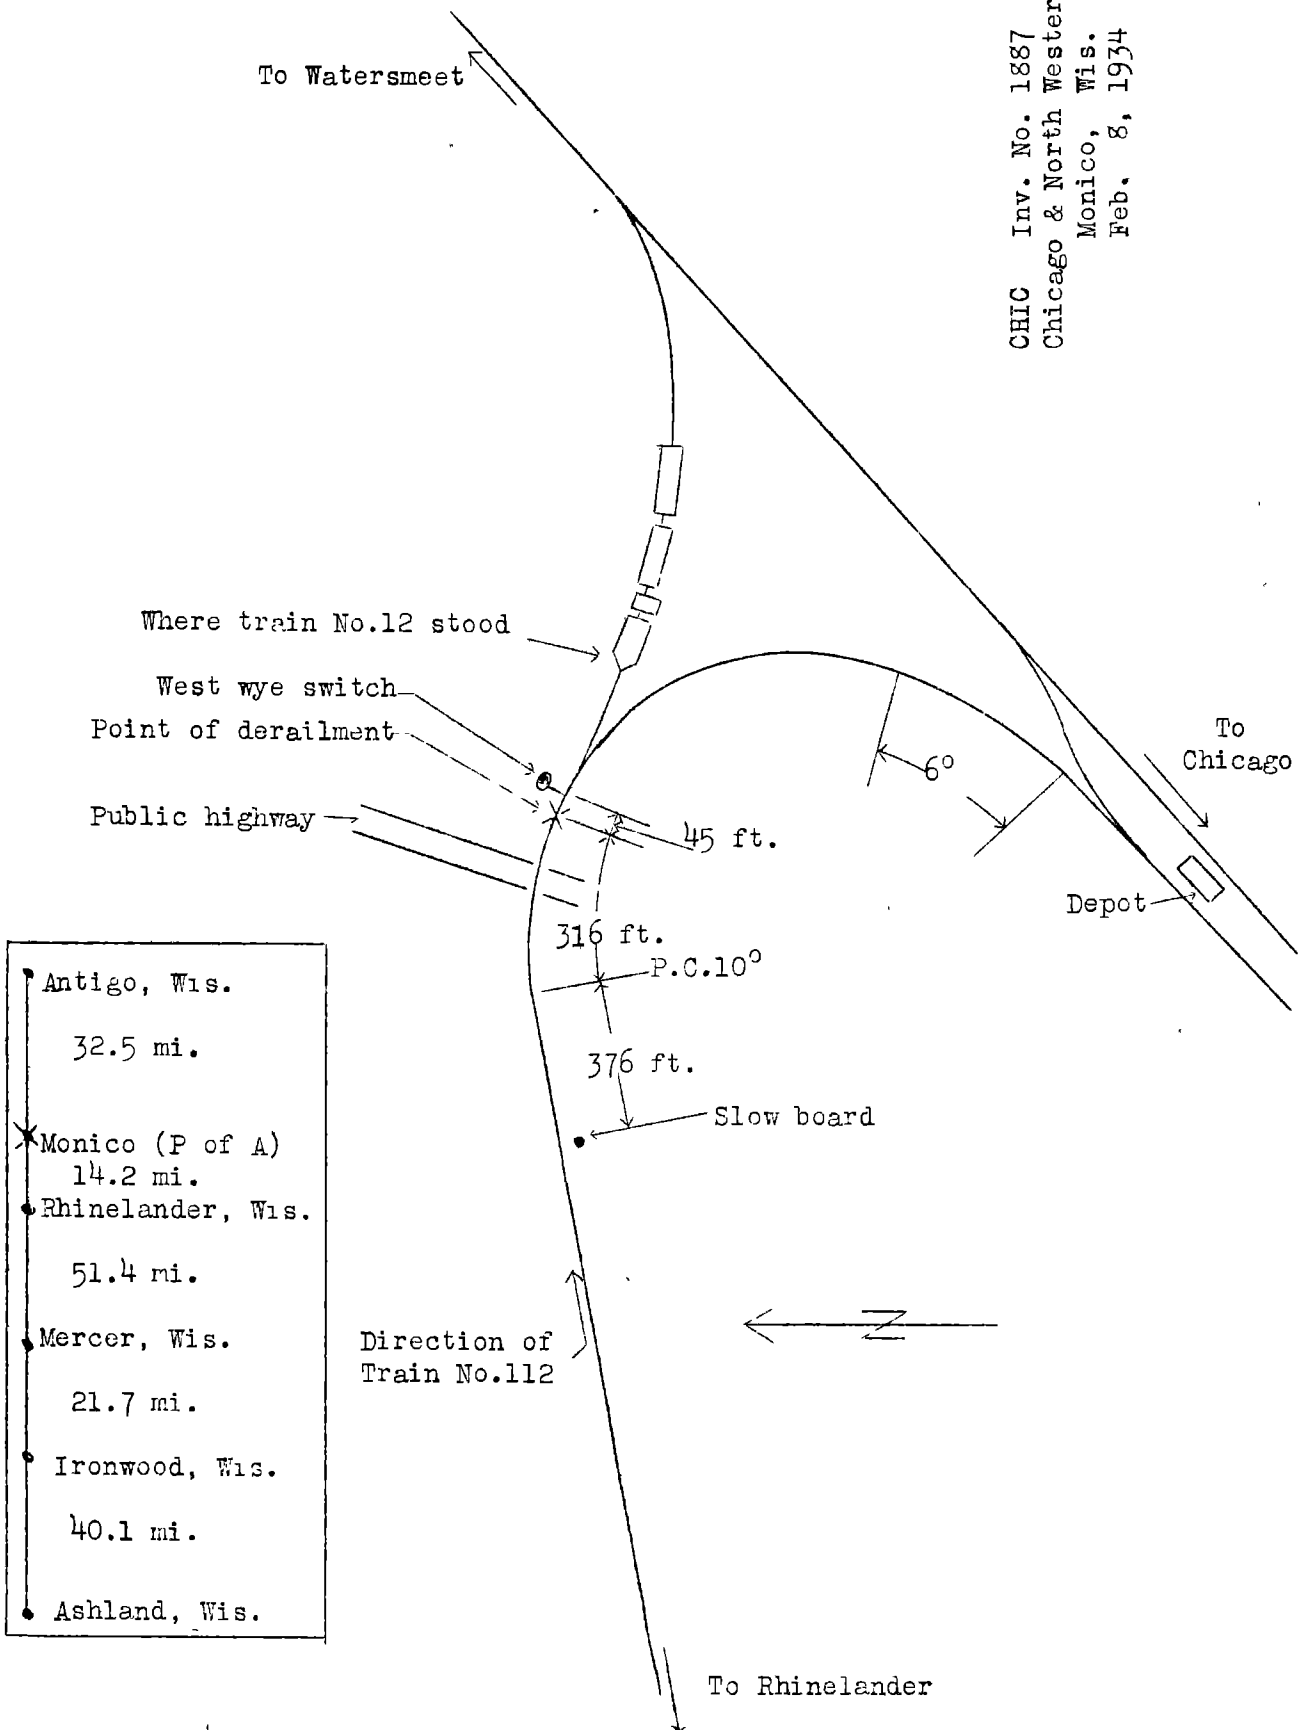
CHIC Inv. No. 1887  
Chicago & North Western Ry.  
Monico, Wis.  
Feb. 8, 1934

rails. The first marks of derailment were flange marks on the high rail of the curve which continued diagonally across the rail for a distance of 7 feet to the point where they passed off on the outside. The next mark was a flange mark on the north end of a tie 26 inches farther east, 9 inches from the base of the rail; flange marks then continued along the ends of the ties, in a diagonal direction, for a distance of 32 feet; then they could be seen in the frozen road bed for a distance of 72 feet to where they passed off the shoulder of the 4-foot fill and the engine overturned. The switch stand was broken off and the connecting rod bent around the end of a tie in such a manner as to hold the switch points securely in their original position. The first track damage was a broken rail east of the frog, or about 120 feet east of the first marks of derailment, where the mail car apparently became derailed.

This accident apparently was caused by Train No. 112 entering a 10° curve at a rate of speed for which the elevation of the outer rail did not provide an adequate margin of safety.

The maximum permissible speed for passenger trains on the 10° curve involved is 25 miles per hour and the estimates of the crew as to the speed varied between 25 and 30 miles per hour. Apparently the speed was high enough, however, to cause the engine to turn over from centrifugal force without first being derailed, there being no flange marks between the rails which would have been present had the wheels on the right side of the engine been derailed before the engine overturned. Marks on the ties and ground on the outside of the outer rail indicated that the engine traveled a distance of approximately 111 feet with only its left wheels on the ground, overturned on a 4-foot fill into a swamp, and slid about 80 feet further and stopped with the boiler submerged in the frozen swamp; the first car in the train was not derailed until 100 feet or more beyond the first flange marks and then continued until it struck engine 476, of Train No. 12, with sufficient force to turn that engine over into the swamp, the mail car then turning end for end and stopping with its nearest end nearly 200 feet beyond the point where it became derailed. This evidence indicates that Engineman Hanson and the other members of the crew were mistaken in their estimates as to the speed at the time of the accident, and that the accident in fact was due to speed in excess of the maximum permissible speed of 25 miles per hour allowed on the curve. There is a question, however, whether the elevation on this curve was adequate to provide a reasonable margin of safety for the prescribed speed limit. The elevation averaged 2 inches, while the recommended practice of the American Railway Engineering Association calls for an elevation of 4 1/8 inches

on a 10° curve for a speed of 25 miles per hour. In the interest of safety, either the elevation should be increased or the maximum permissible speed limit should be reduced.
