INVESTIGATION NO. 2853
THE CHICAGO & NORTH WESTERN RAILWAY COMPANY
REPORT IN RE ACCIDENT
NEAR POPLAR GROVE, ILL., ON
DECEMBER 24, 1944

Accident near Poplar Grove, Ill., on December 24, 1944,
caused by a broken rail, as a result of the presence
of transverse fissures.

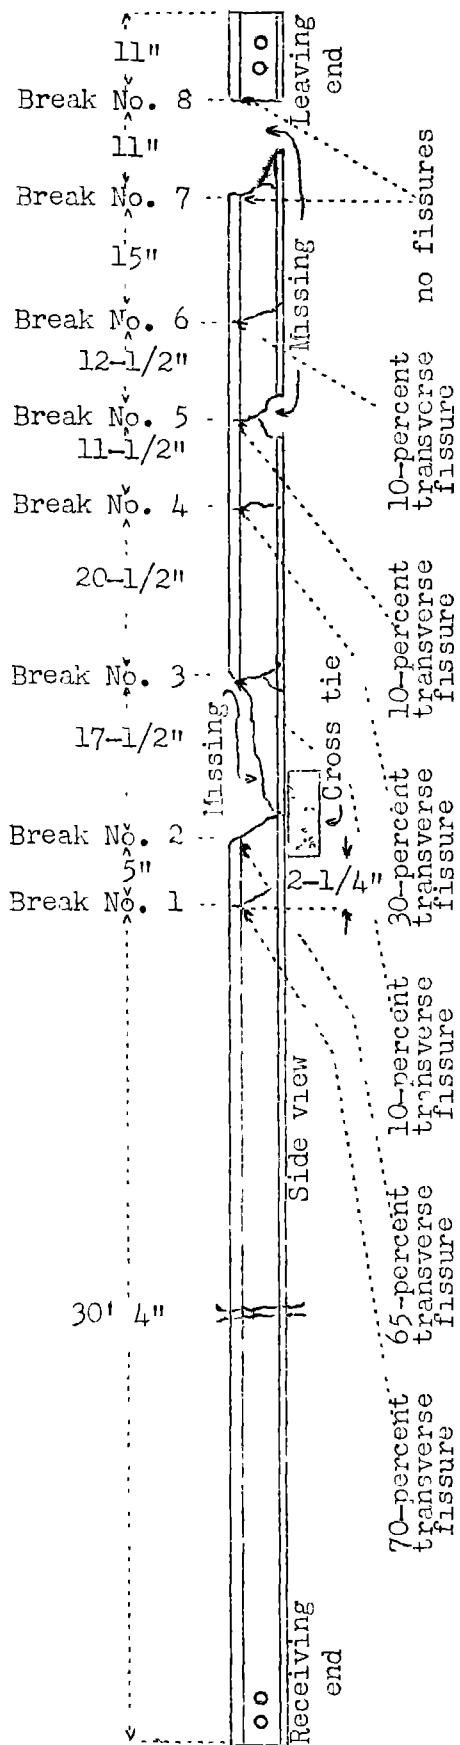
70-percent transverse fissure
 65-percent transverse fissure
 10-percent transverse fissure
 30-percent transverse fissure
 10-percent transverse fissure
 10-percent transverse fissure
 10-percent transverse fissure
 no fissures

After the accident a broken rail was found on the south side of the track. The rail was broken into many pieces, eight of which were recovered. The pieces were scattered throughout a distance of about 200 feet east of the point of derailment. The first break occurred between two ties at a point 30 feet 4 inches east of the receiving end of the rail. This piece of rail remained in normal position. At the first break there was a transverse fissure which covered about 70 percent of the cross-sectional area of the head of the rail. At the second break, which occurred 5 inches east of the first break, there was a transverse fissure which covered about 65 percent of the cross-sectional area of the head. At the third, fourth, fifth and sixth breaks there were transverse fissures which, respectively, covered 10, 30, 10 and 10 percent of the cross-sectional area. None of these fissures extended to the outer surface. In the opinion of the division engineer, the failure of the rail at the first and second breaks occurred when the front part of the train passed over this portion of the rail, the piece between these breaks was forced out of proper alignment, and the other fractures occurred as wheels jumped across the gap. The first piece was displaced before the rear truck of the eleventh car passed over this point, then the twelfth and thirteenth cars were derailed. Apparently the fourteenth and fifteenth cars were derailed at this point, but were rerailed when the wheels came in contact with the west end of the portion of the fractured rail, 11 inches long, which remained in normal alignment and attached to the next rail.

It is found that this accident was caused by a broken rail, as a result of the presence of transverse fissures.
