RAILROAD ACCIDENT REPORT

CHICAGO AND NORTH WESTERN
TRANSPORTATION COMPANY

FREIGHT TRAIN DERAILMENTS
AND COLLISION

GLEN ELLYN, ILLINOIS

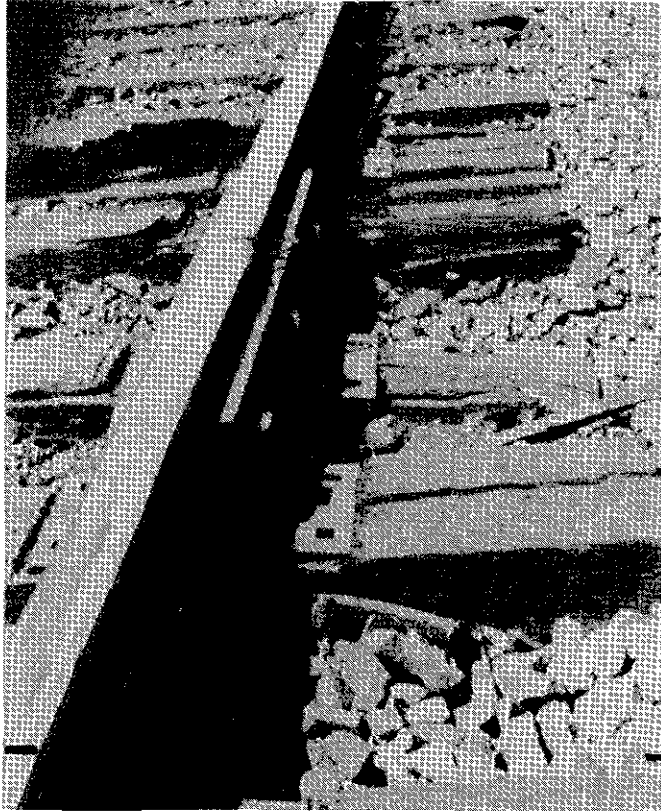
Following the accident, an inspection of track 2 west of the accident site disclosed some defective conditions at the joint areas. One joint area, located on the superelevated north rail about 700 feet west of the derailment point had 170 inches between nondefective crossties. (See figure 2.) This track condition would not qualify for a FRA Class 1 designation, which permits a maximum freight train speed of only 10 mph. There were six additional crosstie defects at joints within 1,700 feet west of the derailment point that would meet only FRA Class 3 specifications, which permit a maximum freight train speed of 40 mph. The six defects were deteriorated crossties or crossties that were not spiked to the rail in the joint area. (See appendix A for track measurements.)

Figure 2. Defective crossties about 700 feet west of derailment point.

7. The defective crosstie conditions at joints contributed to the track defects which generated the high lateral forces produced by the locomotive as it moved around the compound curve.

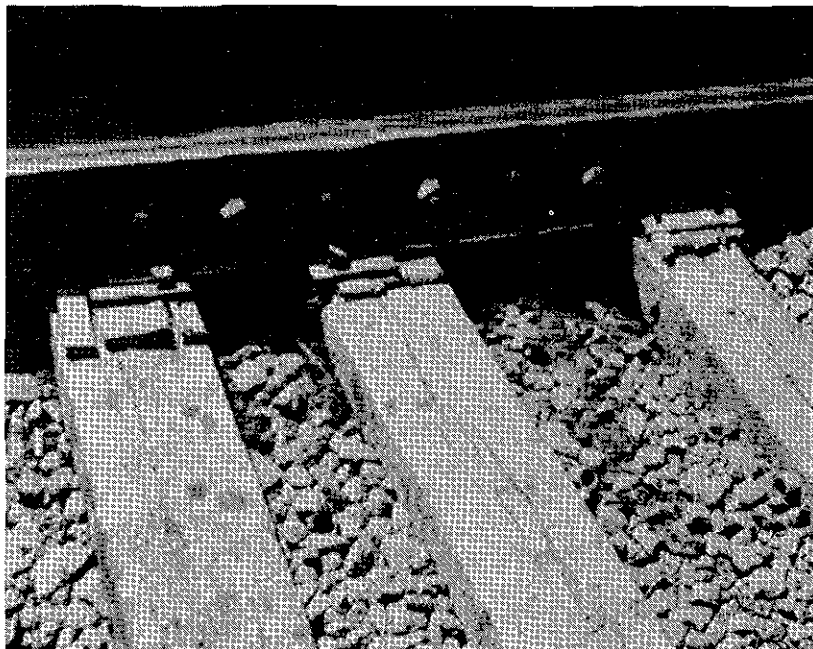
The track measurements taken following the accident showed several locations within two rail lengths where the elevation varied from 1 1/2 inches to 1 3/4 inches from established elevation and in one location it varied 1 1/4 inches in one rail length. Several other locations had wood shims applied between the tie plates and the crossties at the joints to correct excessive changes in cross level. Some of the shims were not secured. (See figure 3.)

Figure 3. One of several joint locations with shims under tie plates.
