CHICAGO AND NORTH WESTERN  
TRANSPORTATION COMPANY

LEVIS, WISCONSIN

AUGUST 15, 1977

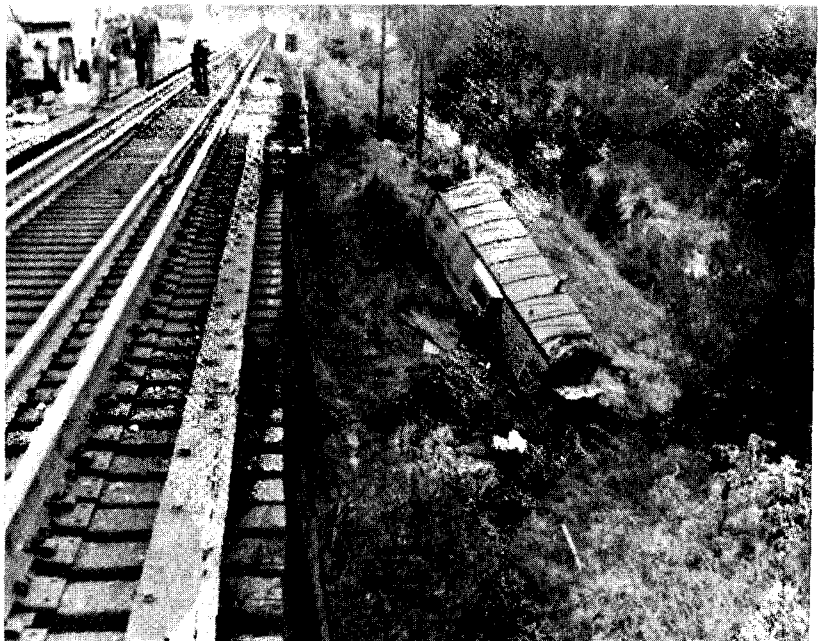
A General View  
of  
The Derailement Site  
Looking West

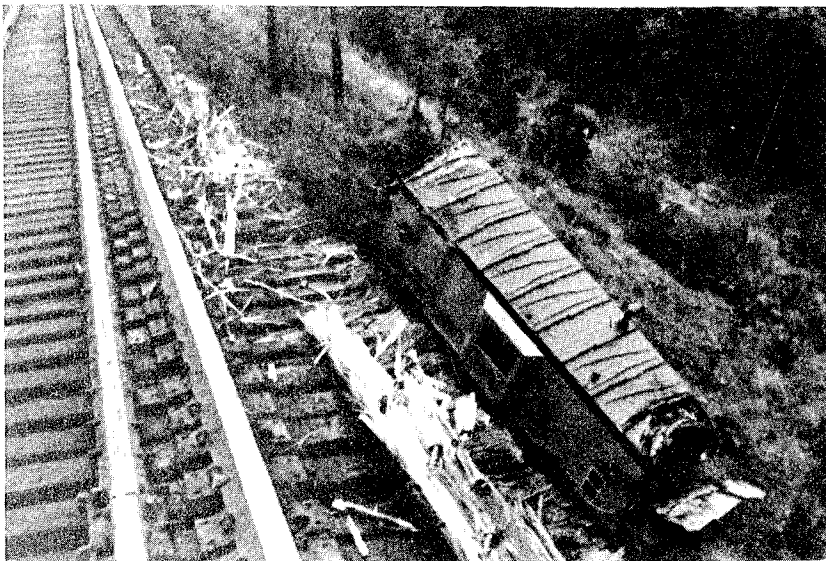
Wheel marks also were visible on the bridge on the field side of the north rail along the ties and stringers to the point where the caboose separated from the train and fell from the bridge.

The point where the left wheels of the caboose broke through the guard rail.
