INVESTIGATION NO. 2957
CHICAGO GREAT WESTERN RAILWAY COMPANY
REPORT IN RE ACCIDENT
NEAR CARROLL, IOWA, ON
DECEMBER 14, 1945

Accident near Carroll, Iowa, on December 14, 1945, caused
by failure to obey a meet order.

Iav. No. 2957
Chicago Great Western Railway
Carroll, Iowa
December 14, 1945

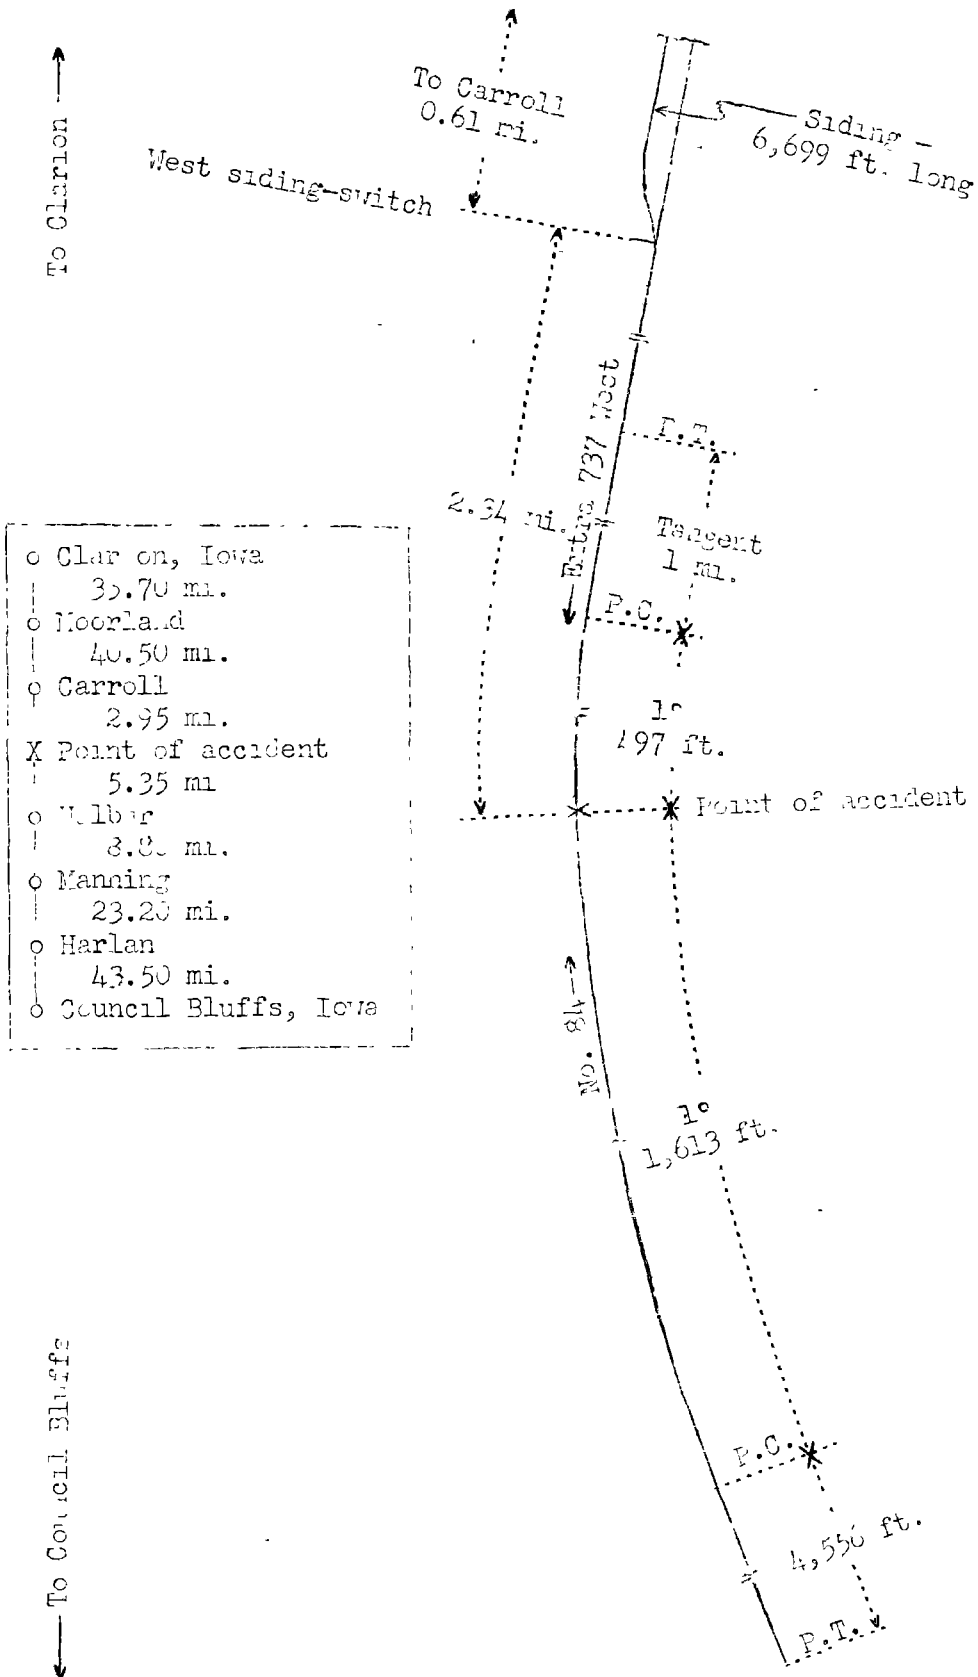
This accident occurred on that part of the Minnesota Division extending between Council Bluffs and Clarion, Iowa, 160 miles, a single-track line over which trains are operated by timetable and train orders. There is no block system in use. At Carroll, 83.8 miles east of Council Bluffs, a siding 6,699 feet in length parallels the main track on the north. The west switch of this siding is 3,222 feet west of the station. The accident occurred on the main track 2.34 miles west of the west siding-switch at Carroll. From the west there is a tangent 4,556 feet in length, which is followed by a 1° curve to the right 1,613 feet to the point of accident and 497 feet eastward. From the east there is a tangent about 1 mile in length, which is followed by the curve on which the accident occurred. The grade is 0.78 percent descending eastward.
