INTERSTATE COMMERCE COMMISSION  
WASHINGTON

ACCIDENT ON THE  
CHICAGO GREAT WESTERN RAILROAD

-----  
CLARE, ILL.  
-----

INVESTIGATION NO. 2264

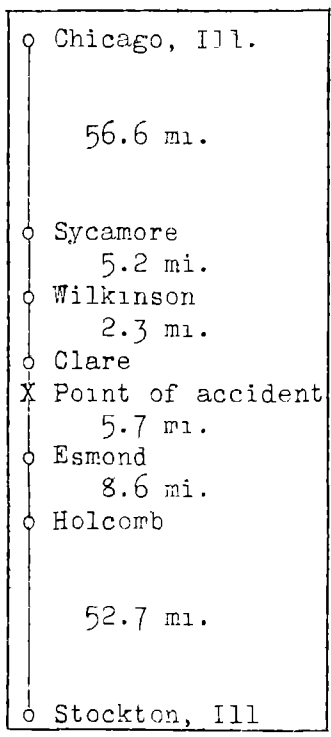
Inv. No. 2264  
 Chicago Great Western R.R.  
 Clare, Illinois  
 April 3, 1938

The automatic block-signal system is the overlap system, consisting of home signals at station sidings, distant signals approaching stations, and intermediate signals between stations. The signals are of the 2-position upper-quadrant, semaphore type, approach lighted; night indications of distant signals are yellow for approach home signal with caution, and green for proceed; night indications of home signals are red for stop and green for proceed. The signals governing west-bound movements are distant signal 63-1, home signal 63-5 and home signal 64-5, located 7,062 feet, 3,762 feet, and 400 feet, respectively, east of the point of accident. Intermediate signal 66-2 and distant signal 64-8, governing east-bound movements are located 8,392 feet and 2,287 feet respectively west of the point of accident; eastward home signal 64-4 is located 26 feet west of the west switch of the siding at Clare.

No. 54 departed from Holcomb the last open office, at 9:36 p.m., passed the distant signal at Clare displaying a caution indication, and on approaching the west siding-switch it collided with No. 1 while traveling at a speed estimated to have been between 5 and 10 miles per hour.
