INVESTIGATION NO. 3127  
CHICAGO GREAT WESTERN RAILWAY COMPANY  
REPORT IN RE ACCIDENT  
NEAR SHANNON CITY, IOWA, ON  
SEPTEMBER 19, 1947

Accident near Shannon City, Iowa, on September 19, 1947,  
caused by a broken rail.

Inv. No. 3127  
Chicago Great Western Railway  
Shannon City, Iowa  
September 19, 1947

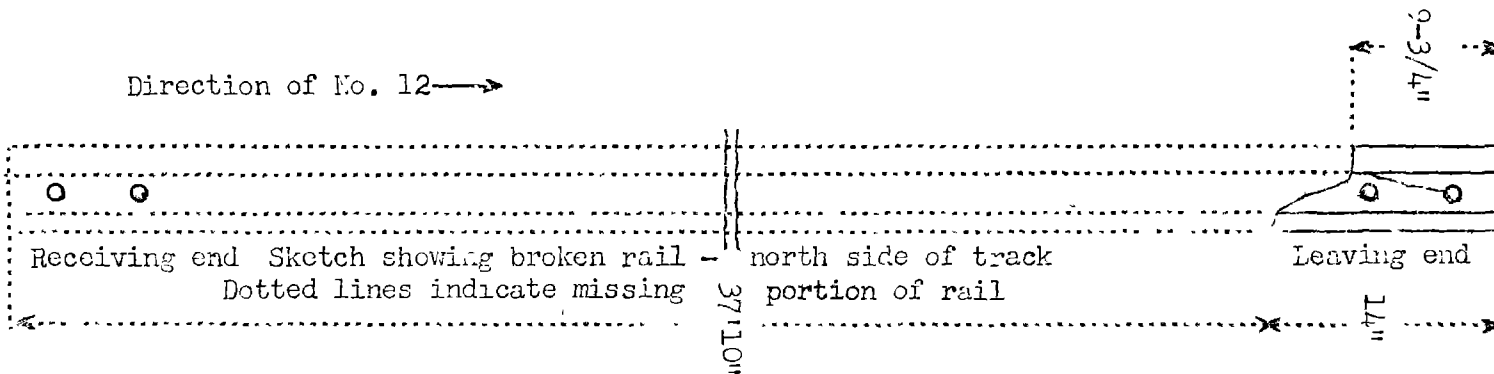
Direction of No. 12 →

Marks on the left No. 1 engine-truck wheel, the bottom surface of the base of the pilot, and a flange mark on the receiving end of the head of the rail at a point about 1-1/2 inches inward from the gage side and on the edge of the top surface indicate that the left No. 1 engine-truck wheel was the first wheel to be derailed.
