REPORT OF THE DIRECTOR
BUREAU OF SAFETY

ACCIDENT ON THE
CHICAGO GREAT WESTERN RAILROAD

TENNANT, IOWA

INVESTIGATION NO. 2333

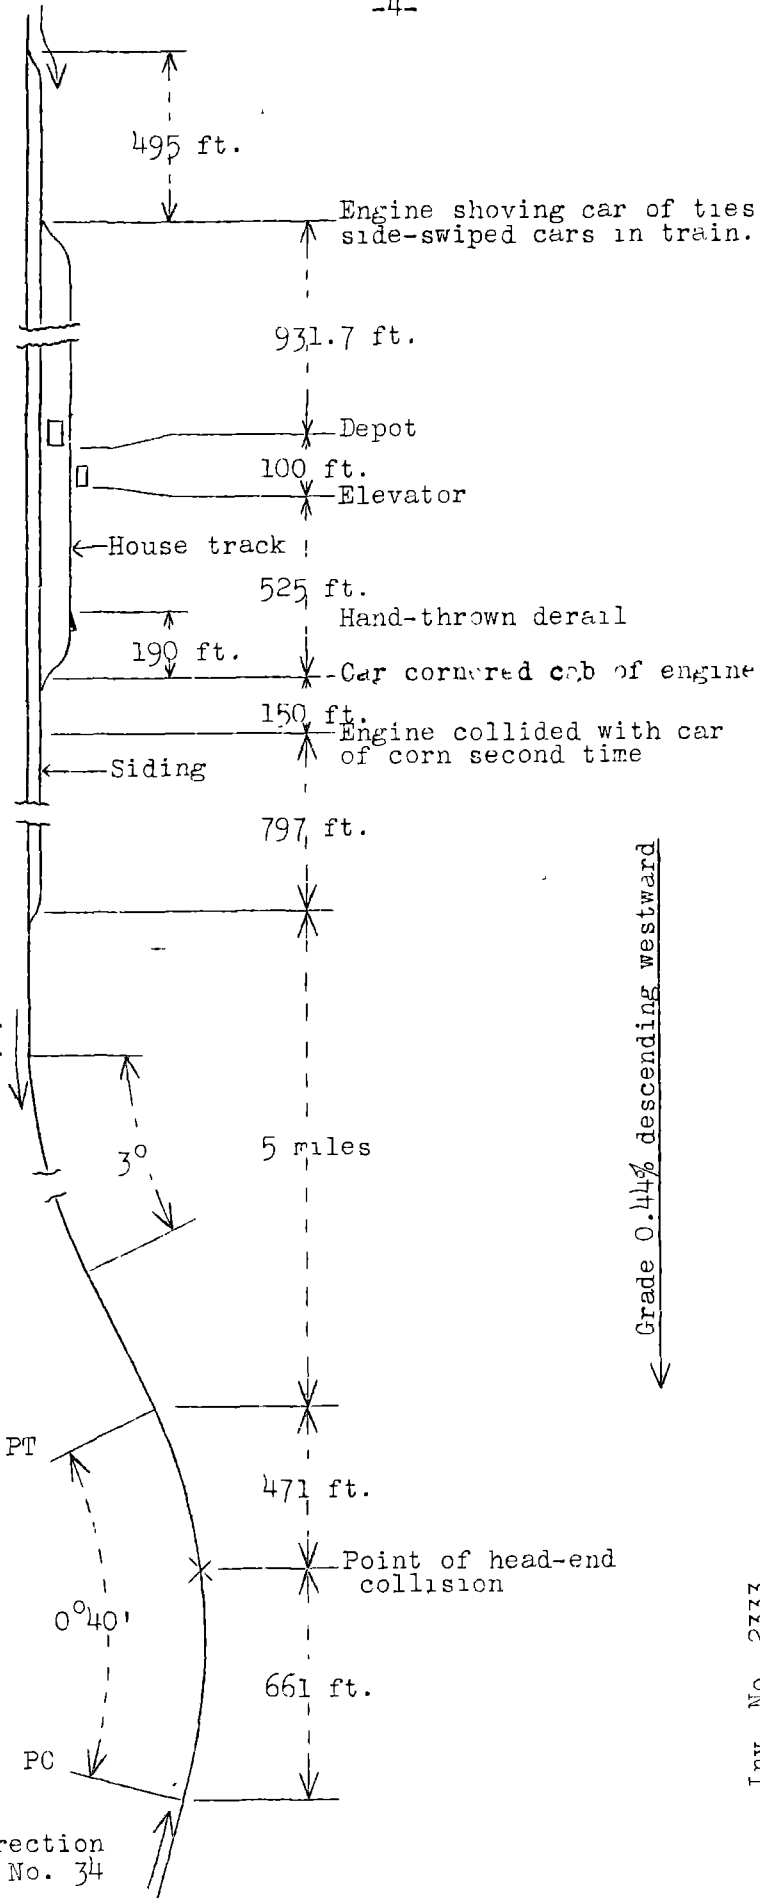
Inv. No. 2333
Chicago Great Western R.R.
Tennant, Iowa
February 18, 1939.

o	Carroll, Iowa	
		40.3 mi.
o	Harlan	
		8.2 mi.
X	Tennant (Point of 1st three collisions.)	
		5.0 mi.
X	Point of head- end collision	
		1.3 mi.
o	Magill	
		29.0 mi.
o	Council Bluffs, Iowa

Direction of
engine and car

Grade 0.44% descending westward

Direction
of No. 34
