INVESTIGATION NO. 2493  
THE CHICAGO GREAT WESTERN RAILWAY COMPANY  
AND  
THE MISSOURI PACIFIC RAILROAD COMPANY  
REPORT IN RE ACCIDENT  
AT LEAVENWORTH, KANS., ON  
MARCH 29, 1941

Accident at Leavenworth, Kans., on March 29, 1941, caused  
by failure to obey interlocking signal indication.

Inv-2493  
 C. G. W. Ry.  
 Mo. Pac. R. R.  
 Leavenworth, Kans.  
 March 29, 1941.

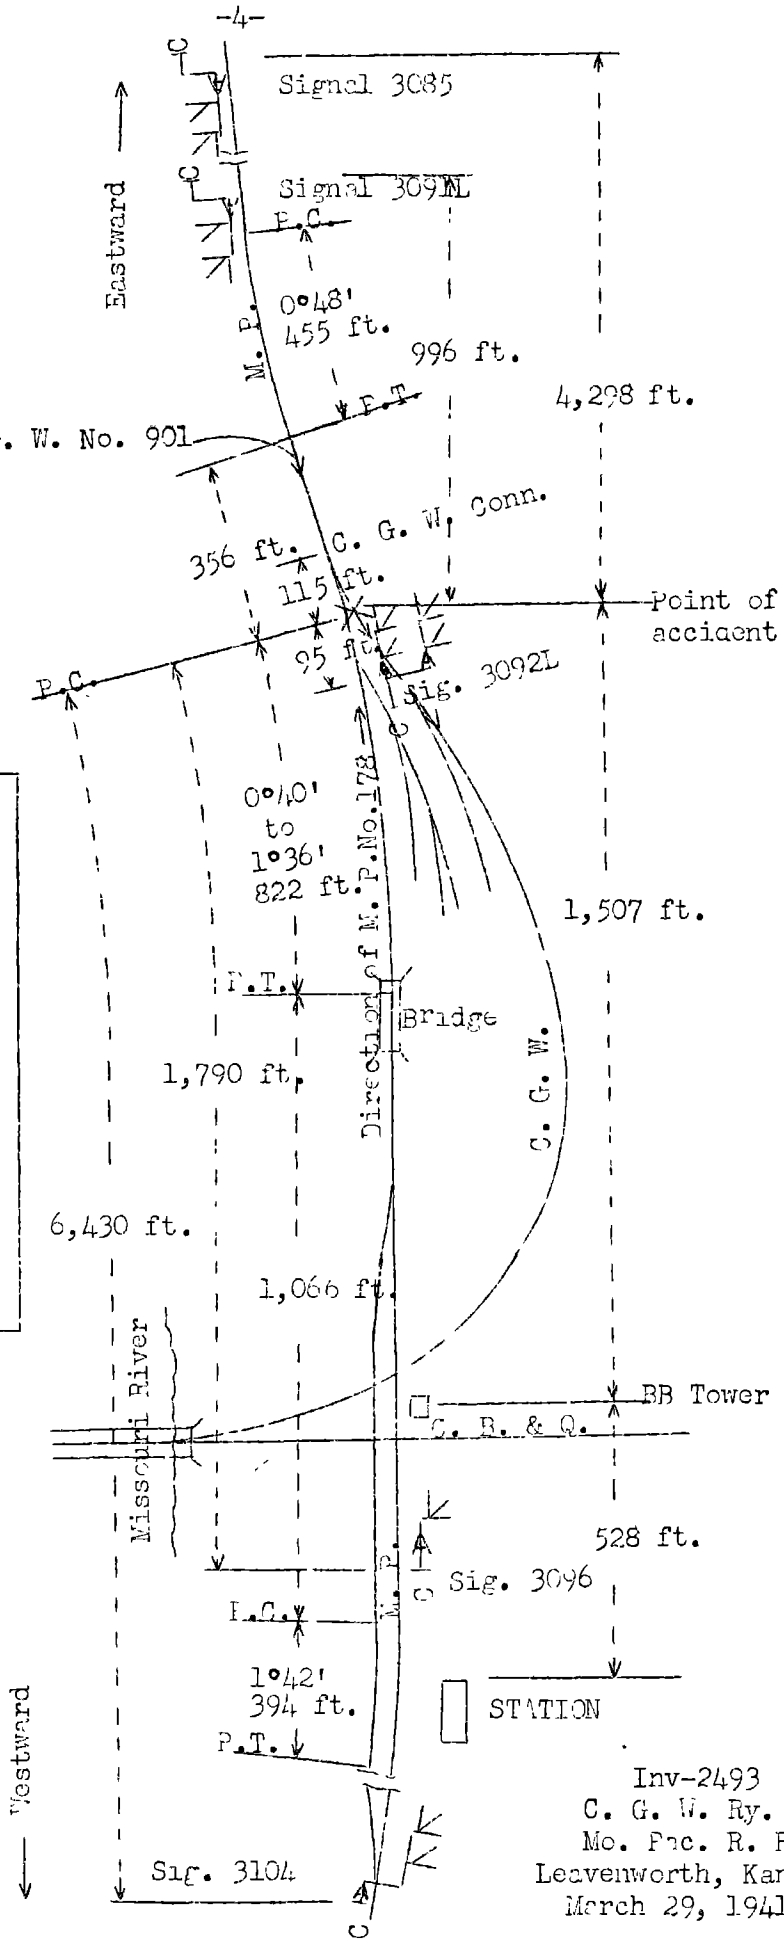
The accident occurred at a connection of the tracks of the Chicago Great Western Railway and the Missouri Pacific Railroad, hereinafter referred to as the C. G. W. and the M. P., respectively. Leavenworth is located on that part of the Iowa Division of the C. G. W. designated as the Seventh District which extends between Leavenworth, Kans., and Conception, Mo., a distance of 74.2 miles, and on that part of the Omaha and Northern Kansas Divisions of the M. P. designated as the Atchison District which extends between Central Avenue, Kansas City, Kans., and Falls City Yard, Nebr., a distance of 98.43 miles. Trains of the C. G. W. are operated over the M. P. between Kansas City and C. G. W. Connection at Leavenworth, a distance of 23.35 miles. In the vicinity of the point of accident the M. P. is a single-track line over which trains are operated by a centralized-traffic-control system. Trains move in either direction by signal indications, which supersede time-table superiority and take the place of train orders. In the immediate vicinity of the point of accident the C. G. W. is a single-track line over which trains are operated by timetable and train orders; there is no block system in use. On the M. P. the C. T. C. system is controlled from BB Tower, located 528 feet east of the station at Leavenworth. At a point 1,622 feet east of BB Tower there is a remote-control switch having a No. 10 turnout and designated as C. G. W. Connection; it is facing-point for west-bound trains, controlled from BB Tower, and used by C. G. W. trains moving from the M. P. main track to the C. G. W. main track. The accident occurred at the fouling point at the C. G. W. Connection switch. The C. G. W. track diverges from the M. P. track toward the south at an angle of about 12 degrees, then turns sharply to the north and crosses the M. P. main track at a point 25 feet east of BB Tower. A single-track line of the Chicago, Burlington & Quincy Railroad crosses the M. P. at a point 53 feet west of BB Tower. Both crossings are protected by an interlocking controlled from BB Tower.

As the point of accident is approached from the east there are, in succession, a compound curve to the left 1,726 feet in length having a maximum curvature of  $3^{\circ}28'$ , a tangent 294 feet, a  $0^{\circ}48'$  curve to the left 455 feet, and a tangent 356 feet; the accident occurred at the west end of the latter-mentioned tangent. As the point of accident is approached from the west there are, in succession, a  $1^{\circ}42'$  curve to the left 394 feet, a tangent 1,066 feet, a compound curve to the left having a maximum curvature of  $1^{\circ}36'$  and extending 822 feet to the point of accident. The grade for west-bound trains is level. The grade for east-bound trains is, successively, 0.55 percent

Signals 3104, 3096, and 3092L, which govern eastward movements, are located, respectively, 6,545 feet, 1,905 feet, and 210 feet west of the Connection track switch. Signals 3104 and 3092L are of the 2-unit, color-light type; signal 3096 is of the 1-unit, color-light type. Signal 3096 is both an interlocking home signal at BB Tower and an approach signal for signal 3092L, the interlocking home signal at C. G. W. Connection. The involved aspects, indications and names are as follows:

Signals 3104, 3096 and 3092L, located 6,545, 1,905 and 210 feet west of the switch involved, displayed proceed, restricted speed, and stop, respectively, for No. 178. In relation to the movement of No. 901, these signals displayed proper indications for No. 178. According to the evidence, when the engine of No. 178 was about 1,000 feet west of signal 3096, the approach signal, the speed of the train was 35 or 40 miles per hour. The engineman made an 8-pound brake-pipe reduction and when the engine was about 100 feet west of signal 3096 he made another brake-pipe reduction, and the speed of his train had been reduced to about 25 miles per hour when the engine passed that signal. When the engine was about 700 feet west of signal 3092L, the home signal, the engineman placed the brake valve in emergency position and when the engine was about 125 feet west of the home signal, he placed the reverse lever in position for

The investigation of this accident indicates that there is considerable question whether the spacing of signals in this territory provides adequate stopping distances for trains which are operated at maximum authorized speeds, and this matter should be promptly checked by the Missouri Pacific Railroad.
