INTERSTATE COMMERCE COMMISSION

REPORT OF THE DIRECTOR OF THE BUREAU OF SAFETY CONCERNING
INVESTIGATION OF AN ACCIDENT WHICH OCCURRED ON THE
CHICAGO, INDIANAPOLIS & LOUISVILLE RAILWAY AT
INDIANAPOLIS, IND., ON MARCH 2, 1932.

April 7, 1932.

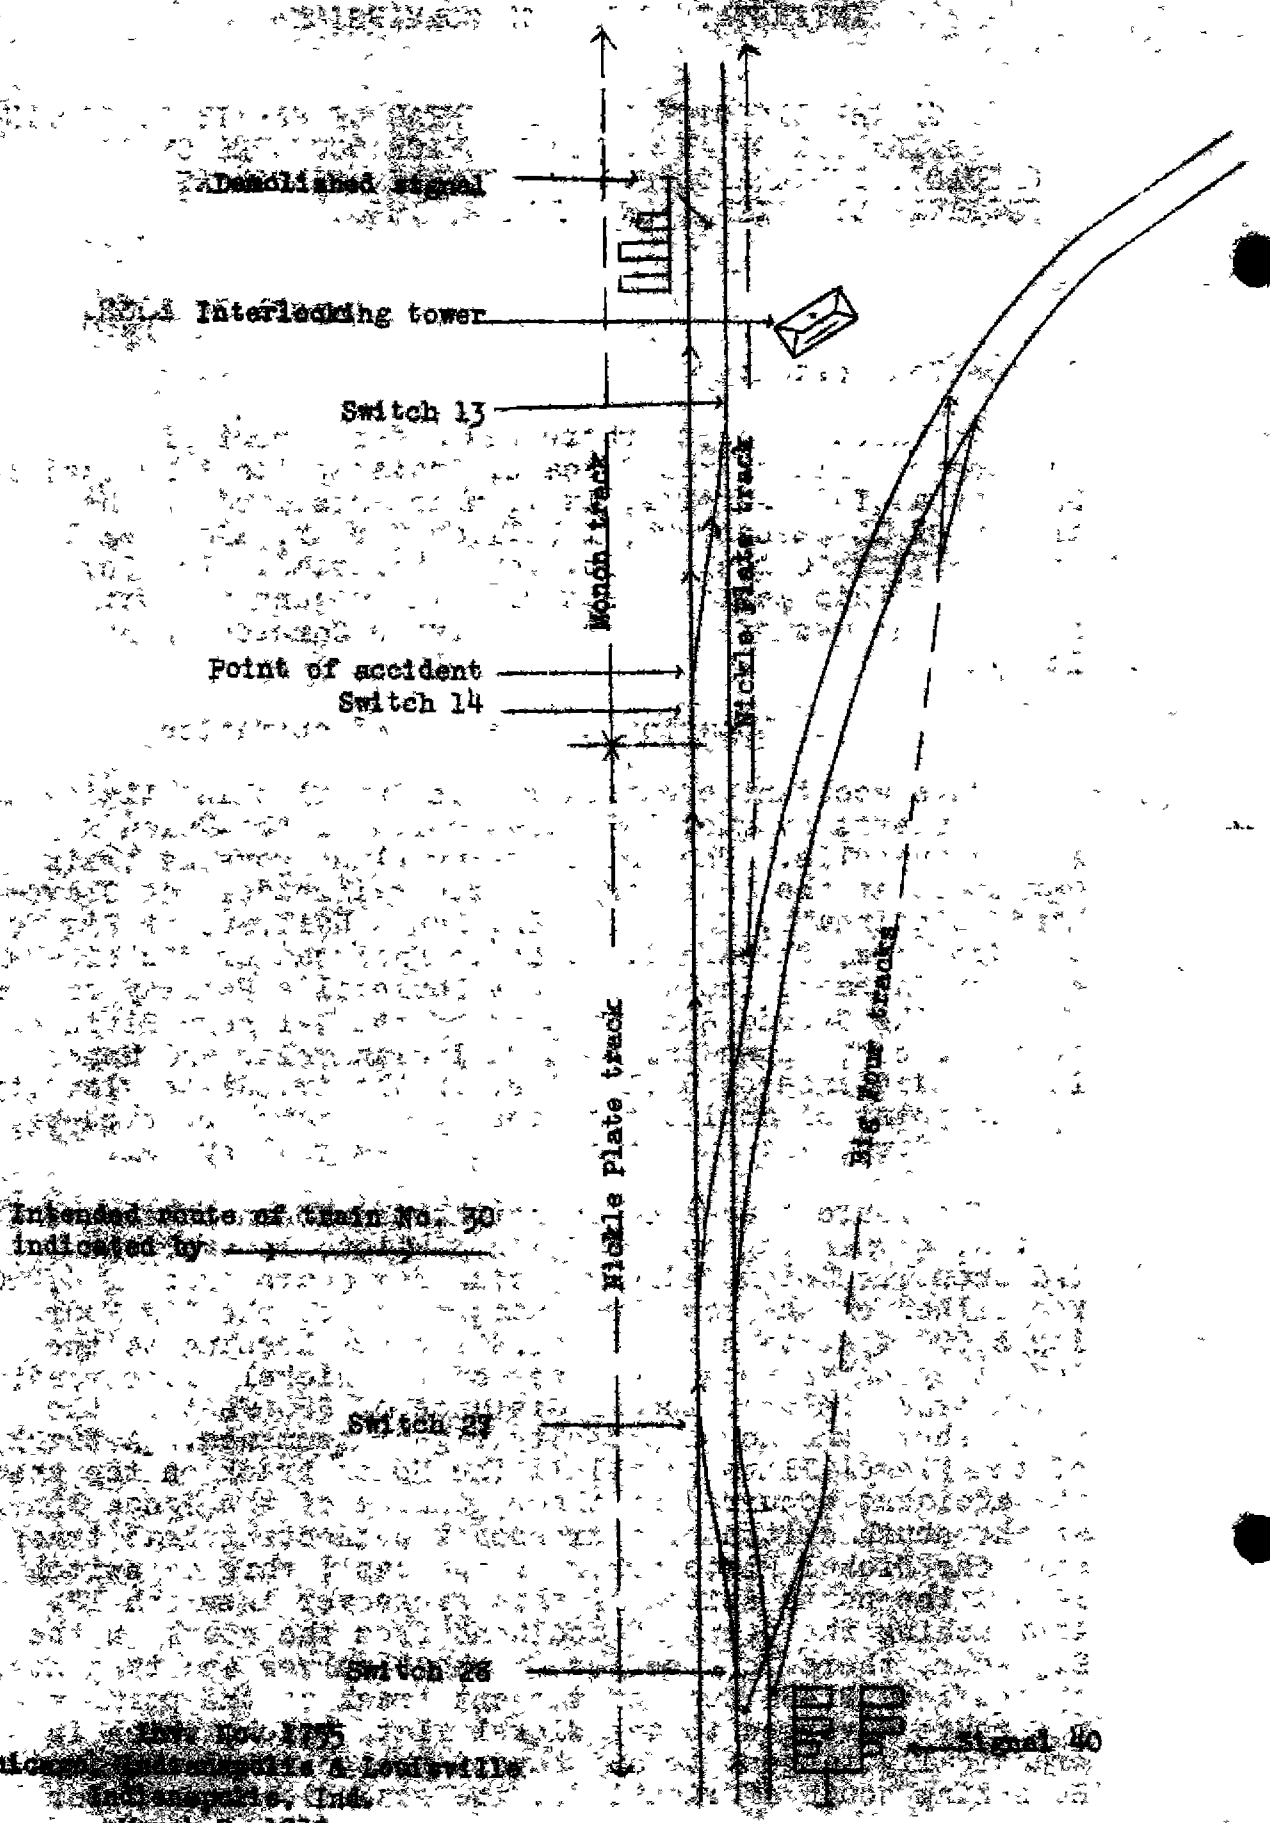
Chicago and Louisville
March 2, 1932

Point of accident
Switch 14

This accident was caused by a switch being opened under the sixth car of train No. 30 within interlocking limits; a contributing cause was the fact that the detector bar which should have prevented the operation of this switch under a moving train failed to perform its intended function, due to improper maintenance.

Inspection and tests clearly showed that the detector bar at the switch involved, which was intended to prevent the operation of the switch under a moving train, failed to function. There was lost motion between the switch machine and the bar, the bar was $\frac{1}{4}$ inch lower than it should have been, and the result was that it was possible to move the switch points under a train without the detector bar preventing such action. The condition of this detector bar and its application to the rail was such that it was not reliable to prevent the very kind of an accident for which it was installed. This condition was one which adequate inspection and maintenance should have corrected. At other switches in this plant detector bars had been replaced by detector circuits, because of the greater reliability of such circuits as a means of protection against accidents of this character. It is believed that consideration should be given to the need for detector locking at all switches in this plant which are not now so equipped.
