ACCIDENT ON THE LINE OF THE
CHICAGO RAPID TRANSIT COMPANY

GRANVILLE AVENUE, CHICAGO, ILL.

NOVEMBER 24, 1936

INVESTIGATION NO. 2121

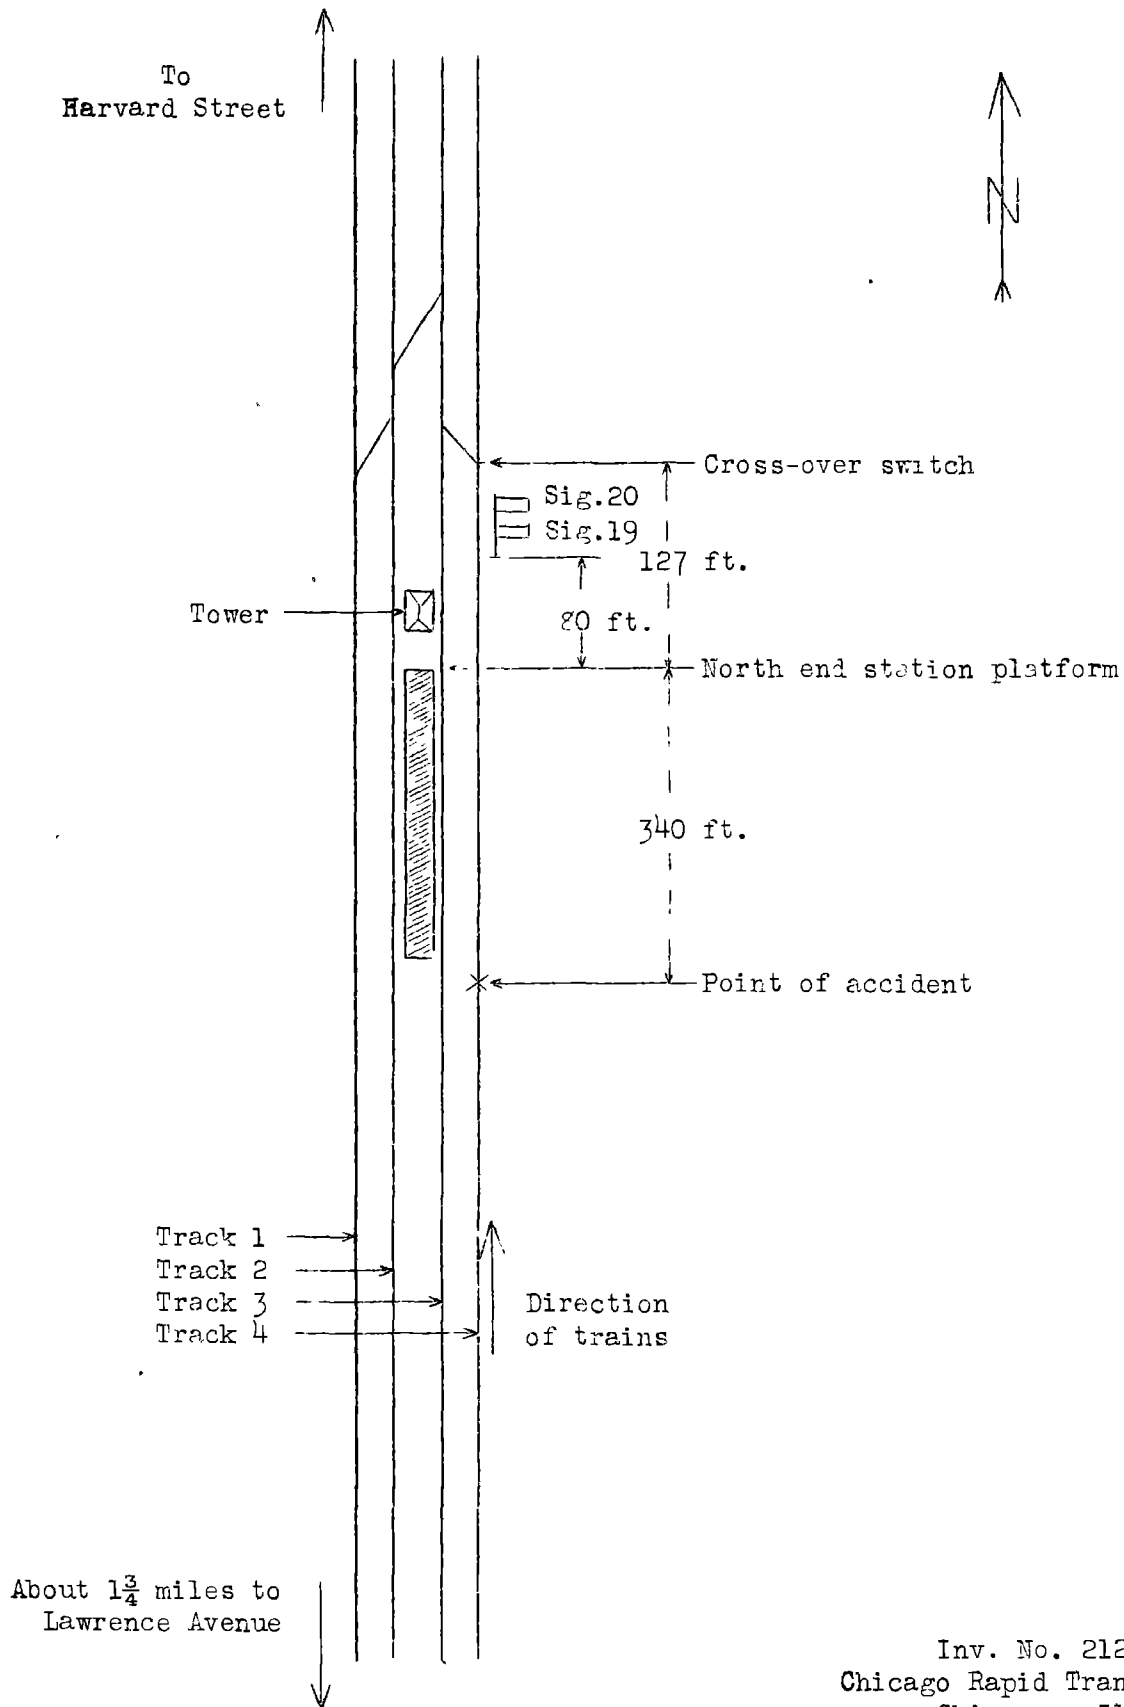
Inv. No. 2121
Chicago Rapid Transit Co.
Chicago, Ill.
Nov. 24, 1936

This accident occurred on track 4, at a point 420 feet south of the home signal. Approaching this point from the south the track is tangent from Lawrence Avenue, a distance of about $1\frac{3}{4}$ miles, while the grade is practically level. The view from Lawrence Avenue northward to the point of accident is unobstructed.
