# NATIONAL TRANSPORTATION SAFETY BOARD

## RAILROAD ACCIDENT REPORT<sub>IND.</sub>

REAR END COLLISION OF TWO  
CHICAGO TRANSIT AUTHORITY TRAINS  
NEAR THE MONTROSE AVENUE STATION  
CHICAGO, ILLINOIS  
AUGUST 17, 1984

NTSB/RAR-85/11.

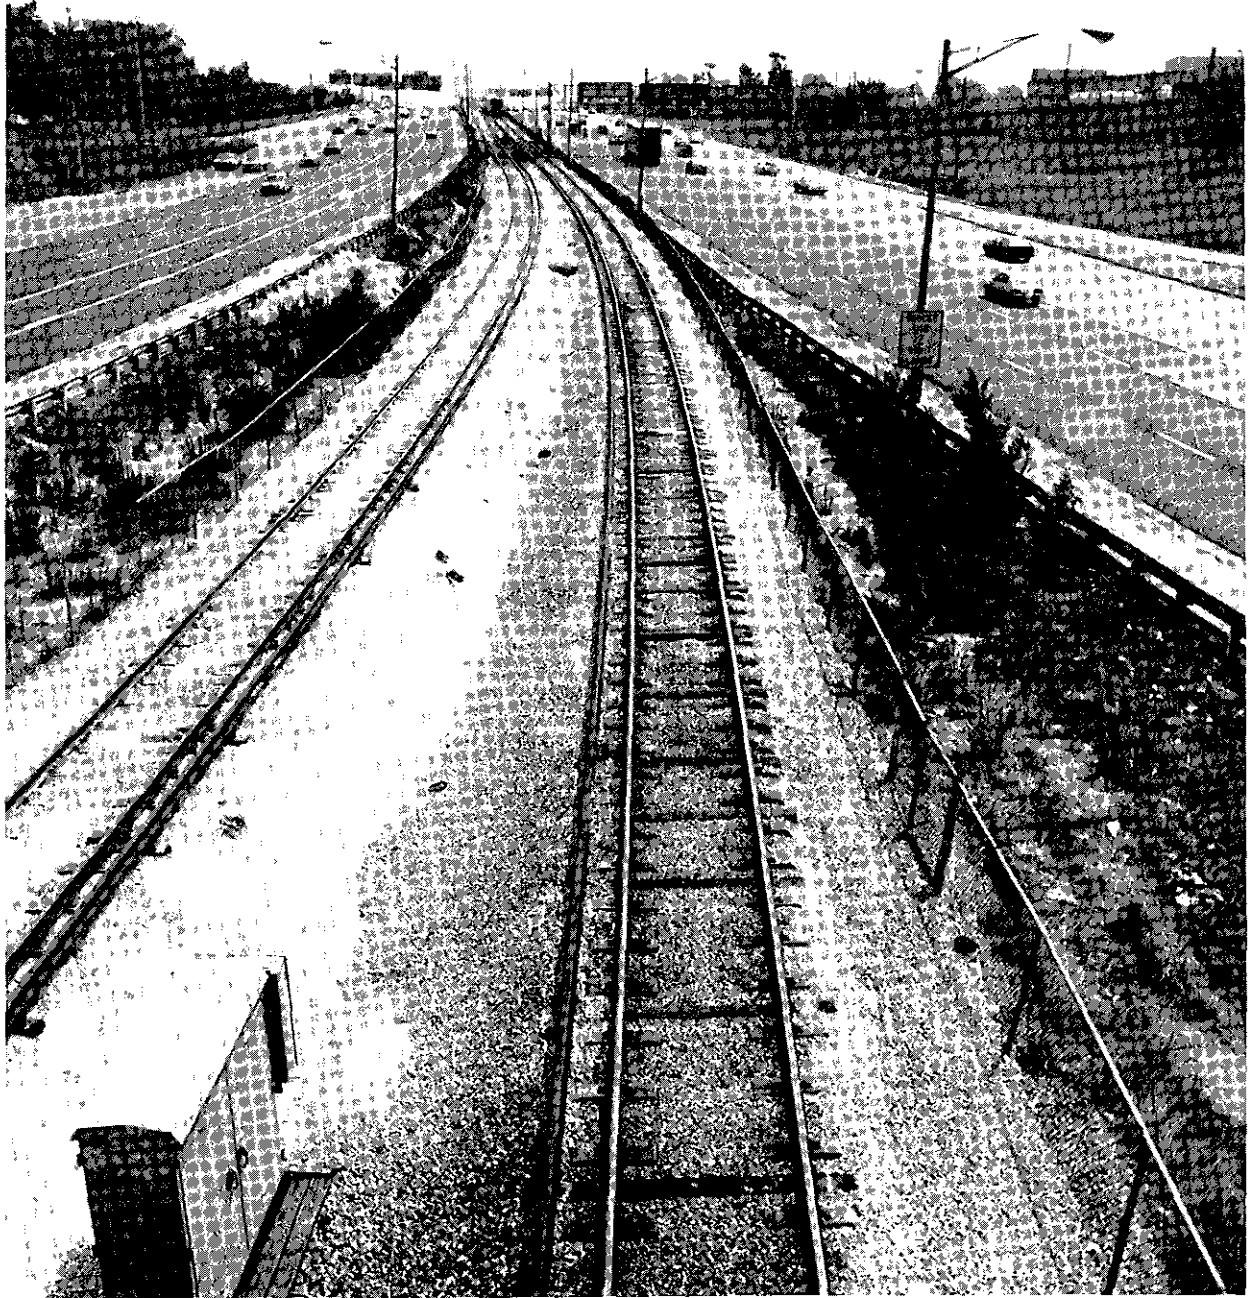
Figure 2.—View of the accident site south of the Montrose Avenue Station.

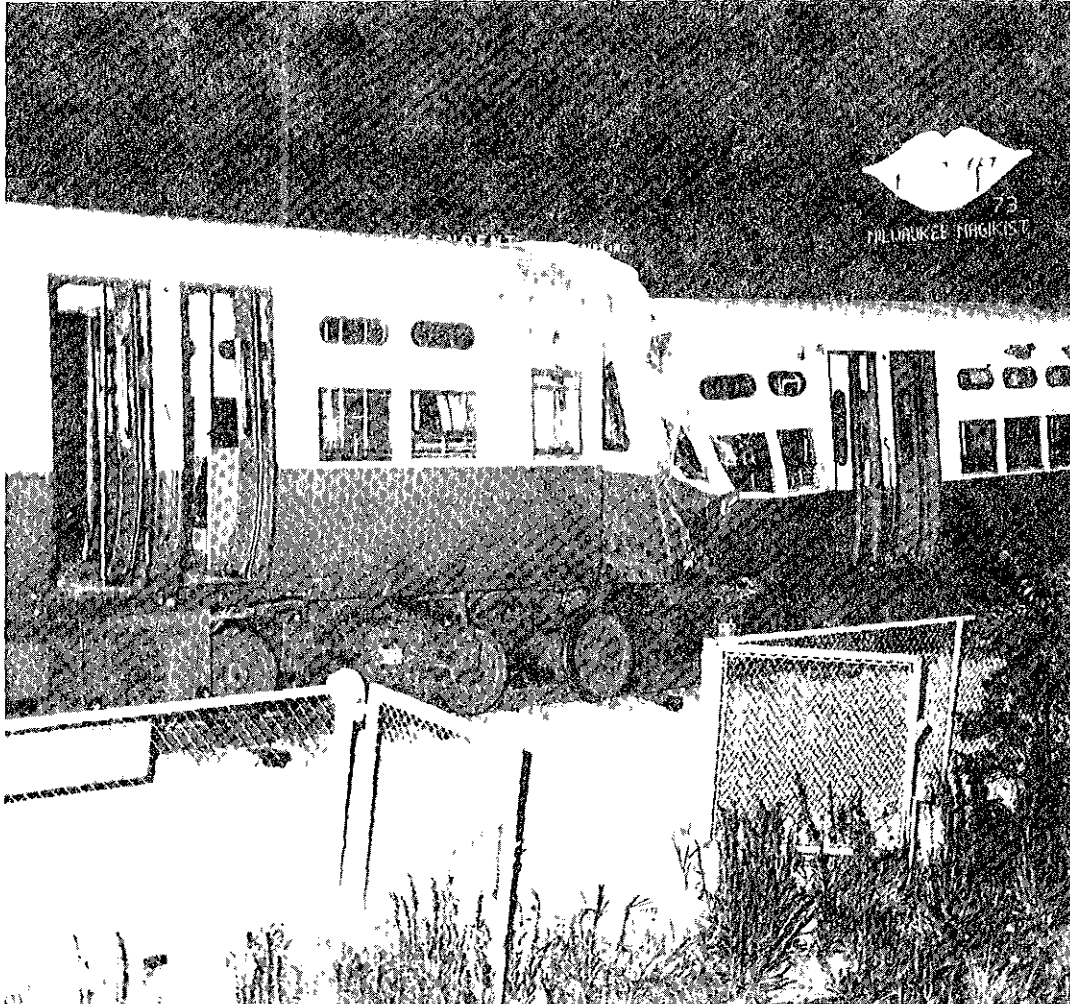
Figure 3.—View from the west side of the crushed end of car 6648.  
(Chicago Transit Authority photograph).

The No. 2 end of car 6648 that was coupled to car 6647 was damaged the most severely. The antilimbers engaged and crushed the car 4 feet inward at floor level across the full width of the car. The sidewalls of the car flared outward 15 inches on one side and 16 inches on the other side. The crushed end of the car also was forced upward, causing the roof to bulge upward 16 inches. The right side of the car was crushed upward, and the left side was crushed inward and ripped open in the area of the first four seats. (See figure 6.) The first four seats on each side and the floor under them were destroyed. That part of the end frame to which the antilimbers are attached bent downward, and the crushing caused the floor to split across the entire width of the car behind the third seats and buckle upward 53 inches. (See figure 7.) The end windows adjacent to the first seats were out; the end door was jammed and would not open. The No. 1 end of car 6648 retained its basic structural integrity and was not crushed inward; there was only slight damage to the antilimber. There was no examination of the structural members to determine whether any of the members had deteriorated.

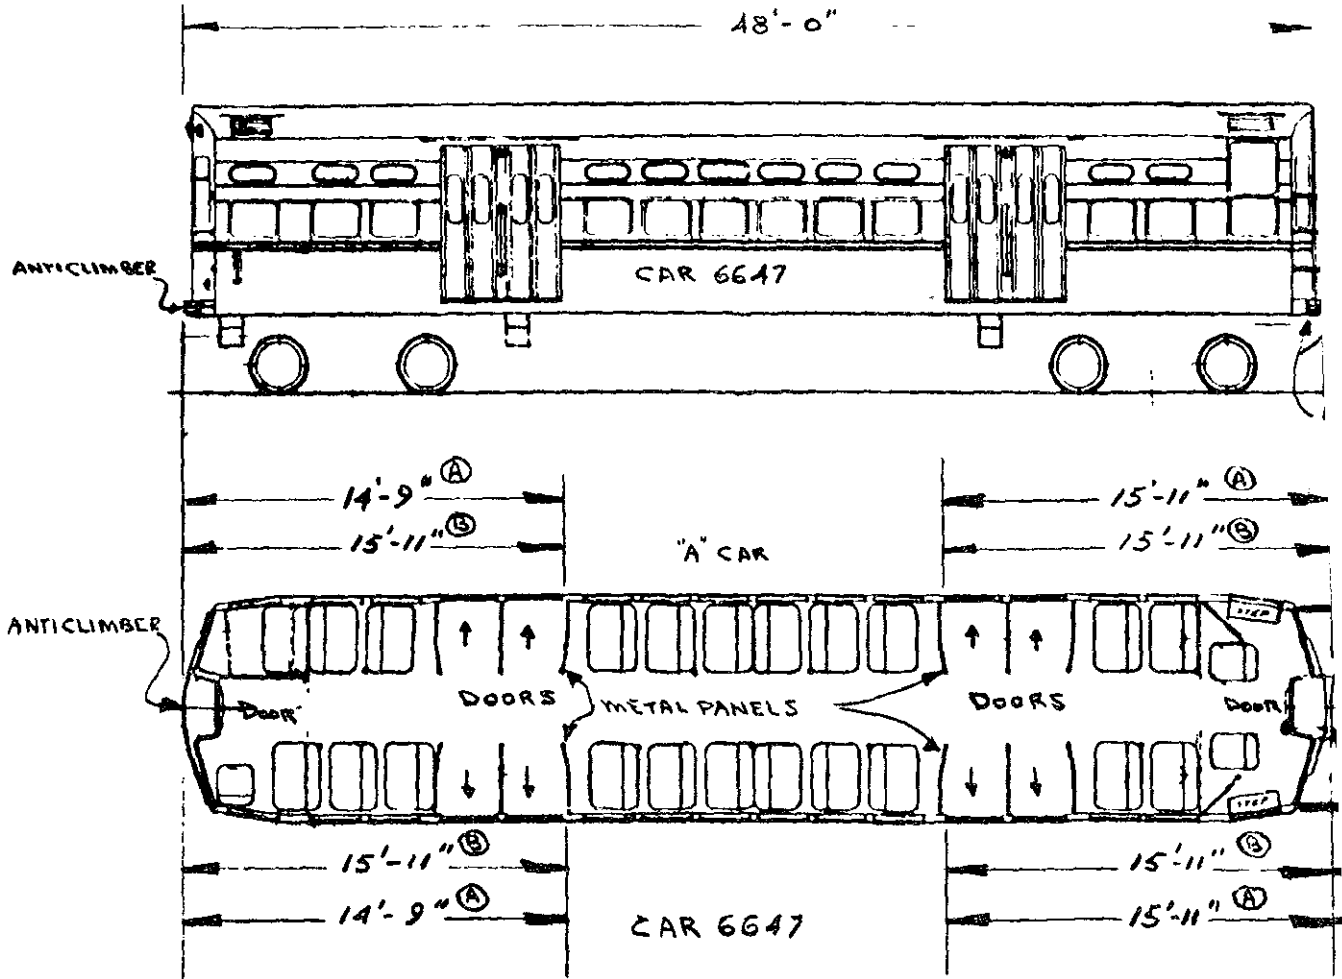
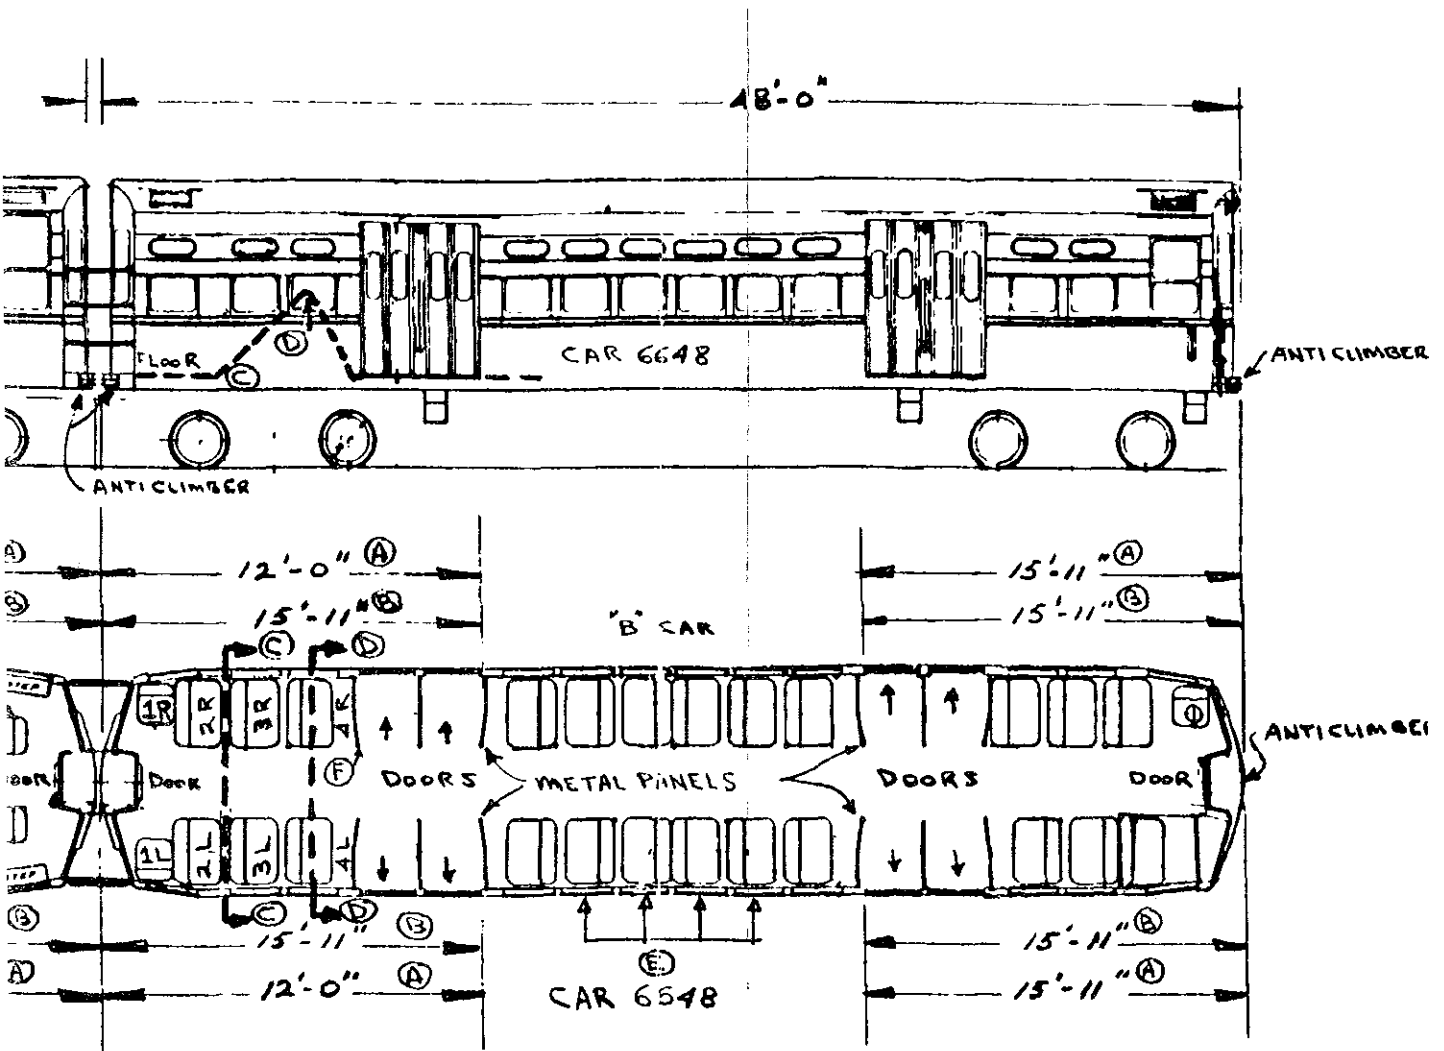
FIGURE 4 - - SKETCH

against the left side of the seat. The inboard legs of the seat were loose and deformed outboard, and the floor under the seat was buckled upward 6 to 8 inches. Seven of the eight side doors could not be opened by hand. The No. 2 end door was partially jammed and could not be opened fully.

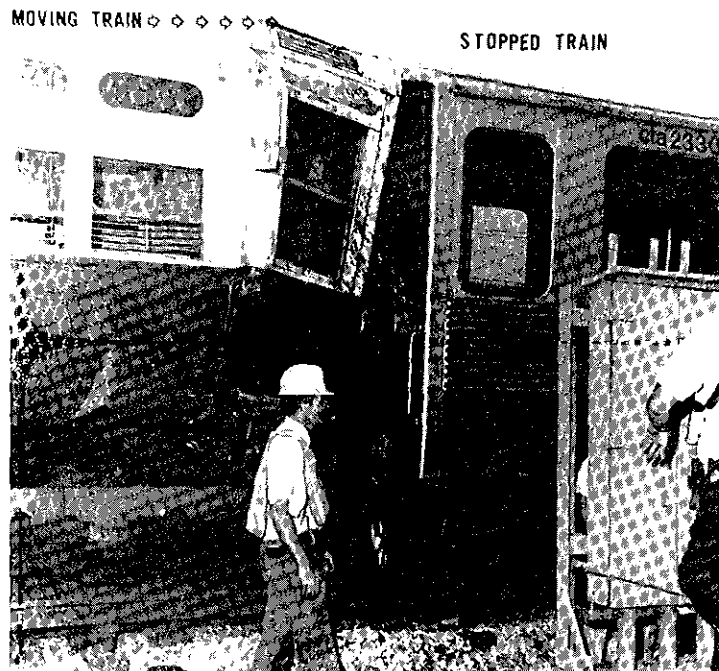
Figure 5.--Collision between last car (6647) of train 135 and first car (2330) of standing train 143.

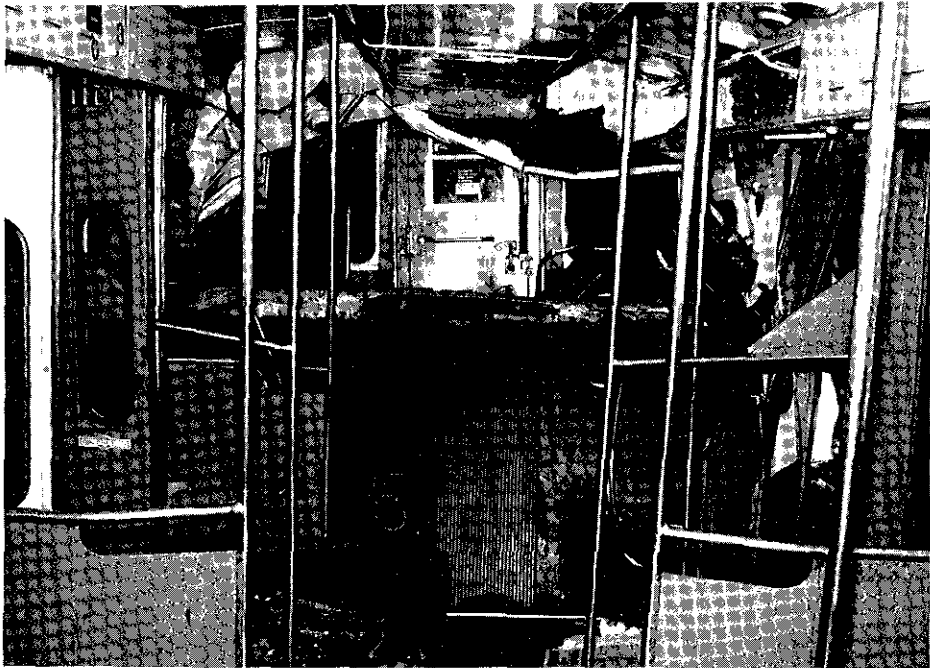
Figure 7.--End of car 6648 that was coupled to car 6647. Note buckled floor and ceiling.
