REPORT NO. 3560
CHICAGO UNION STATION COMPANY
IN RE ACCIDENT
AT CHICAGO, ILL., ON
MARCH 10, 1954

Accident at Chicago, Ill., on March 10, 1954, caused by failure to operate the Chicago, Burlington & Quincy passenger-equipment train in accordance with a signal indication.

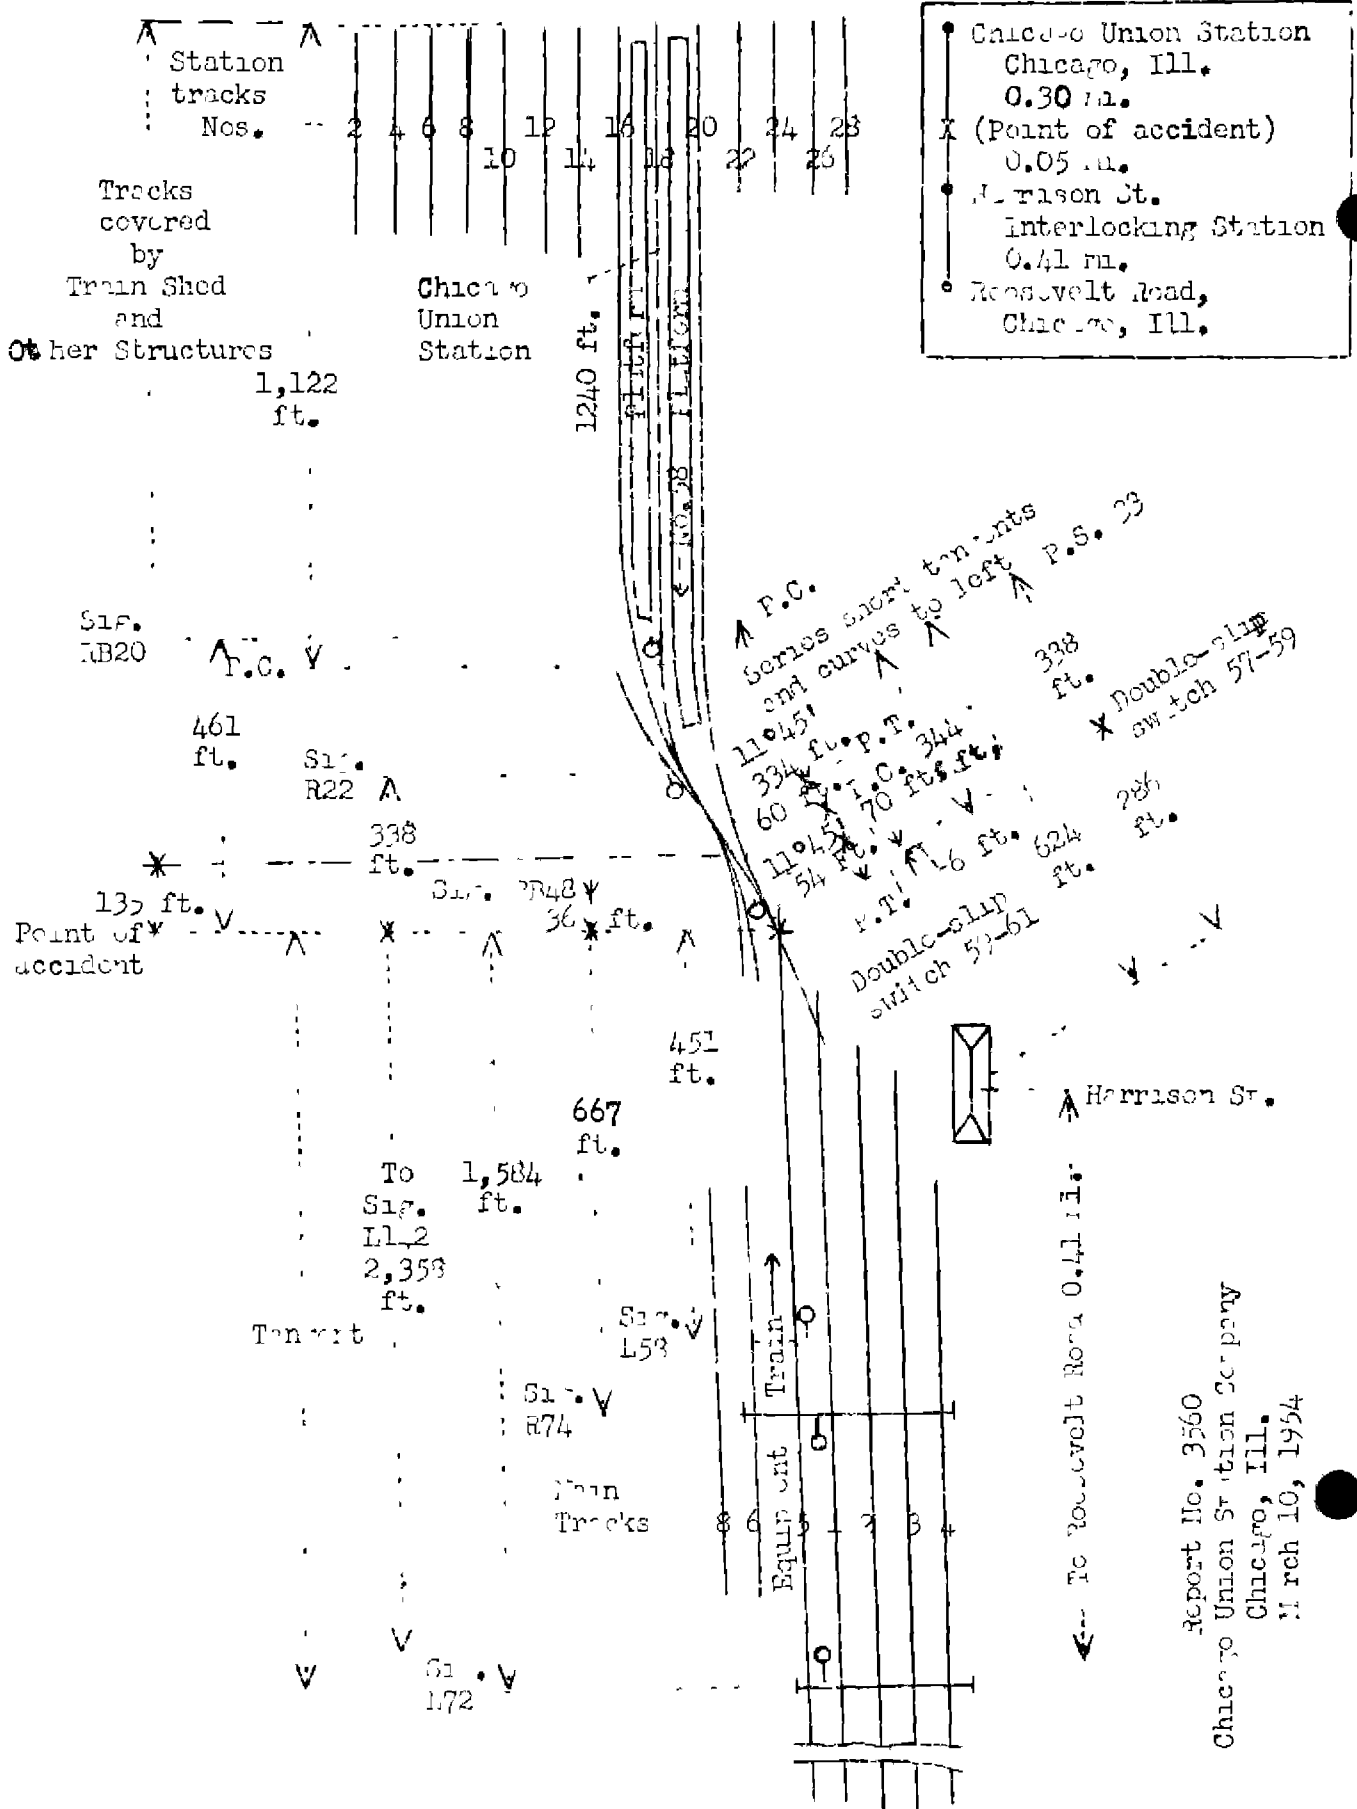
Report No. 3560
 Chicago Union Station Company
 Chicago, Ill.
 March 10, 1954

This accident occurred on that part of the railroad extending between Roosevelt Road and Chicago Union Station, Chicago, Ill., 0.76 mile. Trains of the Chicago, Burlington & Quincy Railroad and the Pennsylvania Railroad are regularly operated over this portion of the line of the Chicago Union Station Company. Between Roosevelt Road and Harrison Street Interlocking Station, 0.41 mile north of Roosevelt Road, this is a seven-track line, over which trains are operated by signal indications. The main tracks are designated from west to east as tracks Nos. 8, 6, 5, 1, 2, 3, and 4. Within interlocking limits, and immediately north of Harrison Street Interlocking Station the main tracks diverge to 14 station tracks. The station tracks are designated from west to east by even numbers consecutively as tracks Nos. 2 to 28. A lead track connects with the south ends of station tracks No. 16 and No. 18 at switch 33, crosses main track No. 5 at double-slip switch 57-59, and crosses main track No. 1 at double-slip switch 59-61. Slip switches 57-59 and 59-61 are provided with movable center points. Switch 33 and the center of slip switch 57-59 are located, respectively, 624 feet and 286 feet north of Harrison Street Interlocking Station. Station track No. 18 is 1,240 feet long. A passenger loading platform and a baggage loading platform are provided on the east and west sides, respectively, of this track. The station tracks in this vicinity are located below street level. The north ends of the tracks are covered by a train shed, and between the south end of the train shed and a point 415 feet north of Harrison Street Interlocking Station the tracks are covered by buildings and other structures. The accident occurred at a point 6 feet south of the center of slip switch 57-59, where the lead track crosses track No. 5. Track No. 5 is tangent throughout a distance of more than 2,100 feet immediately south of the point of accident. From the north on track No. 18 and the lead track there are, in succession, a tangent 1,122 feet in length, a 9° curve to the left 46 feet, a tangent 7 feet, a No. 8 turnout to the left 61 feet, a tangent 15 feet, a 6° curve to the left 22 feet, a tangent 55 feet, a No. 10 double-slip switch to the left 69 feet, a tangent 60 feet, a No. 8 turnout to the right 70 feet, and a tangent 54 feet to the point of accident. The grade is level at the point of accident.

Semi-automatic signal L142, governing north-bound movements from 14th Street Passenger Yard to the main tracks of the Chicago Union Station Company, and semi-automatic signals L72 and L58, governing north-bound movements on track No. 5, are located, respectively, 2,358 feet, 1,584 feet, and 451 feet south of the point of accident. Signals L142 and L58 are of the dwarf type, and signal L72 is mounted on a signal bridge above and to the right of track No. 5 in the direction in which it governs. Semi-automatic dwarf signals RB20, R22, and RB48, governing south-bound movements from station track No. 18 to main track No. 1 via slip switches 57-59 and 59-61 are located, respectively, 461 feet, 338 feet, and 36 feet north of the point of accident. Semi-automatic signal R74, governing south-bound movements on main track No. 1, is located on a signal bridge 667 feet south of the point of accident. These signals are of the position-light type and are continuously lighted. Aspects applicable to this investigation and the corresponding indications and names are as follows.
