BUREAU OF SAFETY

REPORT NO. 1952

REPORT OF THE DIRECTOR OF THE BUREAU OF SAFETY CONCERNING AN
ACCIDENT ON THE CHICAGO, BURLINGTON & QUINCY RAILROAD
AT FREEMAN, ILL., ON DECEMBER 8, 1934.

February 25, 1935.

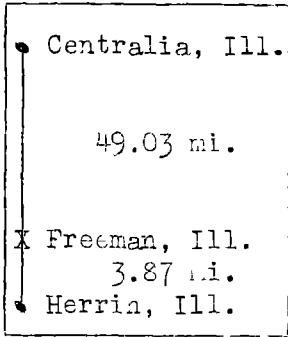
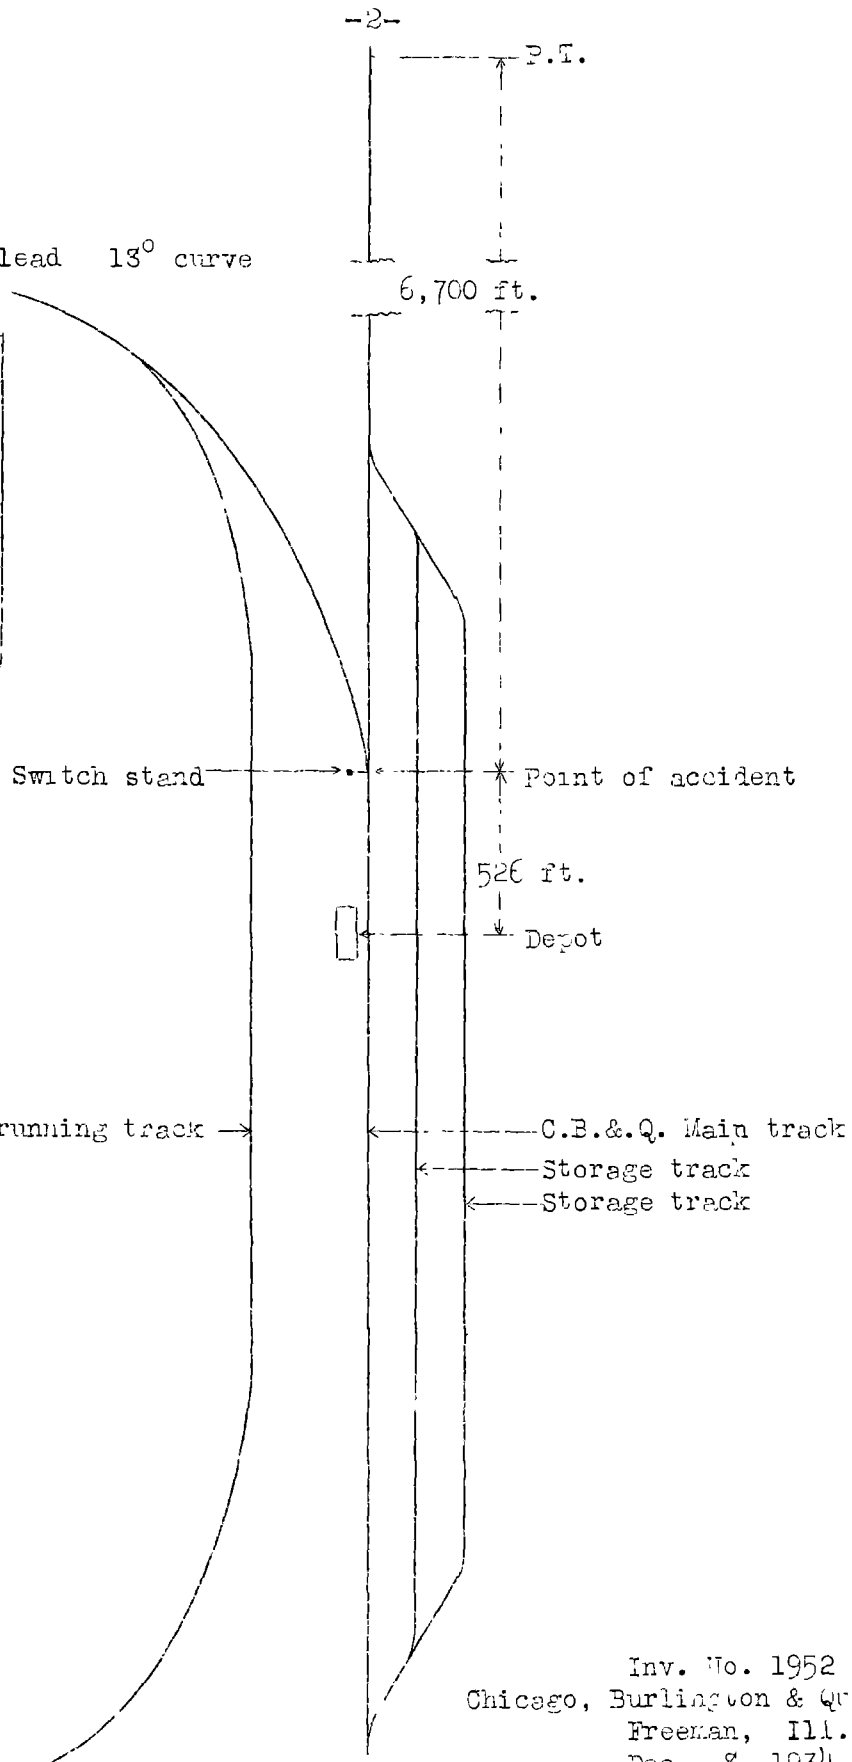
Inv. No. 1952
 Chicago, Burlington & Quincy R.R.,
 Freeman, Ill.
 Dec. 8, 1934.

The lead-track switch stand is equipped with a switch lamp with the center of the lens 7 feet 7 inches above the tops of the rails; the stand is located on the engineman's side of a south-bound train. High coal cars in a train moving from the lead track to the main track would obscure his view of the switch lamp but it could be seen over the tops of low-side coal cars for a distance of at least one-fourth mile. Owing to the sharp curvature of the lead track the marker lights on a caboose moving

Mine lead 13° curve

from the mine track can not be seen by the engineman of a south-bound train on the main track until the caboose is close to the main track.
