ACCIDENT ON THE  
CHICAGO, BURLINGTON & QUINCY RAILROAD

HOAG, NEBR.

APRIL 24, 1936

INVESTIGATION NO. 2059

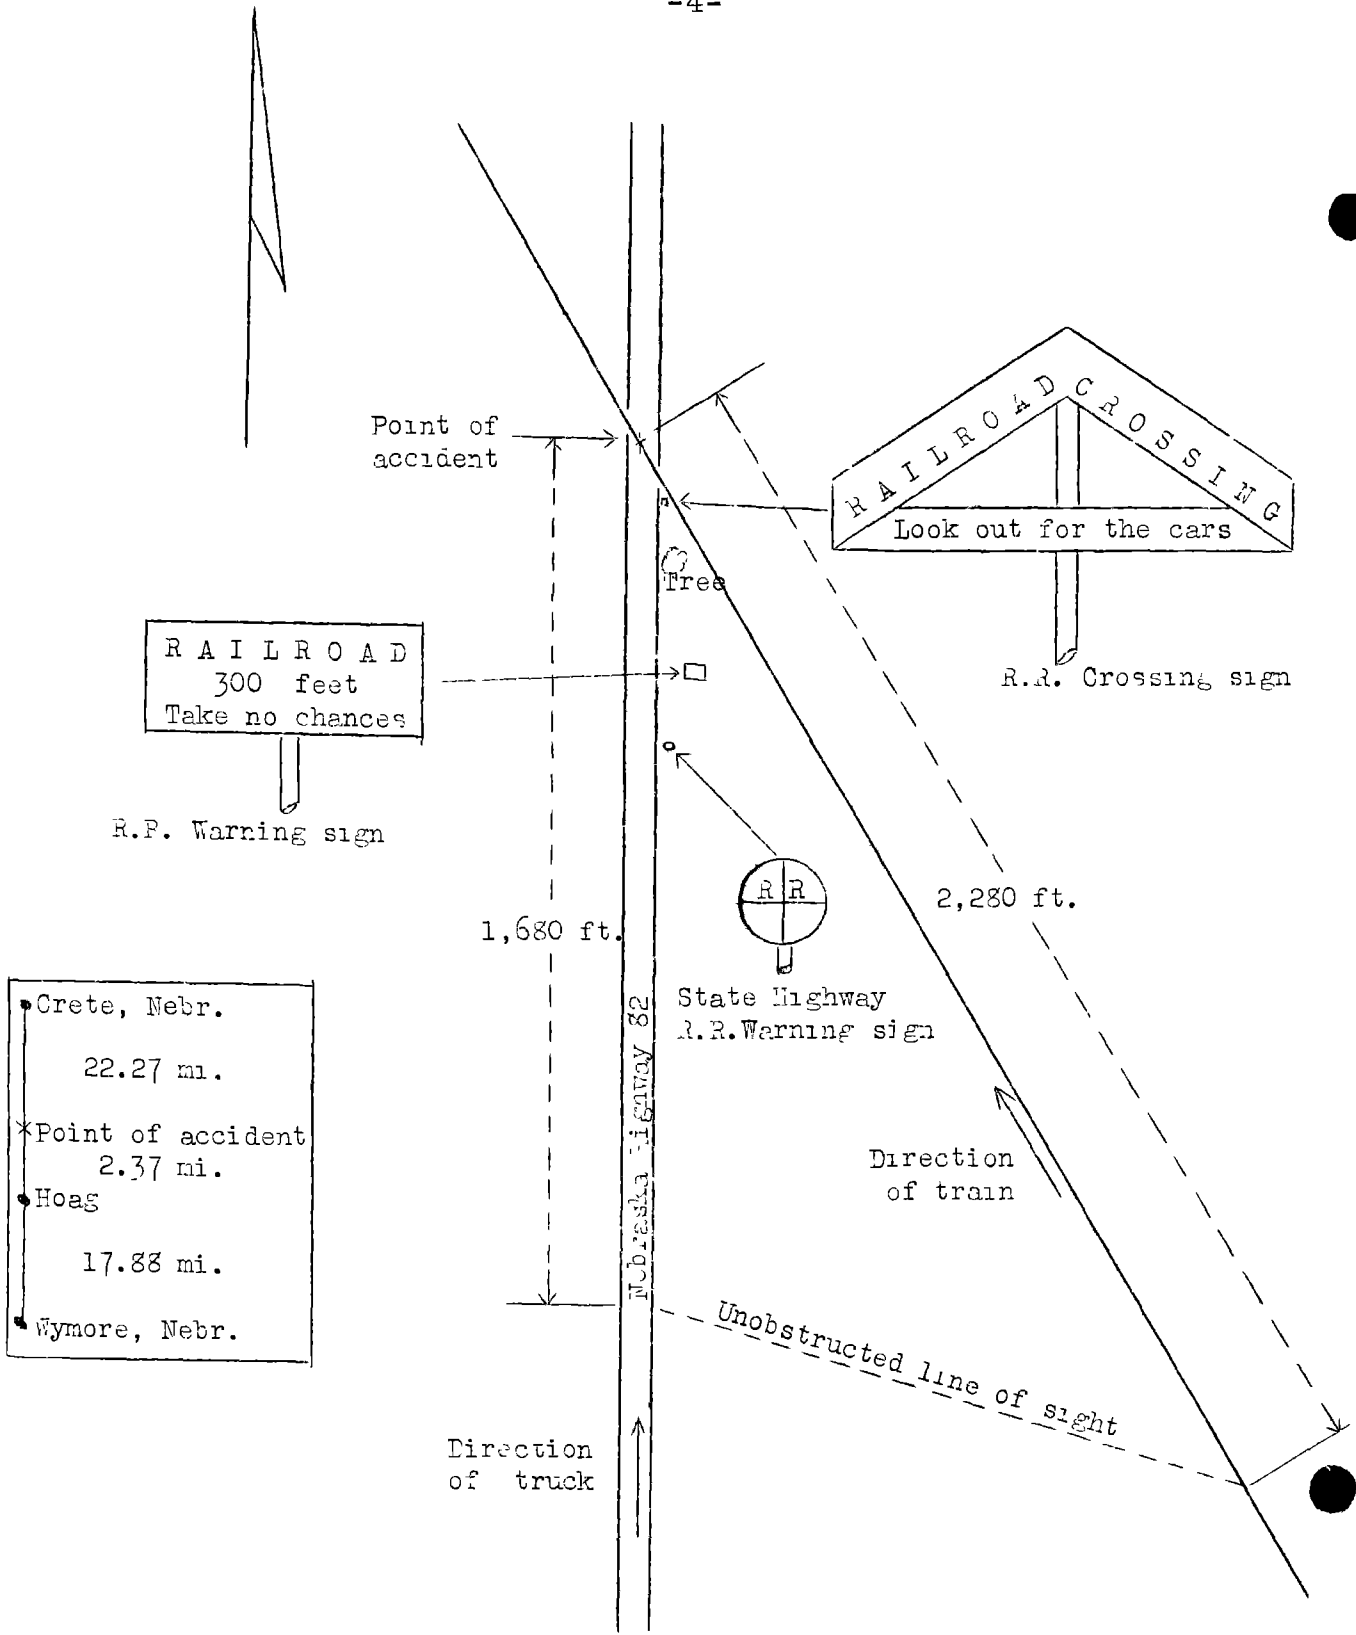
Inv. No. 2059  
 C. B. & Q. R.R.  
 Hoag, Nebr.  
 April 24, 1936.

Nebraska State Highway 82 runs north and south according to compass directions, and crosses the track at an angle of  $36^{\circ} 30'$ ; it is a gravel road, 28 feet in width, and is straight and practically level for more than 2,000 feet south of the crossing. A state warning sign of the disc type, bearing the letters "RR", is located 400 feet from the crossing; a warning sign, maintained by the railroad company, bearing the words, "RAILROAD 300 FEET TAKE NO CHANCES", is located 300 feet from the crossing, and near the fence along the right-of-way, about 25 feet from the track, is a triangular crossing sign reading, "RAILROAD CROSSING LOOK OUT FOR THE CARS". The Nebraska State law provides that "The drivers of all trucks shall, immediately before crossing any railroad track, bring their vehicles to a complete stop and carefully look in both directions for approaching trains before crossing said railroad tracks".

With the exception of a tree about 5 feet in diameter, located about 100 feet from the crossing, to the right of the highway and left of the track, there is nothing to obstruct the view between the highway and the railroad within a distance of 2,280 feet from the crossing on the railroad and 1,680 feet on the highway.
