INTERSTATE COMMERCE COMMISSION

REPORT OF THE DIRECTOR OF THE BUREAU OF SAFETY CONCERNING AN
ACCIDENT ON THE CHICAGO, BURLINGTON & QUINCY RAILROAD
NEAR POTTSTOWN, ILL., ON AUGUST 3, 1932.

Inv. No. 1777
 Chicago, Burlington & Quincy RR
 Pottstown, Ill.
 August 3, 1932.

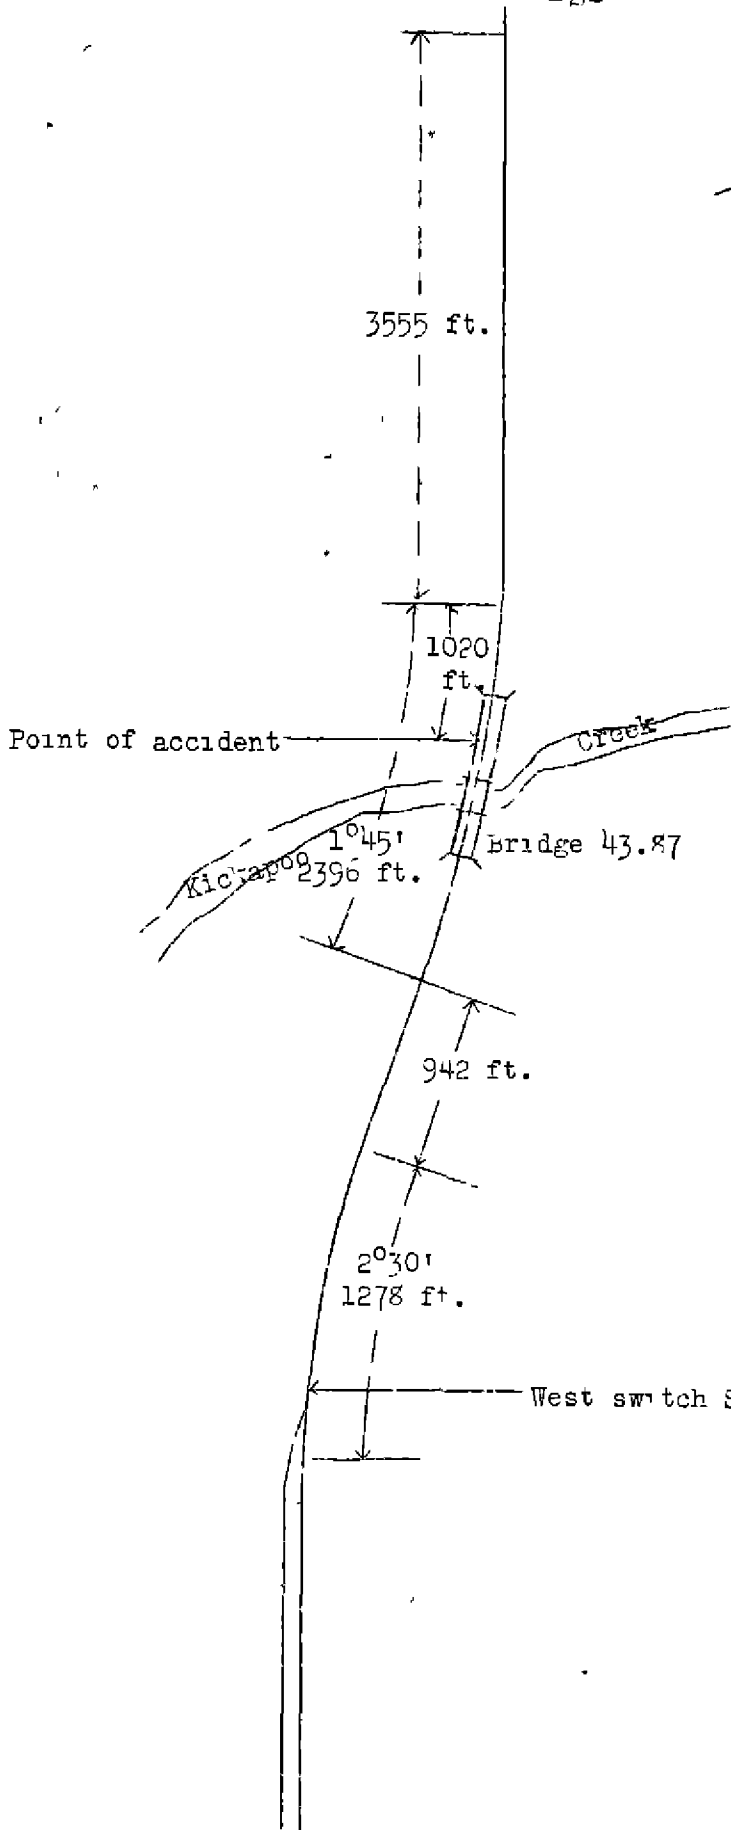
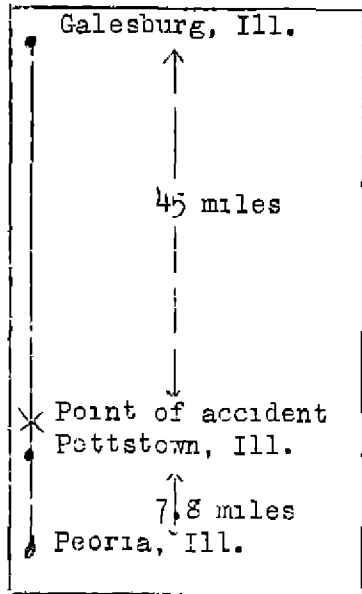
car on the team track at Pottstown, after picking up this car the train was pulled ahead a distance of approximately 1,020 feet where it was again stopped to set out a car with a hot box, and while standing at this point the rear end of the train was struck by train No. 56.

The caboose of extra 5329 was derailed and the superstructure was practically demolished. Motor 9666 stopped on its side with its front end on the ground 13 feet below the level of the bridge; the rear end was supported by the floor of the bridge approach and was still coupled to and held up the front end of the express car about 6 feet above the rail which leaned to the right at an angle of about 45°; the rear trucks remained on the rails. The last car in train No. 56 was not derailed or damaged. The employee killed was the flagman of extra 5329 and those injured were the engineman, conductor, express messenger and roadmaster of train No. 56.

After the accident two torpedoes were found 9 feet apart approximately 1,096 feet west of the point of accident; as the caboose first stopped about 1,020 feet west of the point of accident, it is obvious that the flagman did not go back a sufficient distance to protect the rear of his train, having placed the two torpedoes only 76 feet from the caboose, notwithstanding that he had been specifically instructed by the conductor to flag train No. 56, and knew that train No. 56 was then due out of Edwards, only 6 miles distant, and that there
