REPORT OF THE DIRECTOR

CHICAGO, BURLINGTON & QUINCY RAILROAD

WENDEL, ILL.

INVESTIGATION NO. 2200

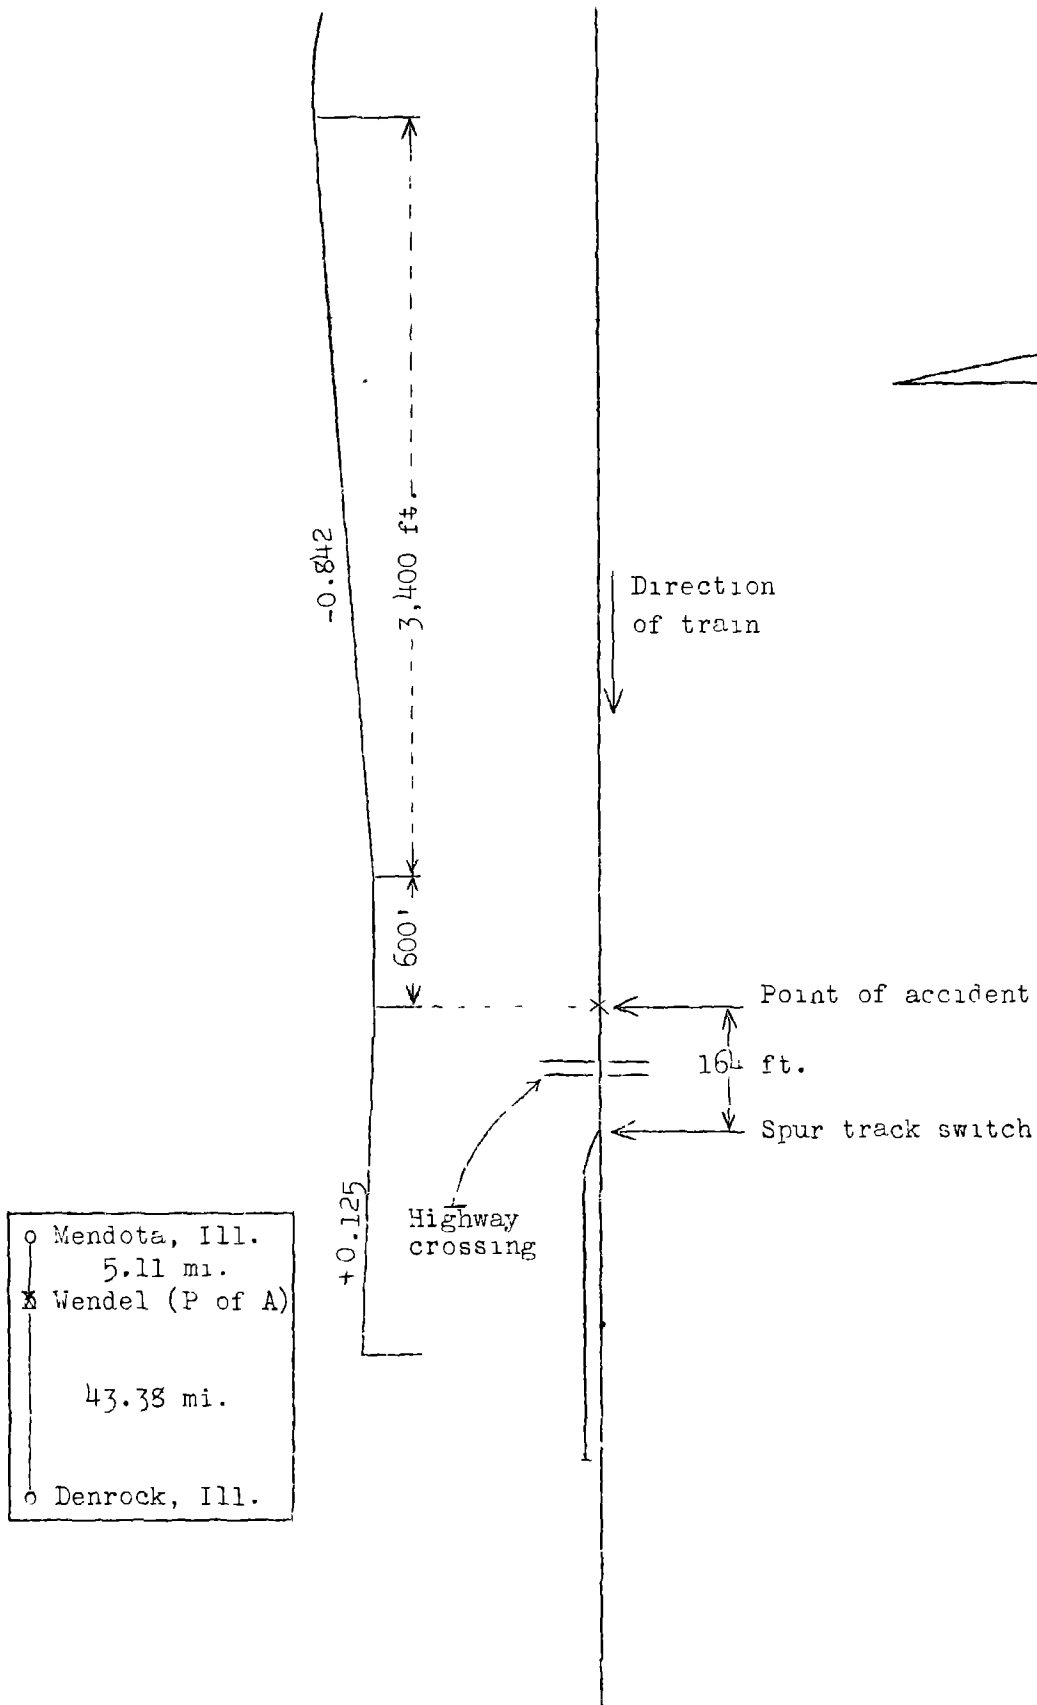
Inv. No. 2290  
Chicago, Burlington & Quincy R.R.  
Wendel, Ill.  
Sept. 24, 1937

The train broke in two between the seventeenth and eighteenth cars; the eighteenth, nineteenth and twentieth cars were derailed. The eighteenth car stopped south of and parallel with the track,

188 feet beyond the point of derailment; the nineteenth car stopped in front of the eighteenth car and the twentieth car stopped at right angles to the track across the spur track a short distance beyond the other derailed cars.
