ACCIDENT ON THE  
CHICAGO, BURLINGTON & QUINCY RAILROAD

WEST BURLINGTON, IOWA

FEBRUARY 26, 1938.

INVESTIGATION NO. 2257.

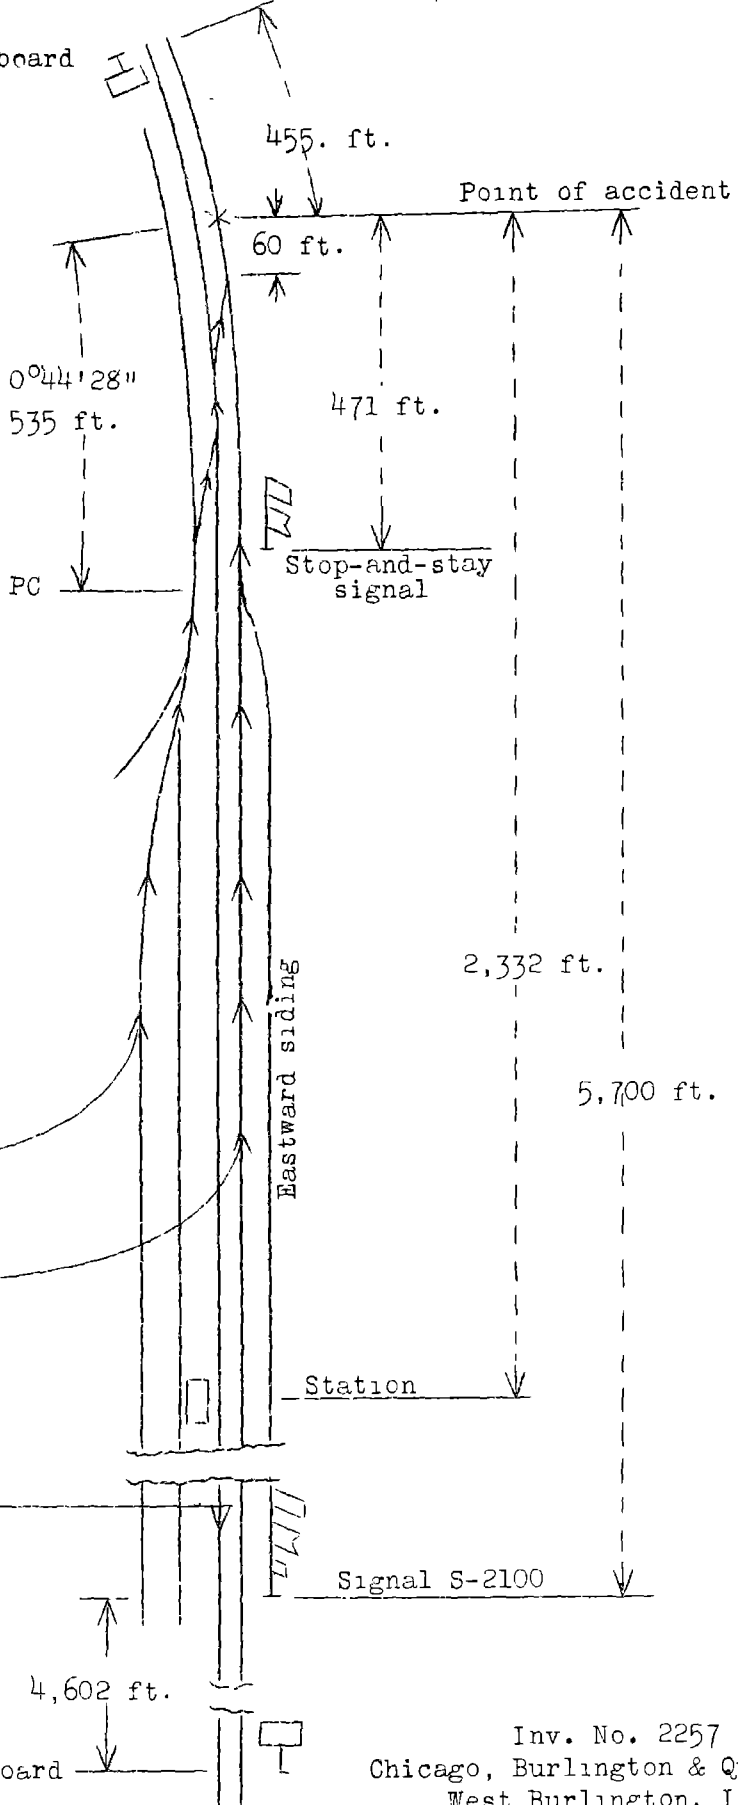
Inv. No. 2257  
 Chicago, Burlington & Quincy RR  
 West Burlington, Iowa  
 Feb. 26, 1938

A running track through the yard situated north of the station connects with the westward main track approximately 2,055 feet east of the station, and from a point 25 feet east of this connection a cross-over running in an easterly direction connects the westward main track with the eastward main track; the accident occurred approximately 60 feet east of the east end of this cross-over. An eastward siding, 4,672 feet in length, parallels the eastward main track on the south. Special instructions contained in the timetable provide a maximum speed of 55 miles per hour for freight trains using 0-5 type engines, the type involved in this accident.

The automatic block signals involved are eastward signal S-2100, located 5,700 feet west of the point of accident, and a stop-and-stay signal located 471 feet west of the point of

Although the location of the cross-over switches involved in this accident is plainly visible for a long distance, the curve at the eastern end of the yard limits prevents the engineman of an east-bound train from seeing to the extreme end of the yard limits; furthermore, within yard limits a clear indication of a block signal gives no assurance that the track governed by that signal will not be occupied immediately ahead of an approaching train. The evidence clearly shows that Extra 5604 was being

operated at a relatively high rate of speed through the yard limits and that this was in accordance with common practice; the shop train started across to the eastward track when the approaching freight train, in view of its speed, was less than stopping distance away.
