**ROAD ACCIDENT REPORT**  
**CHICAGO, BURLINGTON, AND**  
**QUINCY RAILROAD COMPANY**  
**TRAIN 64 AND TRAIN 824**  
**DERAILMENT AND COLLISION**  
**WITH TANK CAR EXPLOSION**  
**CRETE, NEBRASKA**  
**FEBRUARY 18, 1969**

REPORT NUMBER: NTSB-RAR-71-2

CHICAGO, BURLINGTON, AND  
QUINCY RAILROAD COMPANY  
TRAIN 64 AND TRAIN 824  
DERAILMENT AND COLLISION  
WITH TANK CAR EXPLOSION  
CRETE, NEBRASKA  
FEBRUARY 18, 1969

ADOPTED: FEBRUARY 24, 1971

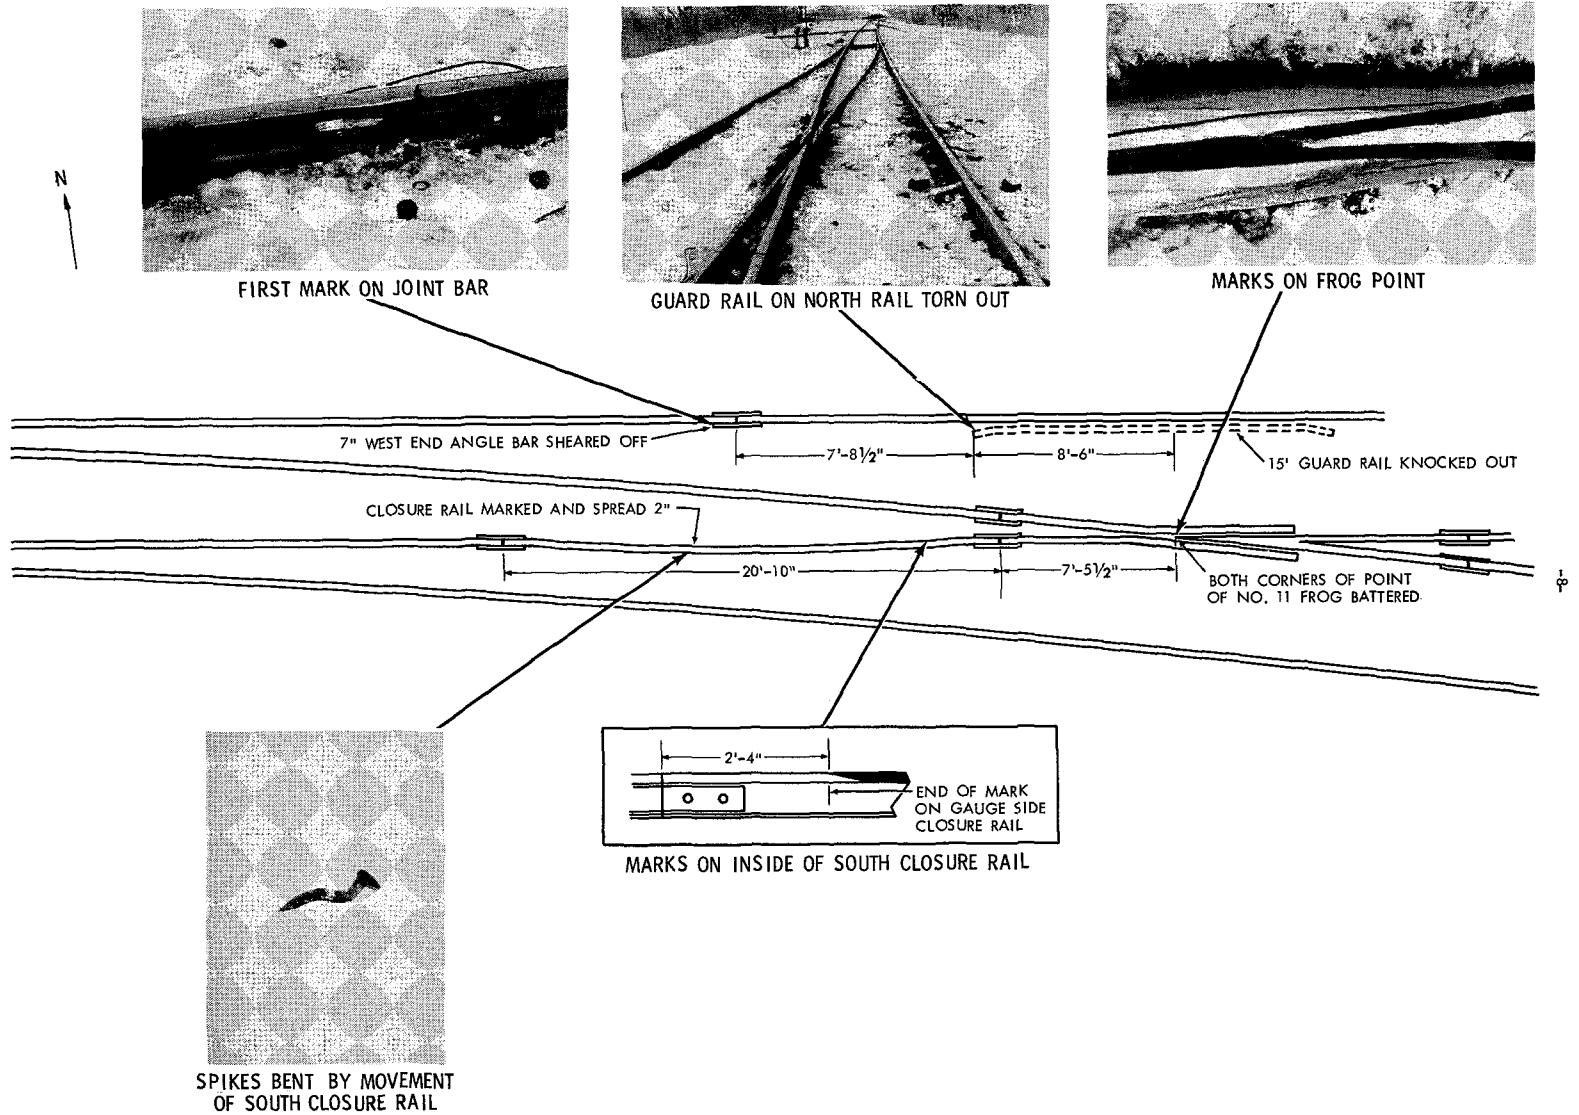
**FIGURE 2**

The guardrail attached to the inside of the north rail, protecting the frog point was broken and torn out. About 4 feet 5 inches of the west end of the guardrail was broken, as shown in the sketch in Figure 3, page 9. The two larger pieces of the broken portion of the guardrail were battered on their receiving ends. The piece of broken guardrail, marked No. 1 in Figure 3, was the piece found by the brakeman on

**FIRST MARKS OF DERAILMENT**

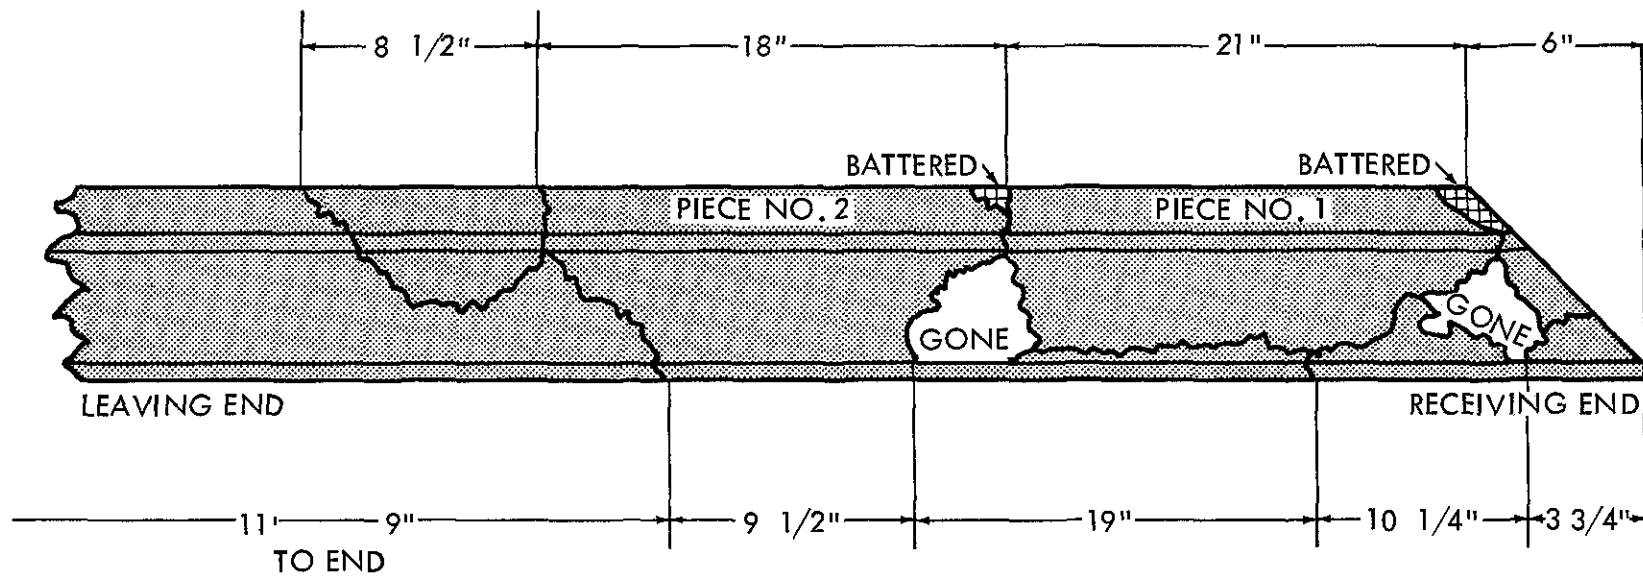
**BROKEN GUARD RAIL**

the 28th car, GN 6583. The piece of guardrail marked No. 2 was found in the vicinity of the turnout, and the piece of guardrail, which was approximately 11 feet 9 inches long, was found under the caboose of No. 6 about 120 feet east of the point of the frog.

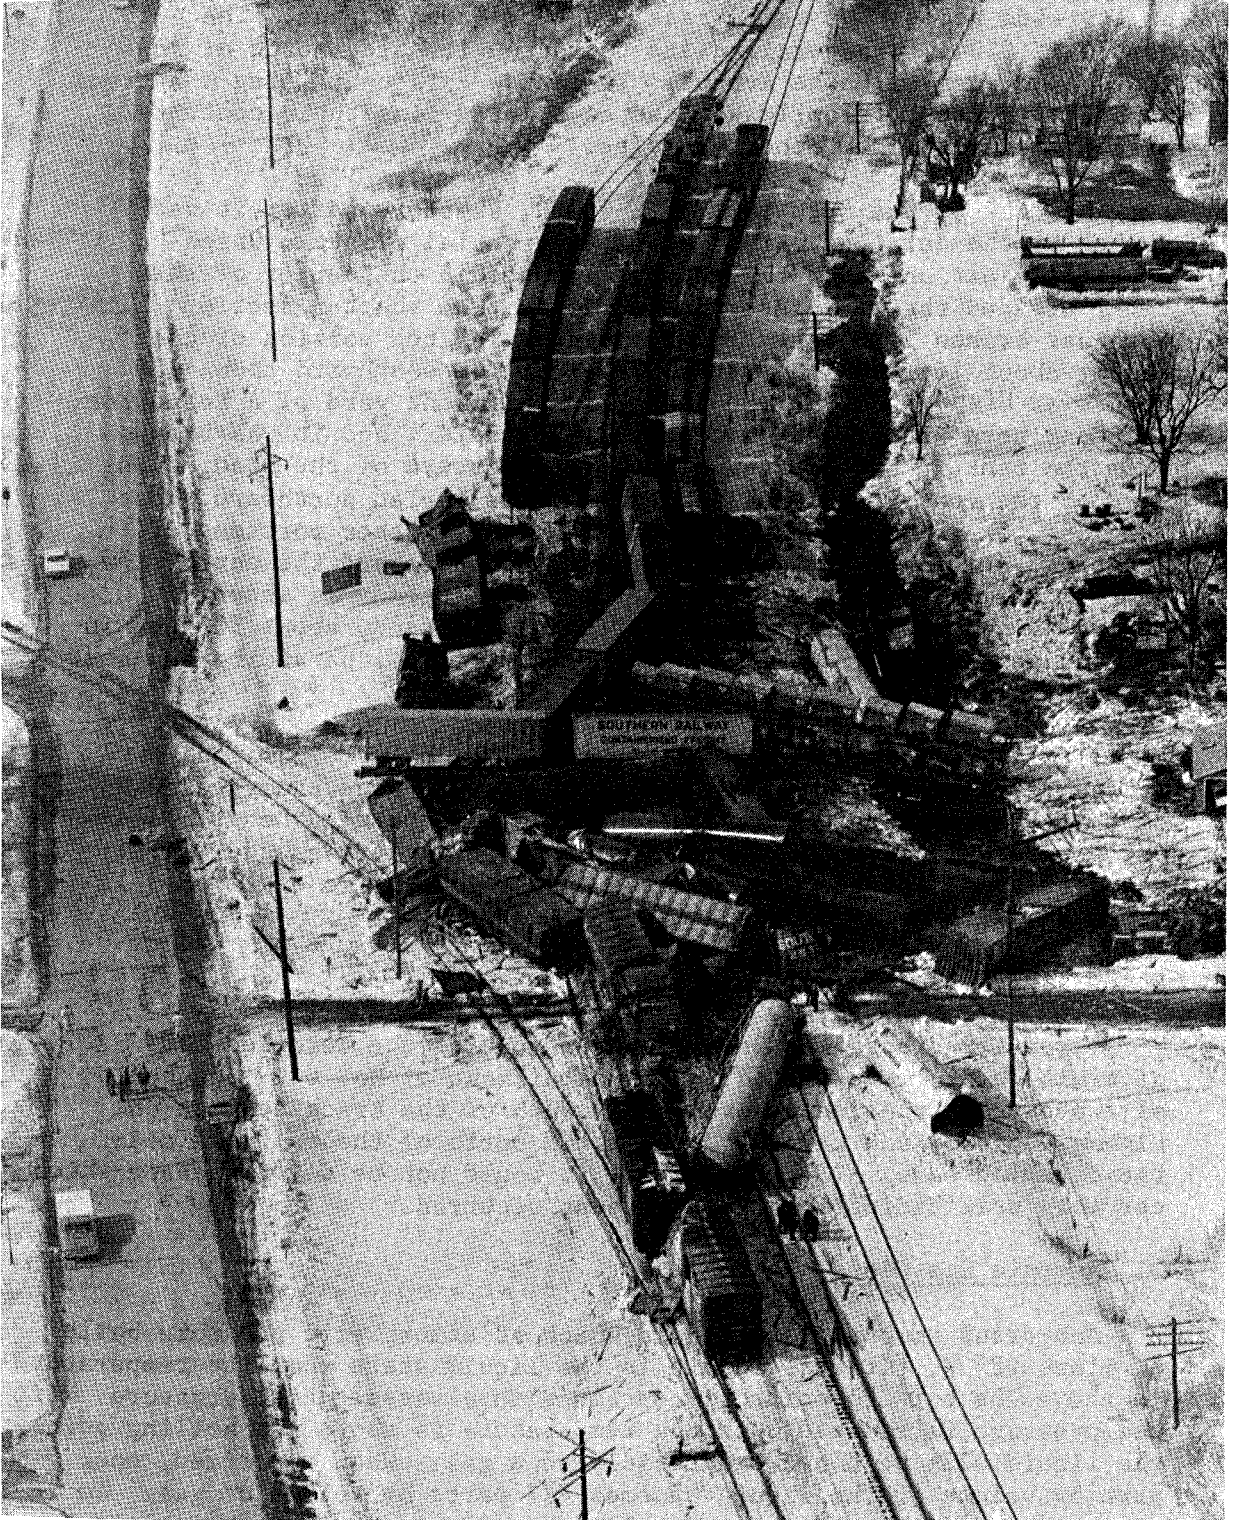
Figure 4

As No. 64 passed over the turnout leading to the Old Wymore Main siding, the spread closure rail allowed the north wheels of the east trucks of GN 6583, the 28th car, to derail inside the north rail just west of the guardrail. The north wheels struck and broke the guardrail, rerailed at the frog, and continued eastward on the track. There is no evidence that any of the following cars derailed until the 72nd car. ATSF 20820, a loaded boxcar, derailed at the frog of the switch towards the southside of the main track--the direction against which the guardrail, now broken, had provided resistance. The 73rd through 90th cars also were derailed. The derailed cars continued eastward along the southside of the main track and struck the boxcar standing on the Old Wymore Main siding. The first car on the siding was propelled eastward, and the second to the fifth cars, inclusive, were turned on their sides south of the track. The 72nd to the 75th cars, inclusive, of No. 64 came to a stop south of the main track in the area of the general derailment, about 700 feet east of the initial point of the derailment. The 76th car, and several of the following cars, were diverted northward across the main track in the area of the general derailment where they struck the standing cars of No. 824 on the siding, including the three tank cars loaded with anhydrous ammonia. (See Figure 4, on page 13 .)

The 38th car in No. 824, GATX 97076, was derailed and turned on its side across the main track, east of Unona Avenue. The 40th car, GATX 97041, was derailed and turned on its side north of the siding and west of Unona Avenue. These two cars containing anhydrous ammonia did not develop leaks, and at a later time their contents were transferred into other vehicles.

The tank of the 39th car, GATX 18120, shattered after it was struck by the derailed cars. A circumferential fracture which developed just ahead of the manway, located in the center of the tank, divided the tank into two sections. The shorter section also was broken into a number of pieces. The top portion of the shell, about 16 feet in length, was propelled southward about 200 feet over Highway No. 33 and landed in the front yard of a residence. The tank head was broken just above the coupler, and it was broken from the tank in two pieces. The bottom portion of the head, with part of the center sill still attached, was hurled northward about 140 feet, where it landed along Unona Avenue. Other portions of fractured sections of the tank were propelled toward the north side of the track, and came to rest in various positions as shown in Figure 5, page 15. The longer section of the tank, about 30 feet in length, remained intact and came to rest north of the siding and east of Unona Avenue.

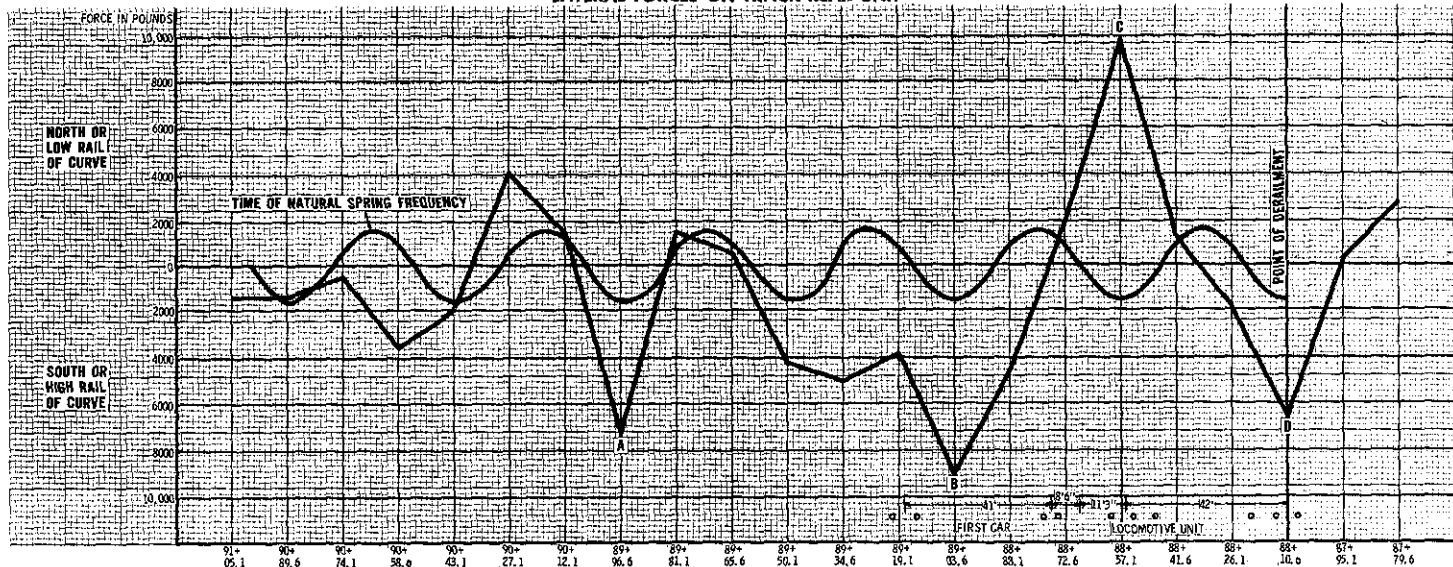
FIGURE 6  
LATERAL FORCES ON TRACK REAR UNIT

When a train moves around a curve, forces are produced from centrifugal force, and these forces vary if the curvature is not uniform. Forces may also be produced if the superelevation varies. These lateral forces have been plotted in Figure 6, page 28 . The plot shows that at points (A) and (B) the wheels of all locomotives were slapped against this outside rail, then at (C) were slapped against the inside rail, and then at (D) against the outside rail. At this point the rail moved outward. This action was rhythmic which could have resulted in an amplification of the force when point (D) was reached.

The most significant force plotted is the lateral force on the track for the north and south rails. This plot represents the sum of the centrifugal force due to the curvature of the rails and the lateral force

The very significant finding from this chart is that the trucks of the locomotive, and every other car, were being thrown from side to side in the 200 feet before reaching the rail failure point, with sharp, regular peaks in the magnitude of the forces against the trucks before the point in the south rail which failed. At (A), the force against the south rail was 7,000 pounds; at (B), it was about 9,000 pounds; and finally at (D), the point of derailment, the lateral force was about 6,500 pounds. At (C), a force of 10,000 pounds was calculated, which force acted against the north rail and was opposite in direction to the failure.

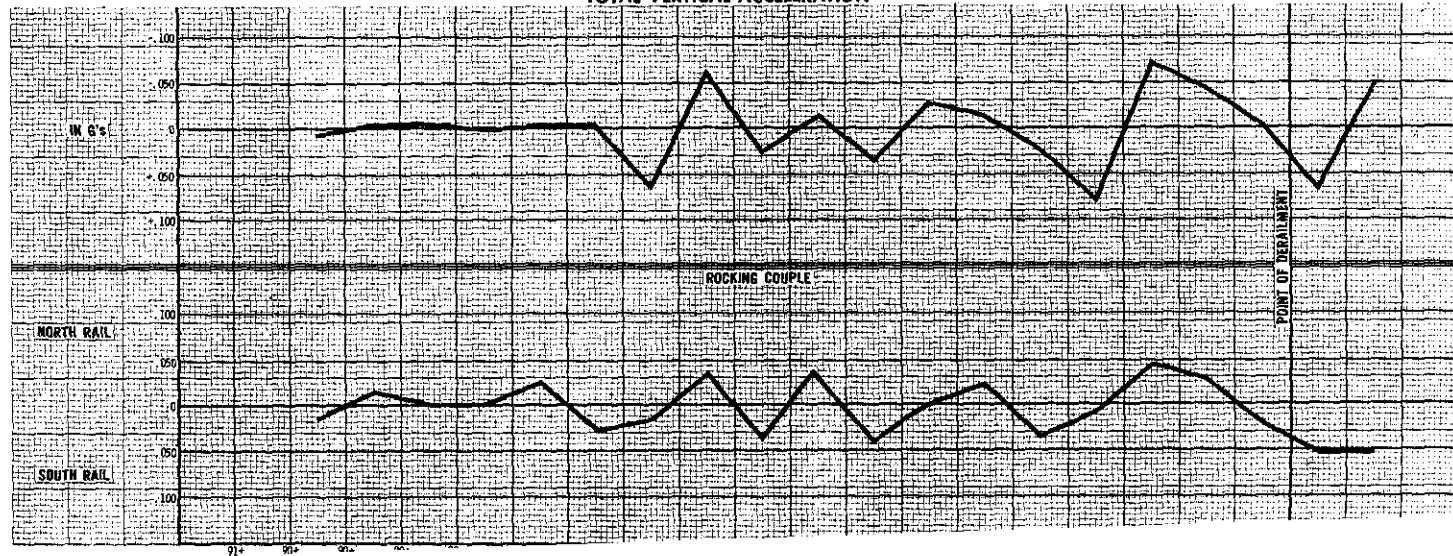
FIGURE 7  
TOTAL VERTICAL ACCELERATION

It is also noted that a vibratory excitation (wavelike variation of forces) existed in the vertical accelerations preceding the point of derailment, and the rocking couple also displayed a longer, but not higher wave in its variations just before the point of derailment.
