ACCIDENT ON THE
CHICAGO, BURLINGTON & QUINCY
RAILROAD

NAPIER, MO

OCTOBER 2, 1939

INVESTIGATION NO 2386

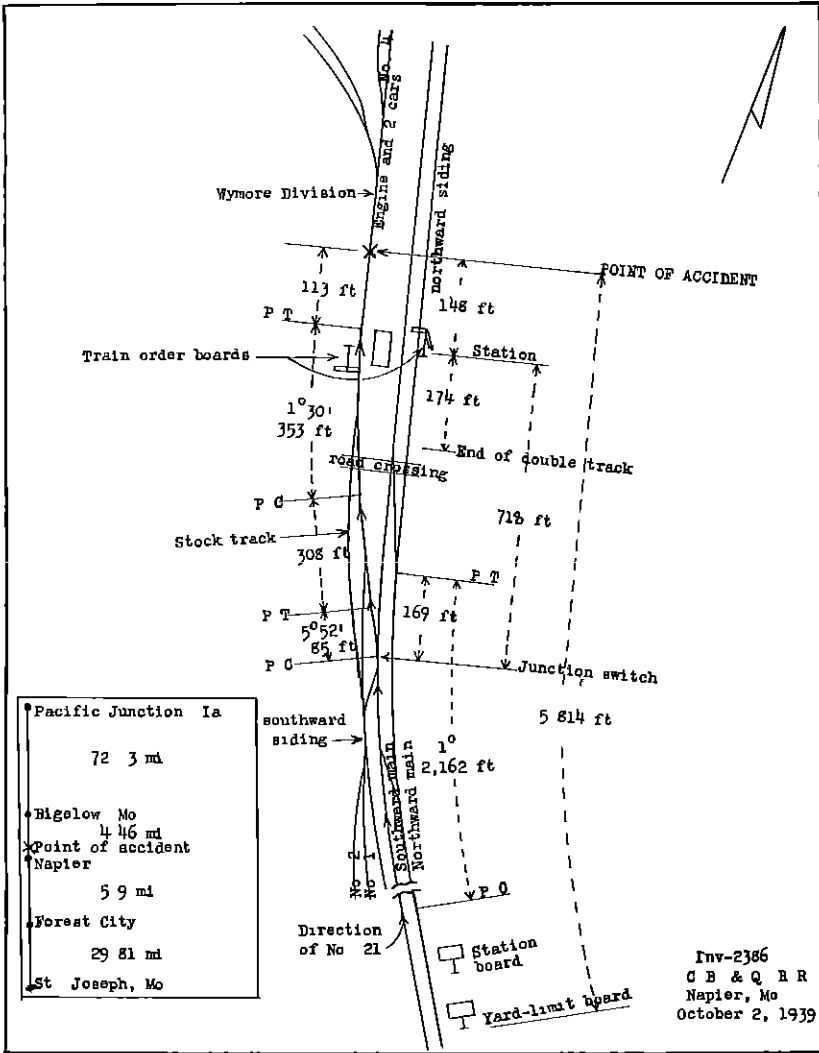
FIGURE 1 - Track layout in vicinity of the point of accident

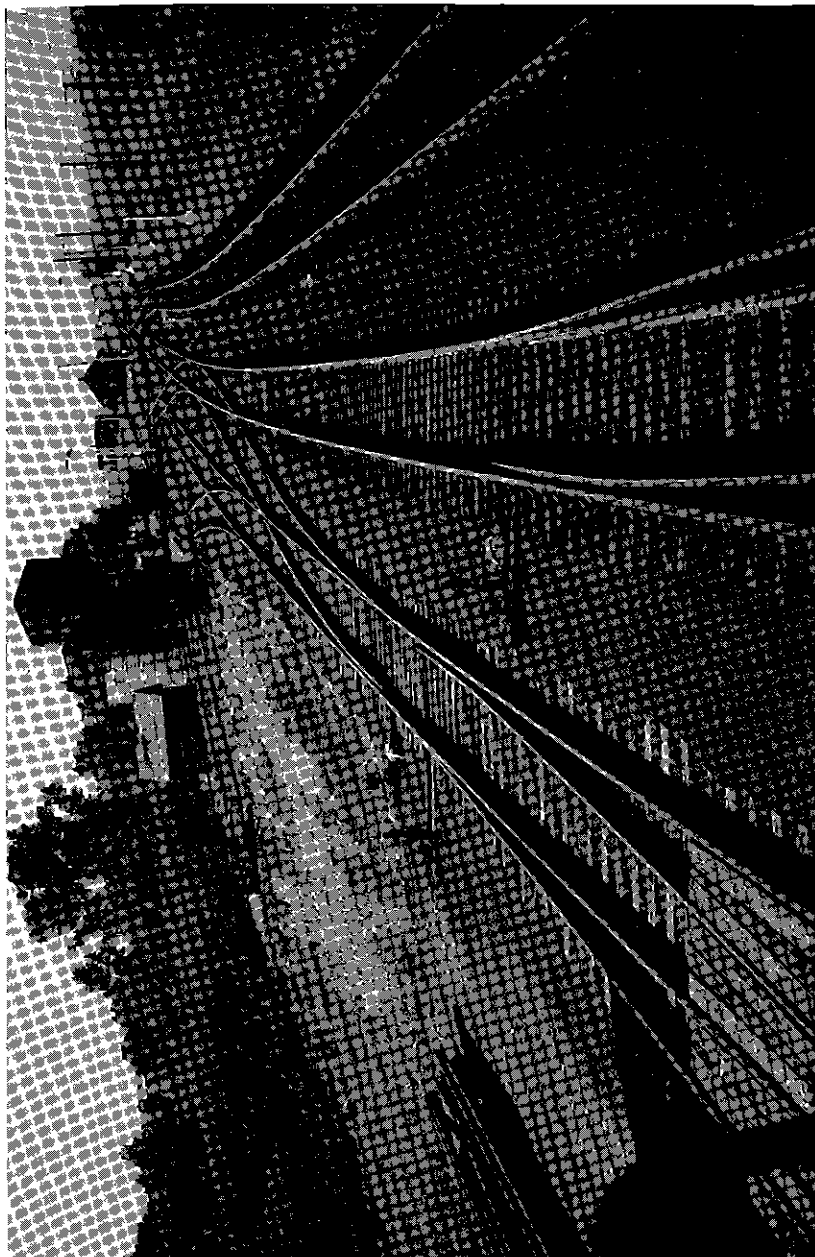
FIGURE 2—View of tracks south of station at Napier

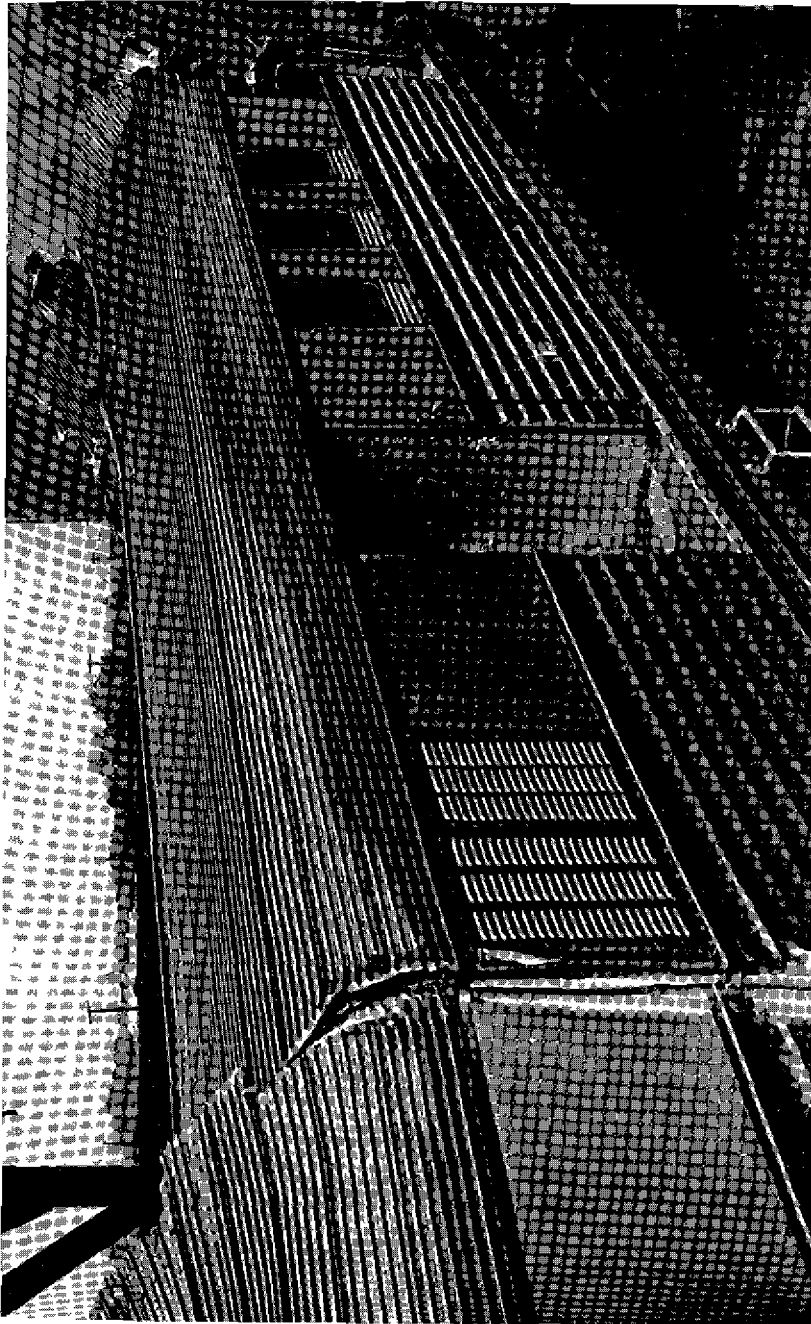
second unit were driven inward 8 to 16 inches and the ends of these two units were bent and damaged.

FIGURE 5—View of rear end of first unit and forward end of second unit, showing damaged condition at articulated joint

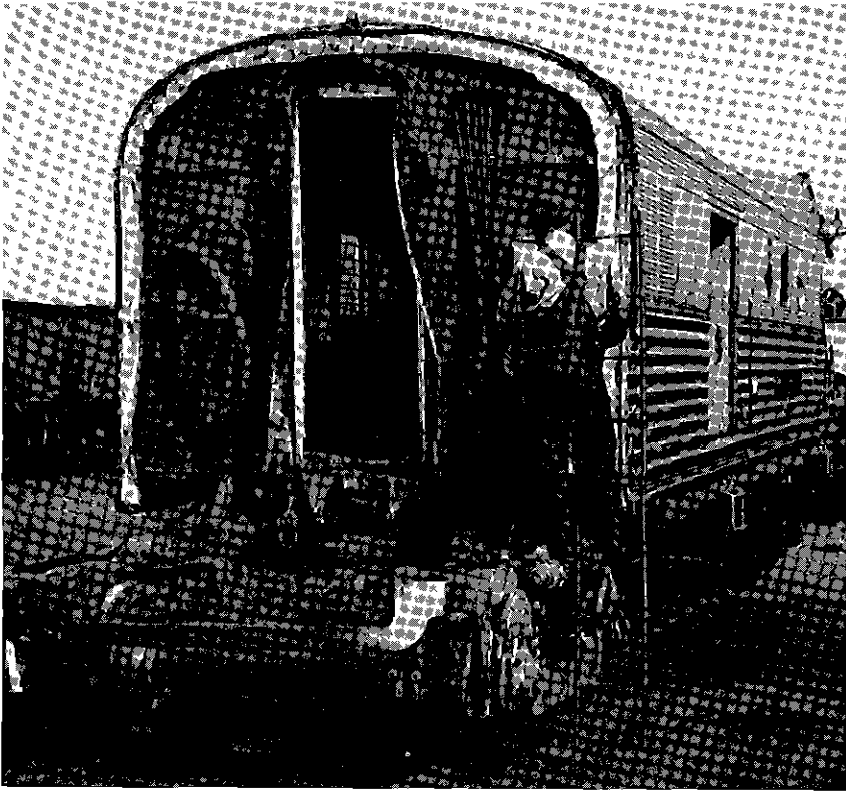
were not telescoped. The damage to the train behind the forward third of the first unit was localized almost entirely at the ends of the first two units, and no general distortion or breaking up of car superstructures occurred. The two end center-sill members of the first unit were buckled in such manner as to push up the floor in this region. The floor corrugations were sheared and the corner posts and the rear edge of the roof were damaged. The front and rear ends of the second unit were damaged in approximately the

FIGURE 6—View of rear end of first unit showing extent of damage
