INTERSTATE COMMERCE COMMISSION

REPORT OF THE DIRECTOR

CHICAGO, BURLINGTON & QUINCY RAILROAD

OLD MONROE, MO.

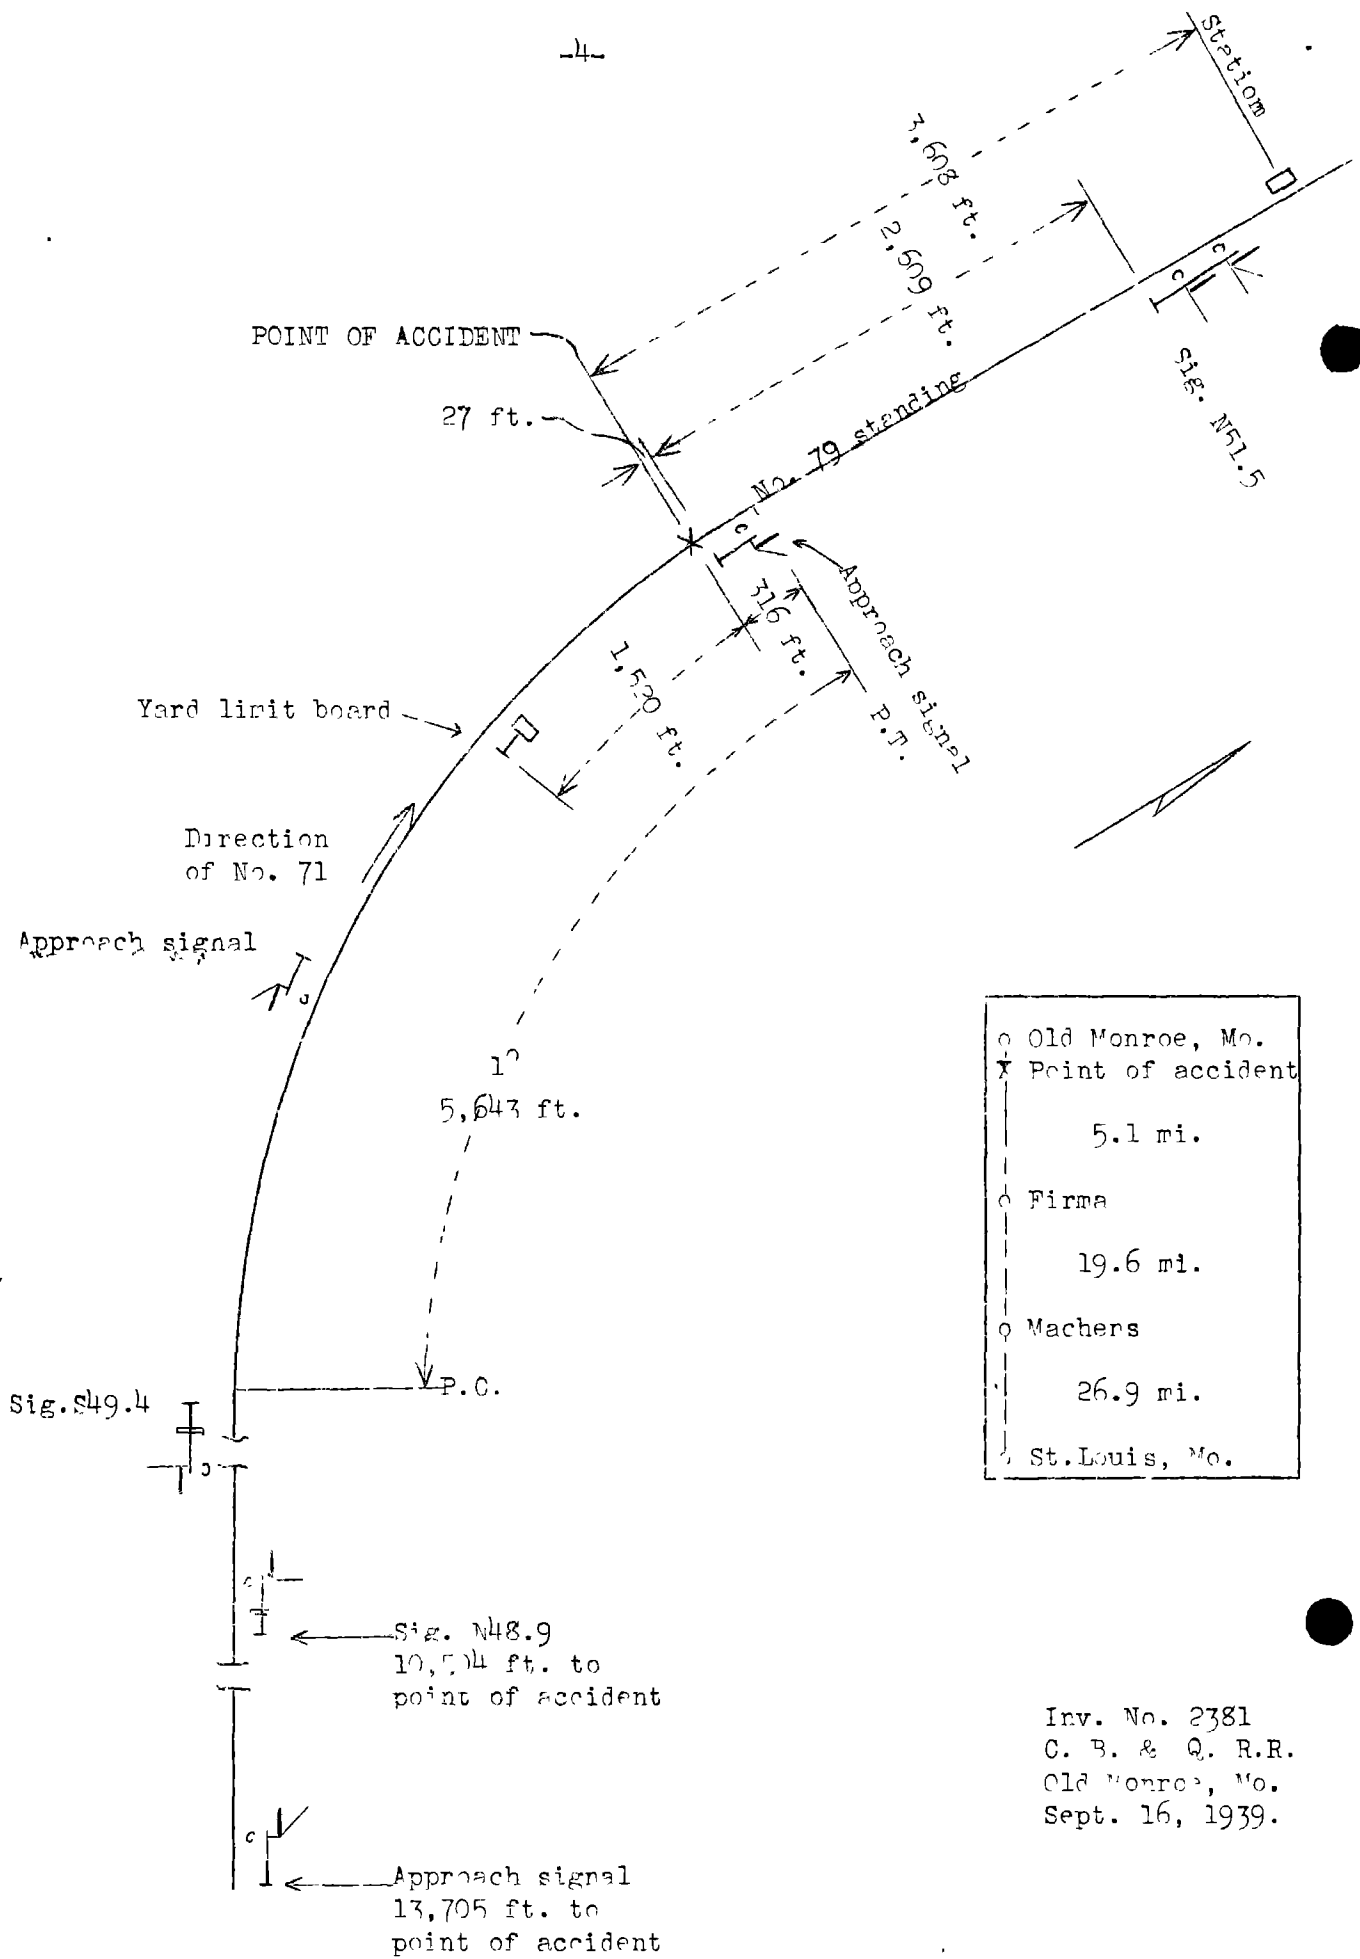
Inv. No. 2381
C. B. & Q. R.R.
Old Monroe, Mo.
Sept. 16, 1939.

| x | Point of accident |
